STRUCTURAL INTEGRITY CRITERIA & HYDROLOGIC/HYDRAULIC CAPACITY ASSESSMENT

MERAMEC ENERGY CENTER

*Meramec Energy Center
8200 Fine Road
St. Louis, MO 63129*

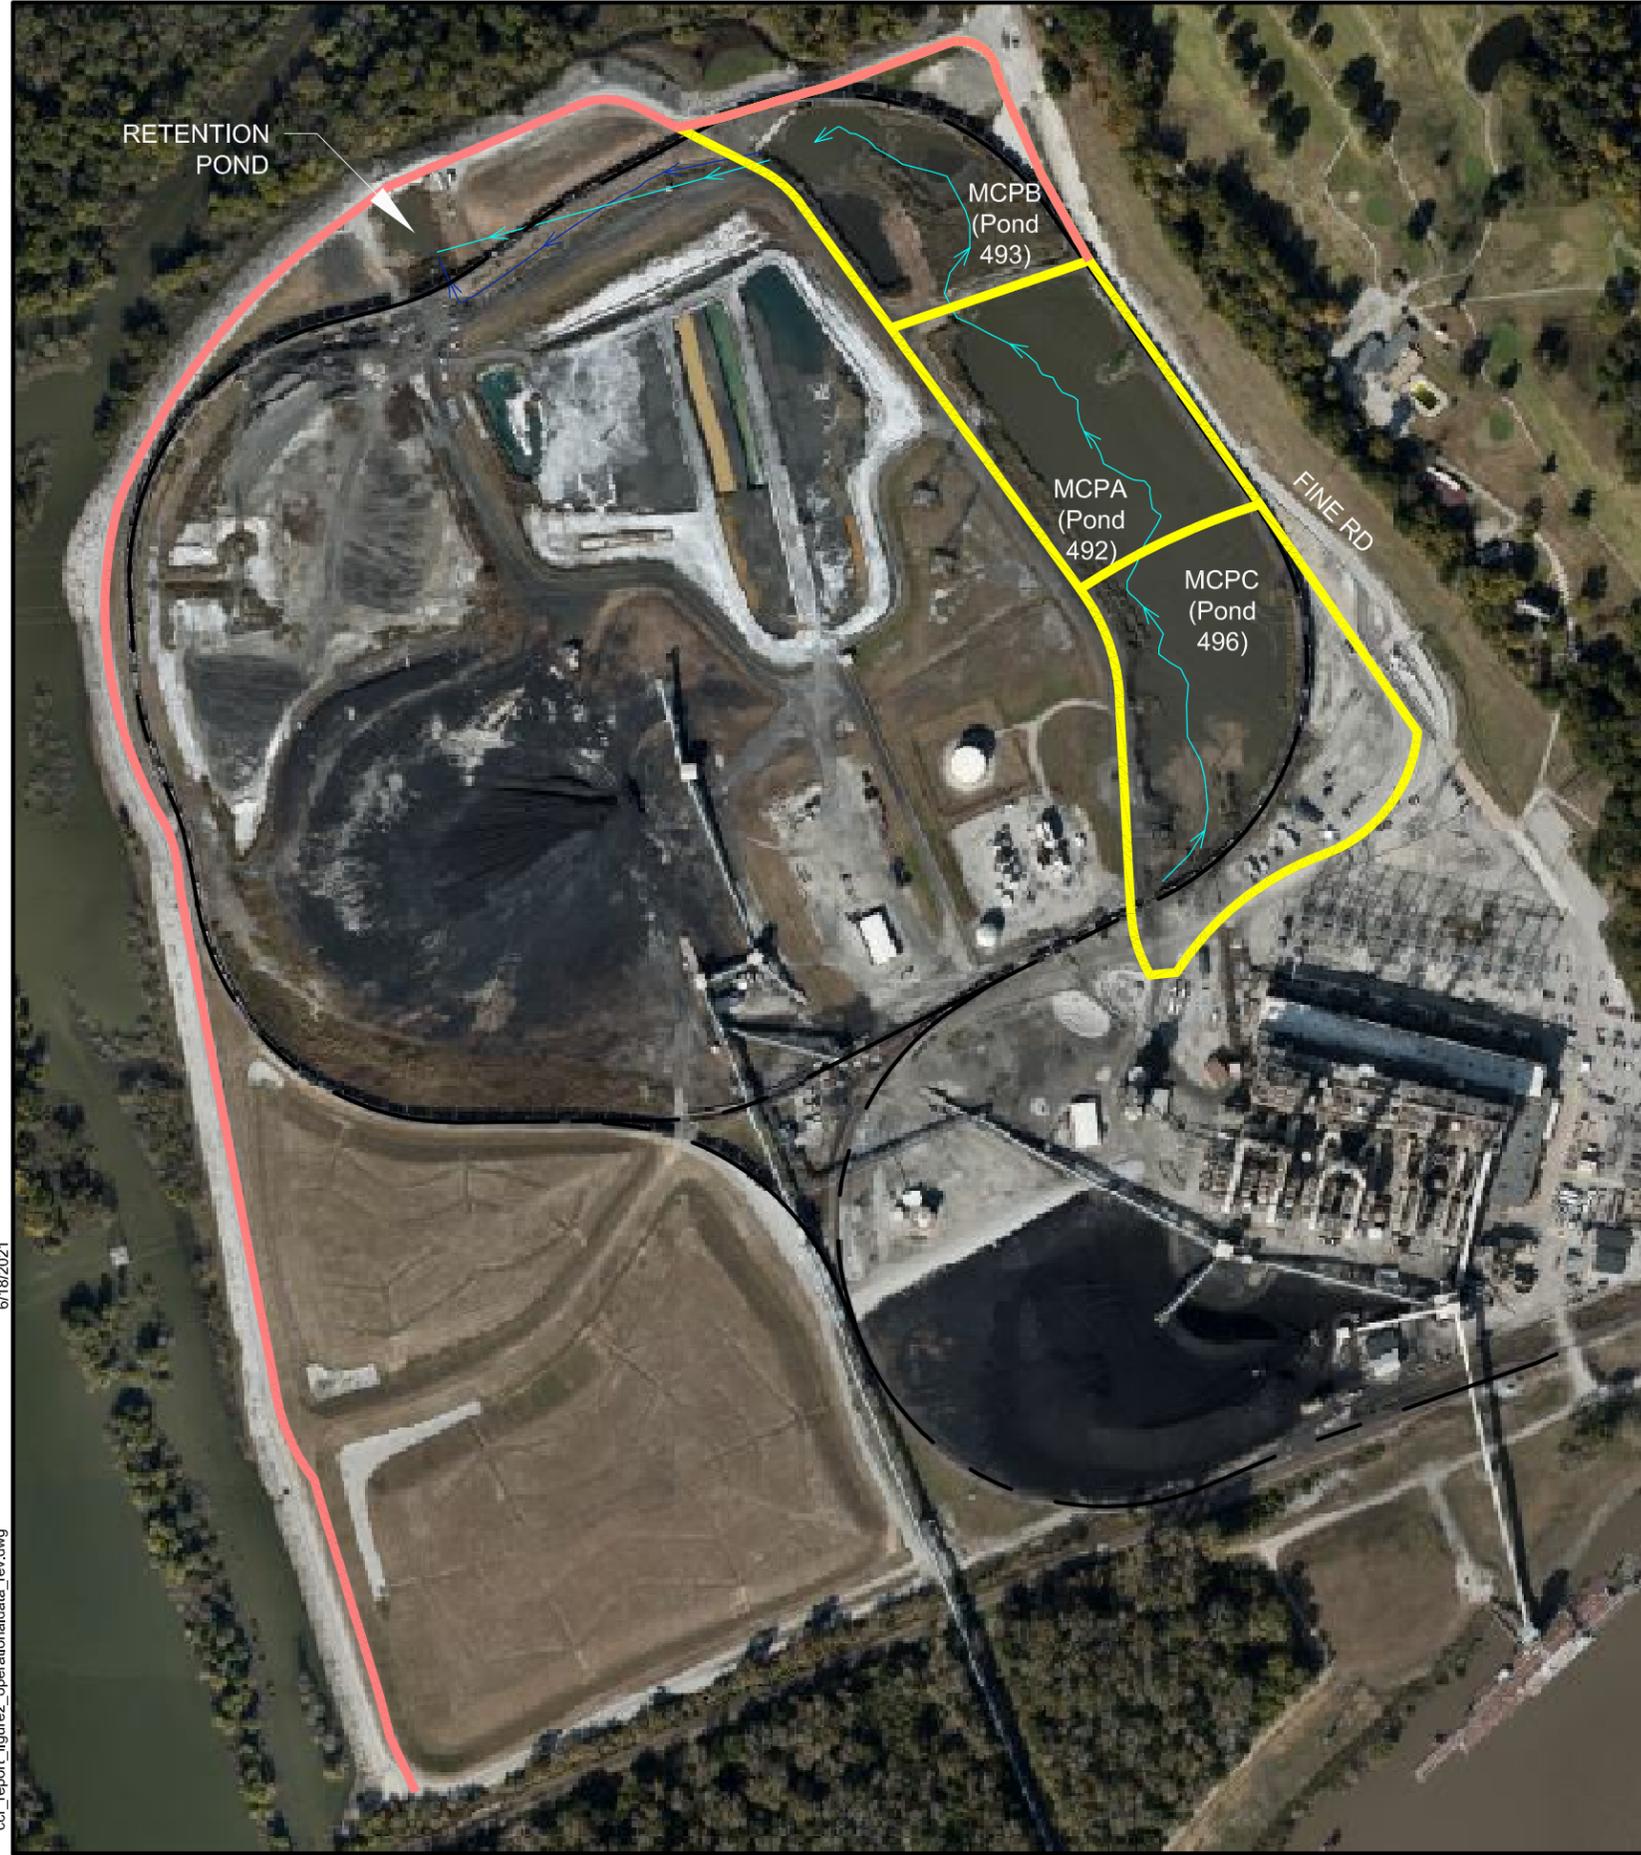
MCPA, MCPB and MCPC were constructed in the 1950s, are interconnected, and two of the ponds (MCPA and MCPC) are incised. MCPD was developed in 2002 as an above grade, HDPE lined impoundment located within the footprint of the original 1950's vintage ash ponds which had been deactivated years earlier. The location of the Meramec Energy Center is depicted on Figure 1, United States Geological Services ("USGS") topographical quadrangle map. Various design and operational features of the CCR units, including water flow path, is set forth on Figure 2.
