**CONSTRUCTION QUALITY ASSURANCE REPORT
CLOSURE OF THE BOTTOM ASH POND
AND FLY ASH POND
MEREDOSIA POWER STATION
800 SOUTH WASHINGTON STREET
MEREDOSIA, MORGAN COUNTY, ILLINOIS**

**AMEREN ENERGY RESOURCES
ST. LOUIS, MISSOURI**

**GEOTECHNOLOGY, INC.
ST. LOUIS, MISSOURI**

JANUARY 18, 2019

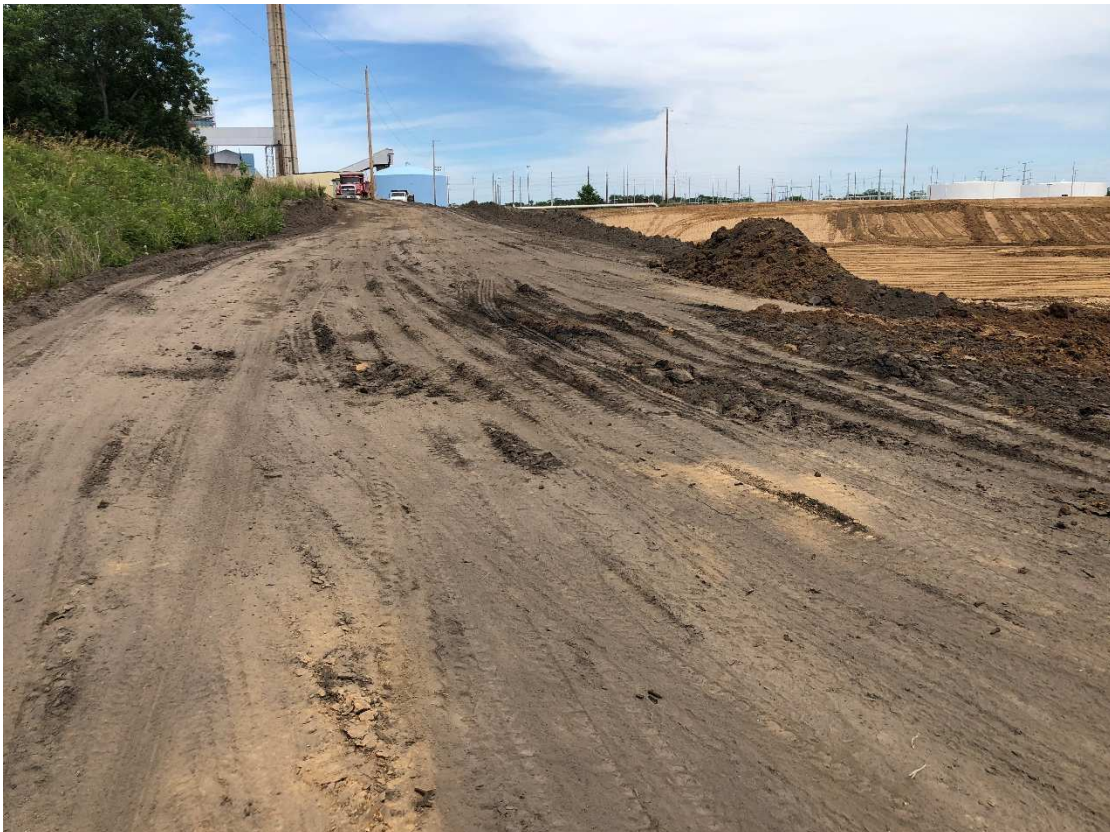
Photograph 4 ▲ - View of Bottom Ash Pond berm backfill activities with pumping subgrade (repaired next day), looking east.

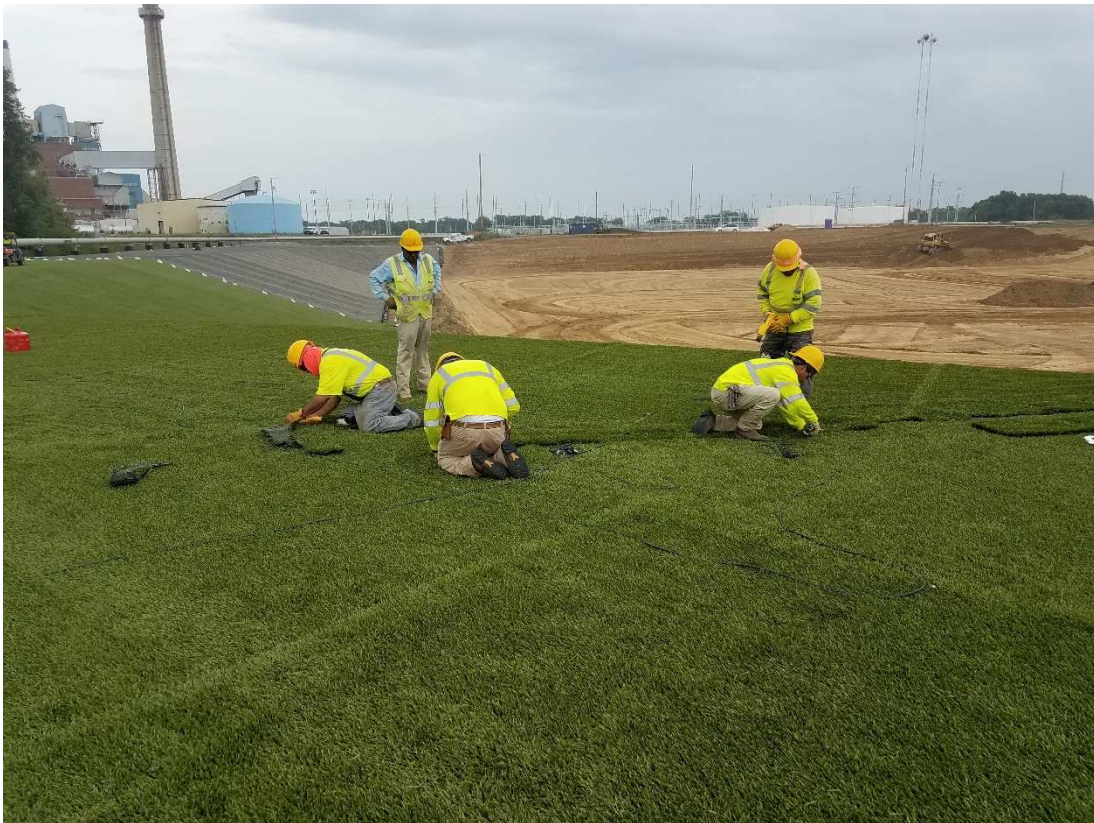
Photograph 8 ▲ - View of turf repairs at the Bottom Ash Berm, looking northeast.

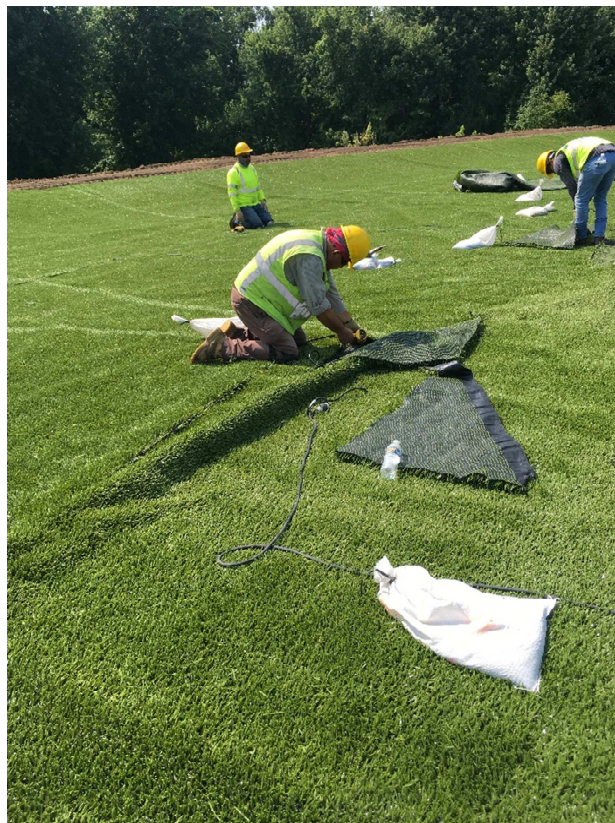
Photograph 6 ▲ - Typical view of turf repair at the Fly Ash Pond, looking northwest.

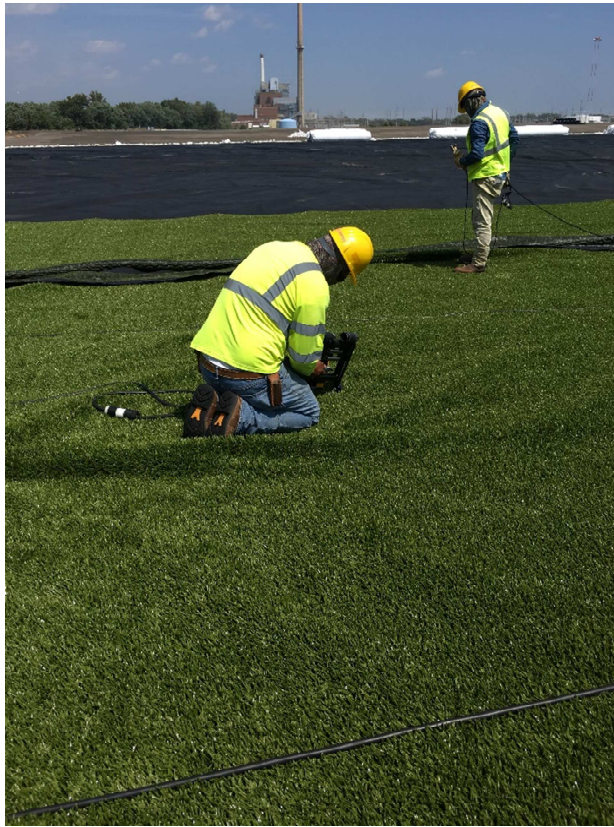
Photograph 1

- Typical view of turf component repair at the Fly Ash Pond.

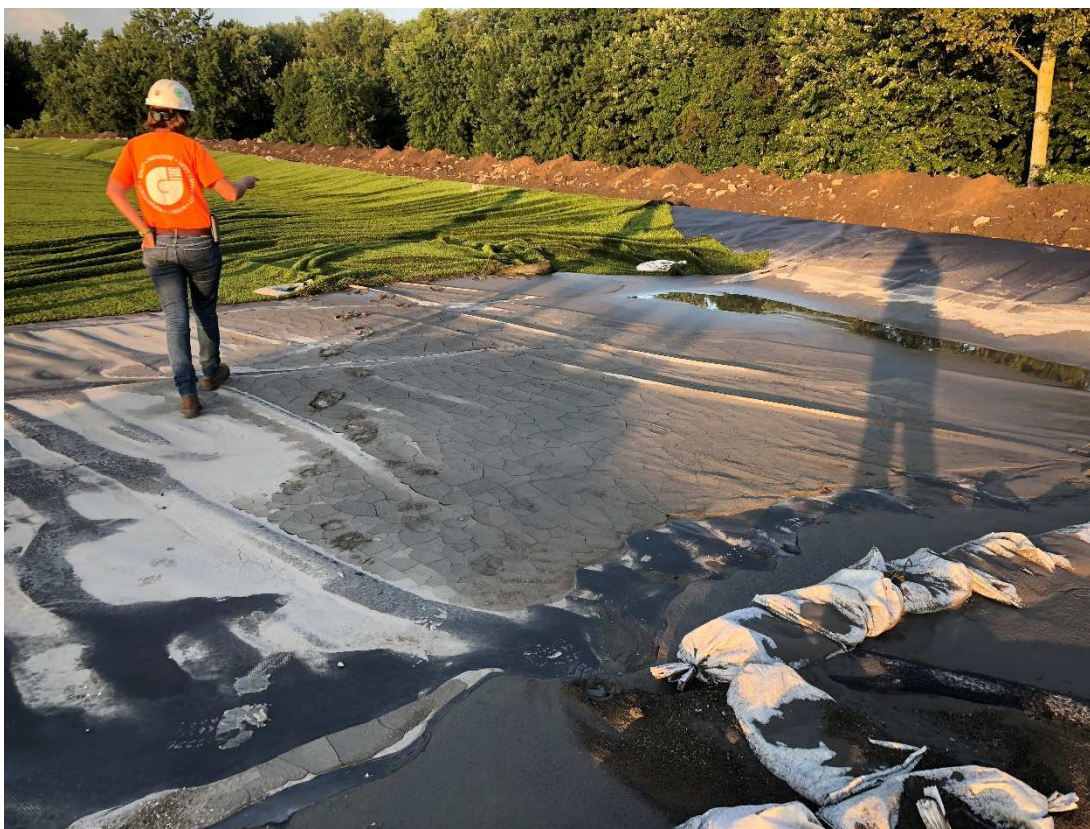
Photograph 3 ▲ - Typical view of minor rain damage at the Fly Ash Pond.

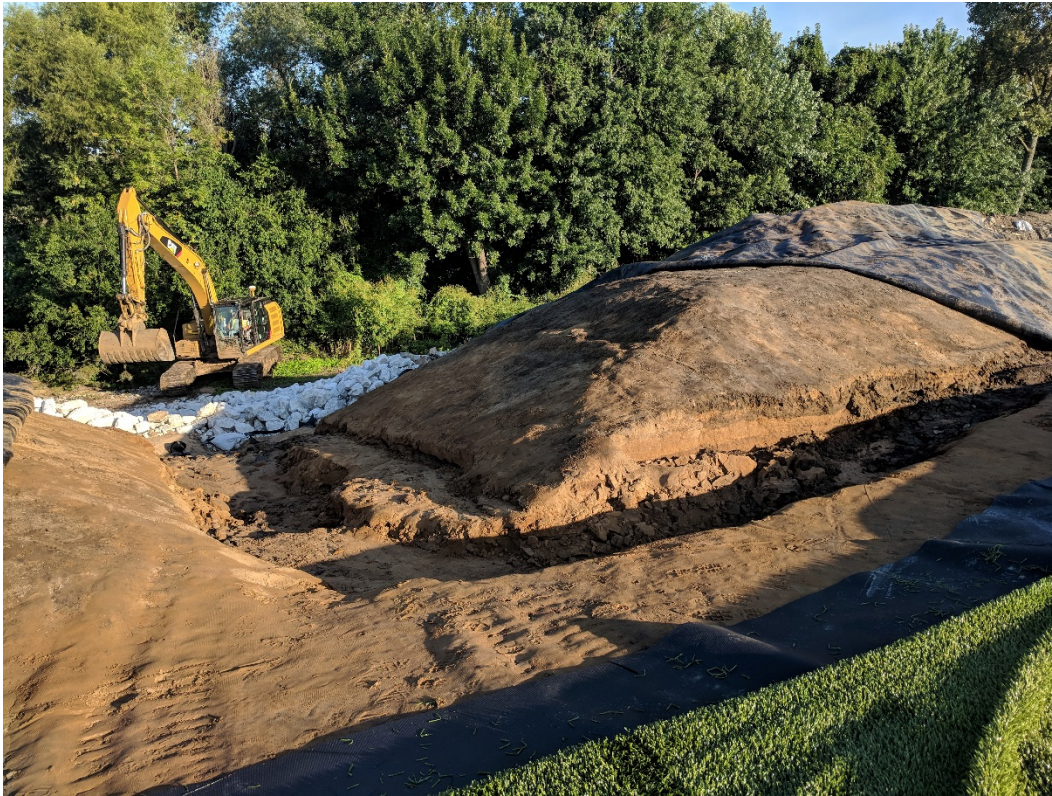
Photograph 1 ▲ - View of downchute erosion under the ClosureTurf at the Fly Ash Pond, looking north.

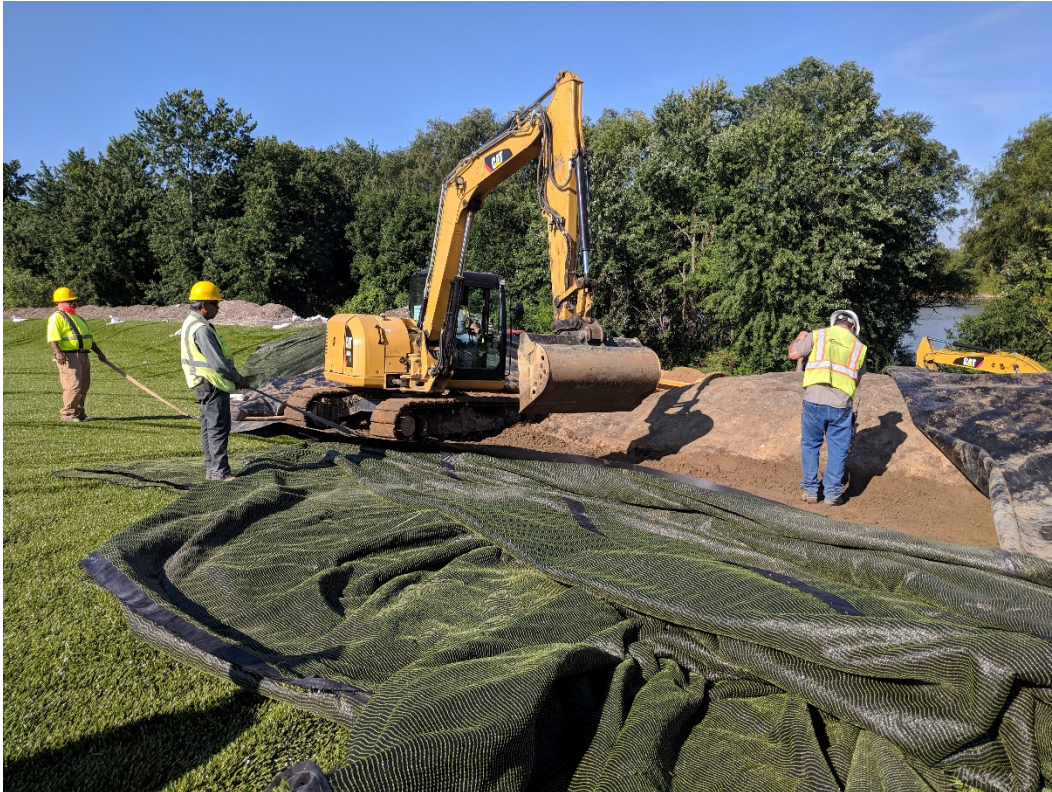
Photograph 2 ▲ - View of downchute erosion repair at the Fly Ash Pond, looking northwest.

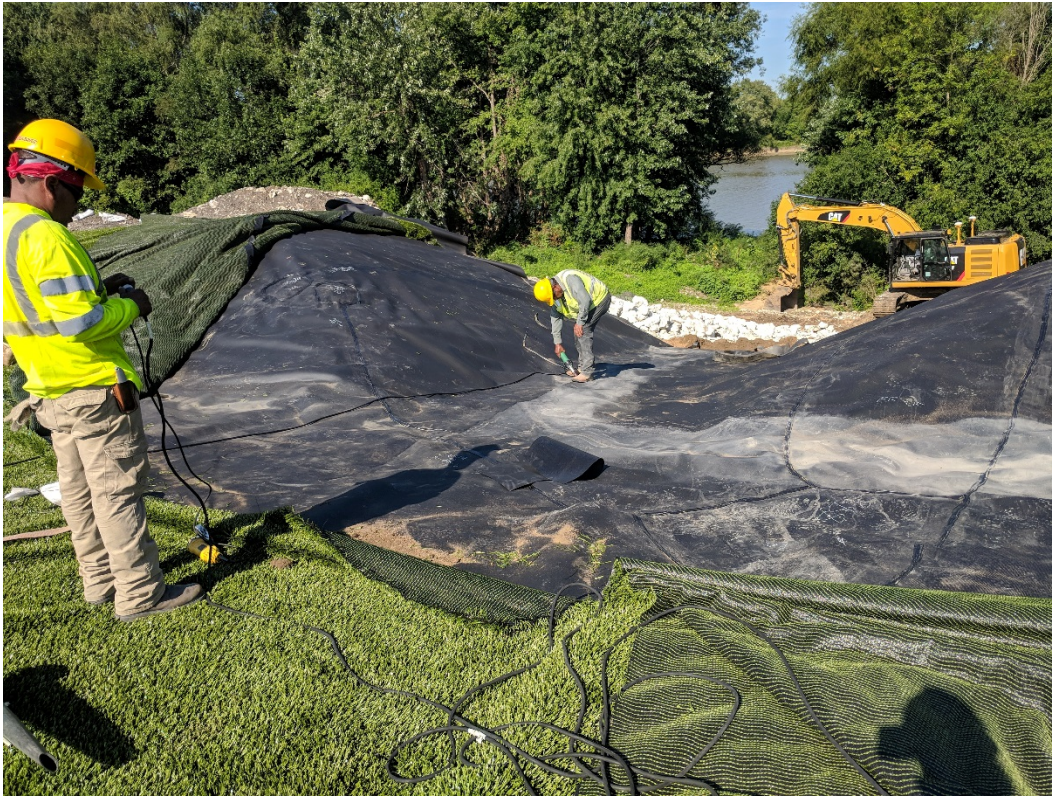
Photograph 3 ▲ - View of geomembrane repair at the eroded downchute, looking northwest.

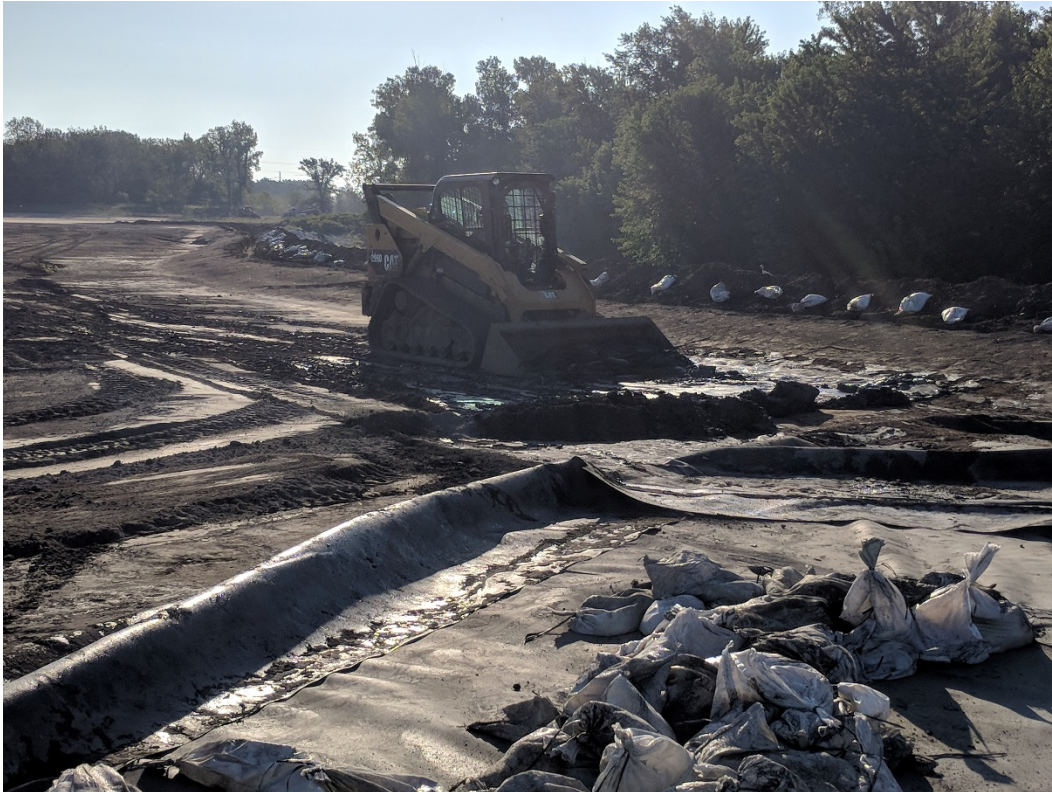
Photograph 4 ▲ - Typical view of subgrade repair activities at the Fly Ash Pond, looking southeast.

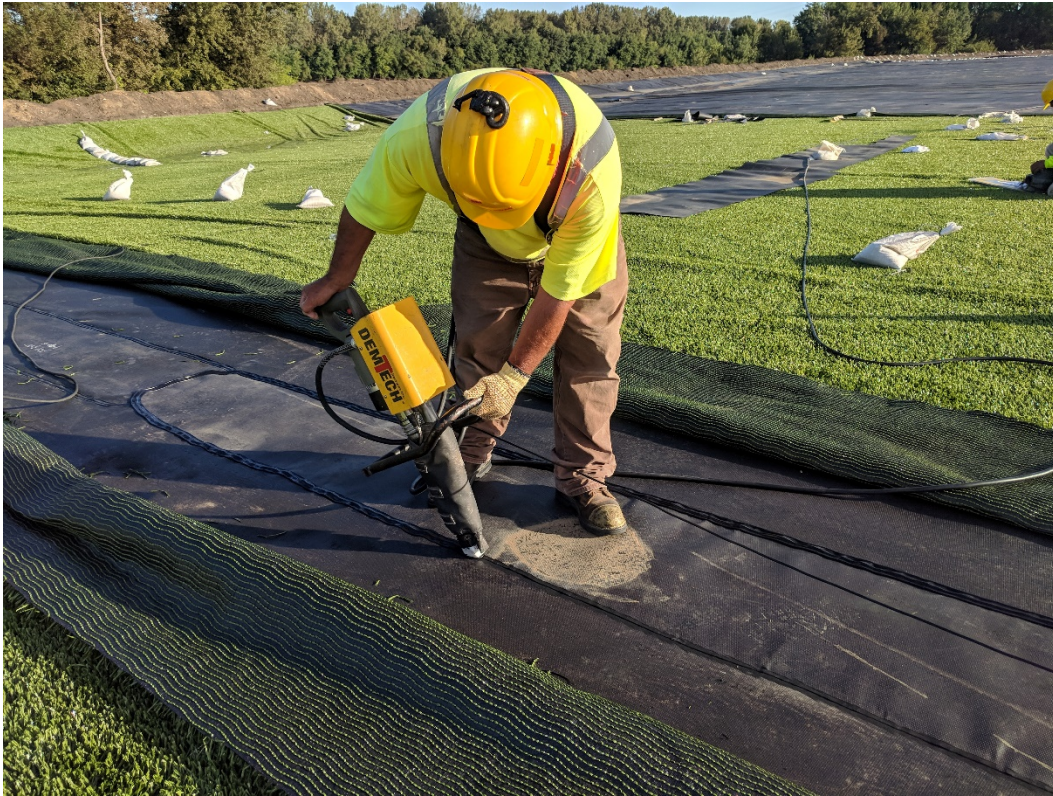
Photograph 3 ▲ - View of HDPE geomembrane repair activities at the Fly Ash Pond, facing north.

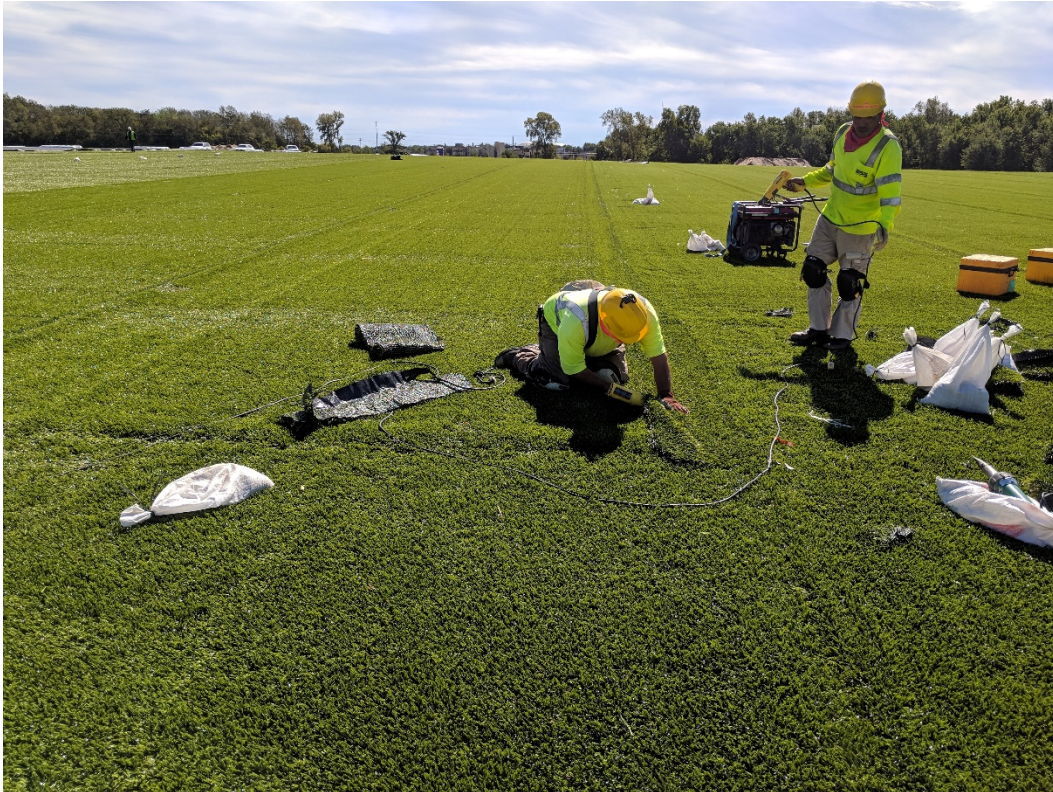
Photograph 4 ▲ - View of typical engineered turf repair activities, facing southeast.

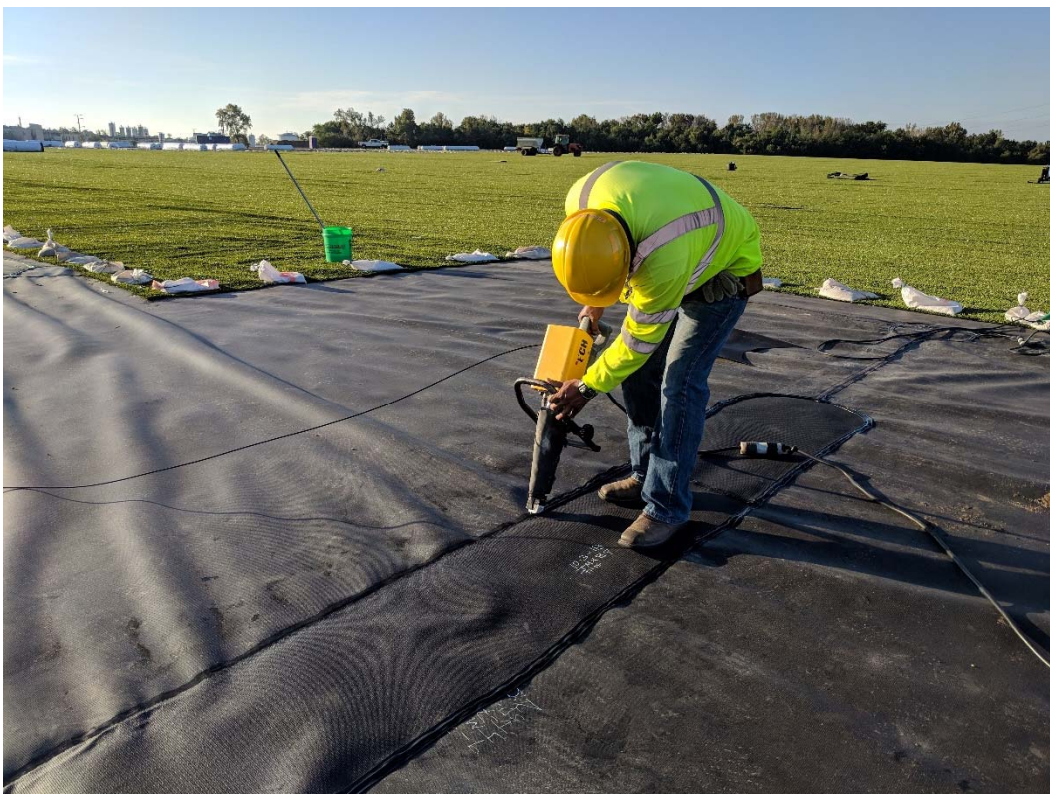
Photograph 4 ▲ - View of typical HDPE geomembrane repair activities, facing northwest.

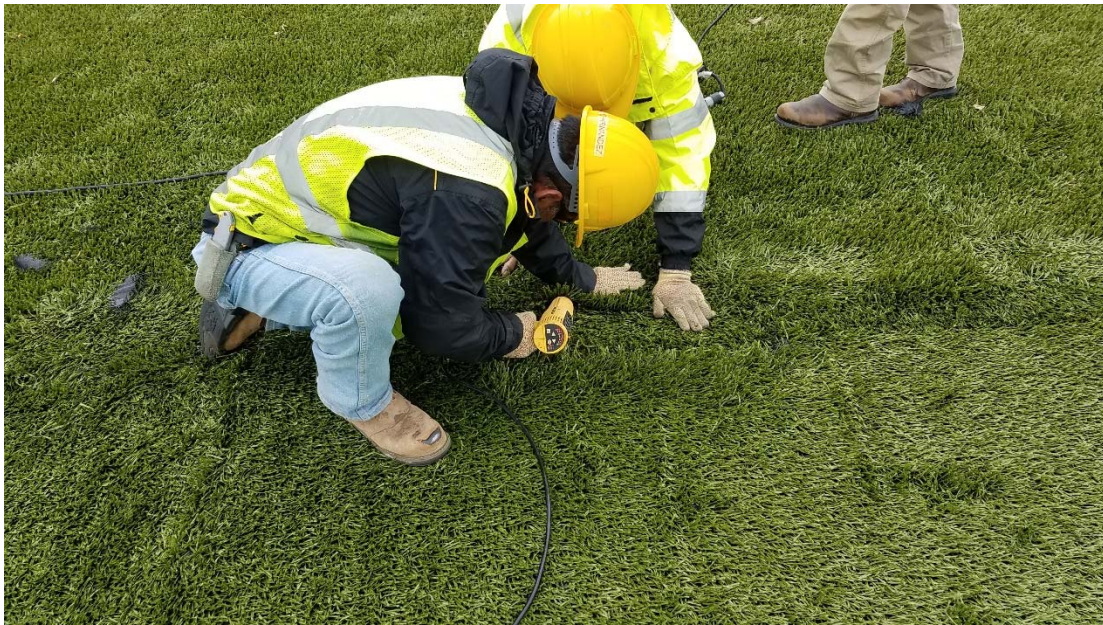
Photograph 1 ▲ - View of typical repair of the engineered turf geosynthetics.
