SAFETY ALERT

AMEREN TRANSMISSION **FIXED-WING DRONE** EVENT

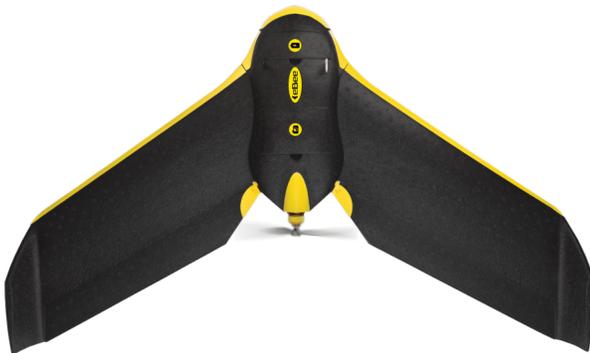
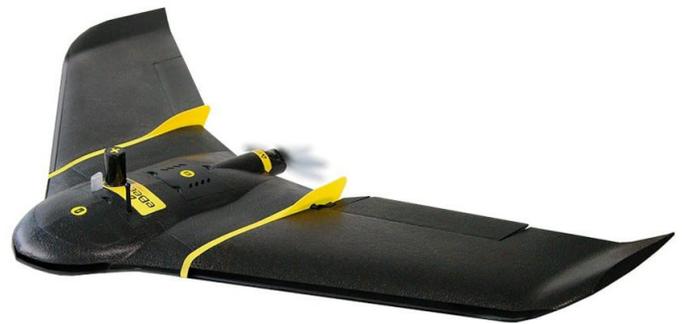
As the co-worker tossed the drone into the air, a gust of wind caught the drone and blew it awry, causing the blade to strike the co-worker on the wrist, lacerating his skin in multiple locations.

- All current protocols and manufacturer's recommendations for operation were followed at the time of the incident. Further analysis determined the manufacturer's procedure was inadequate and additional PPE should have been required to protect the operator.
- The preflight preparation and assessment did not detect the wind gusts that blew the drone awry during launch.

- **Use of the eBee drone was immediately suspended** unless or until an improved launching system and procedure can be developed that eliminates operator contact-exposure with moving parts.
- Additional guidance will be developed regarding wind and gusts that will be issued by the Central UAS Team for use with all drone flights.
- **Transmission will retire the eBee drone** if a suitable and practical launch alternative cannot be developed.
- Central UAS Department will **contact the manufacturer to report the incident and look for recommendations to mitigate this and other potential issues** related to unknown factors, possibly looking at a no or minimal contact launch technique.
