REPORT  
2020012463

**AMEREN MISSOURI LABADIE ENERGY CENTER  
EVALUATION OF CCR UNITS  
40 CFR PART 257  
FRANKLIN COUNTY, MISSOURI**

October 2021

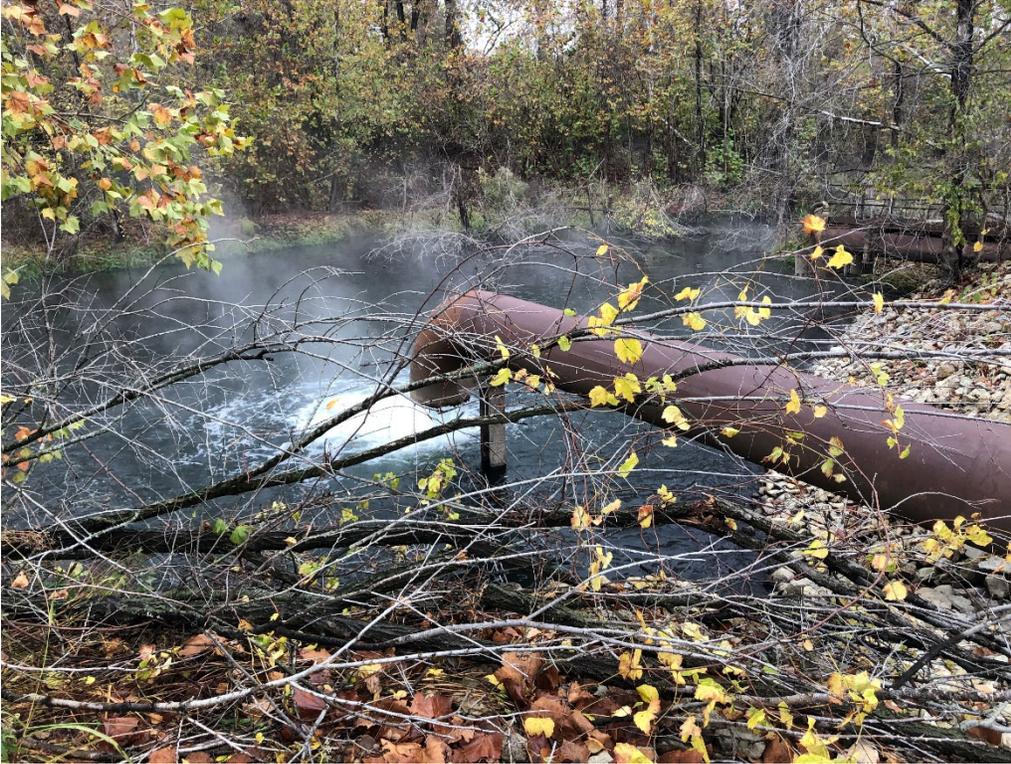
*Figure 1 –LCPA outlet channel in good condition.*

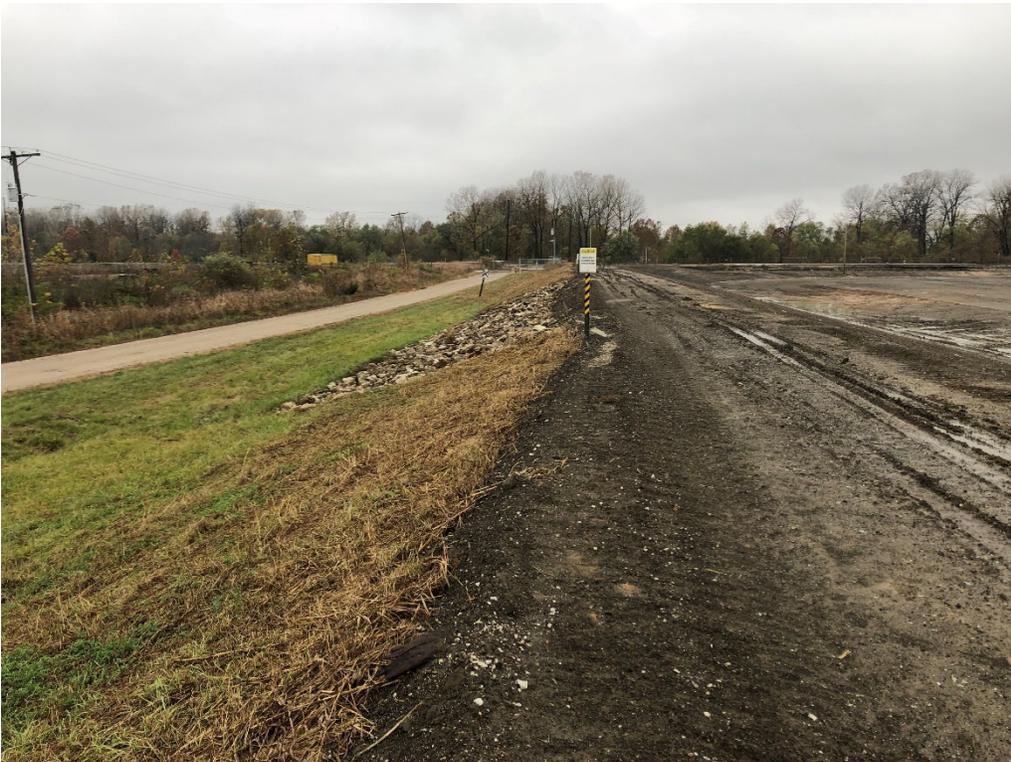
*Figure 2 – LCPA emergency spillway has been removed as part of closure.*

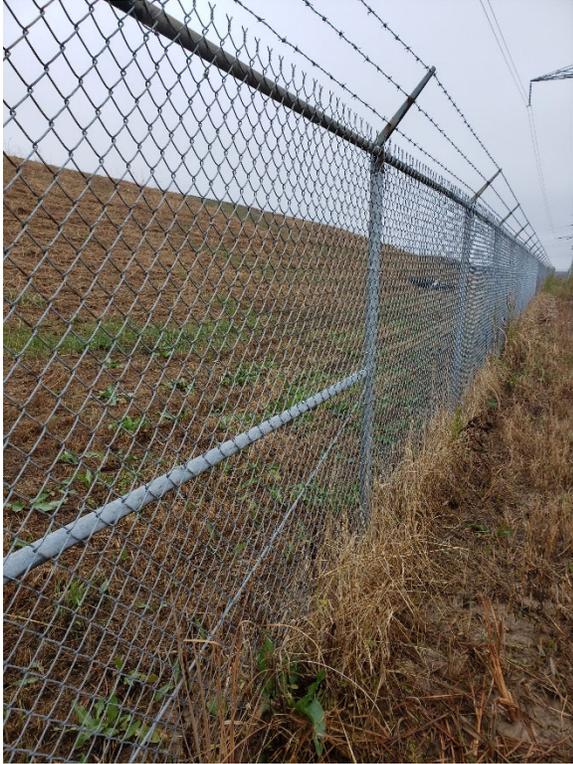
*Figure 5 – The perimeter fence is in good condition.*

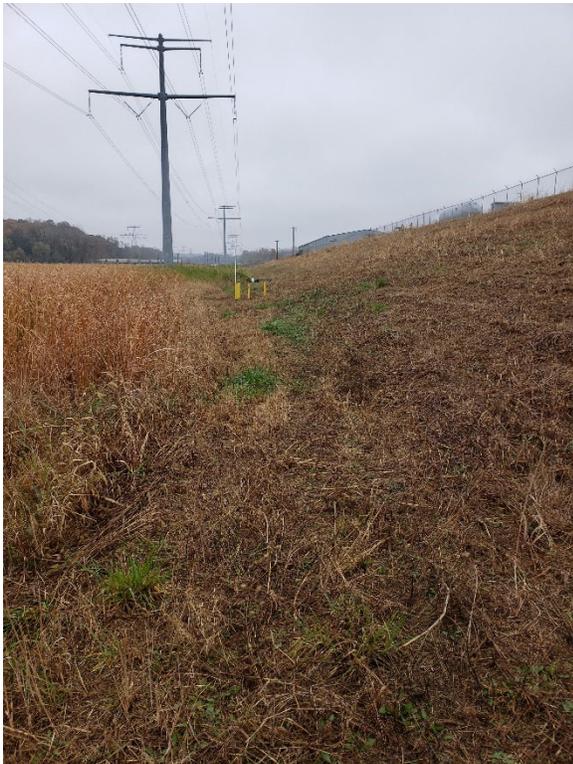
*Figure 6 – Vegetation on downstream slope..*

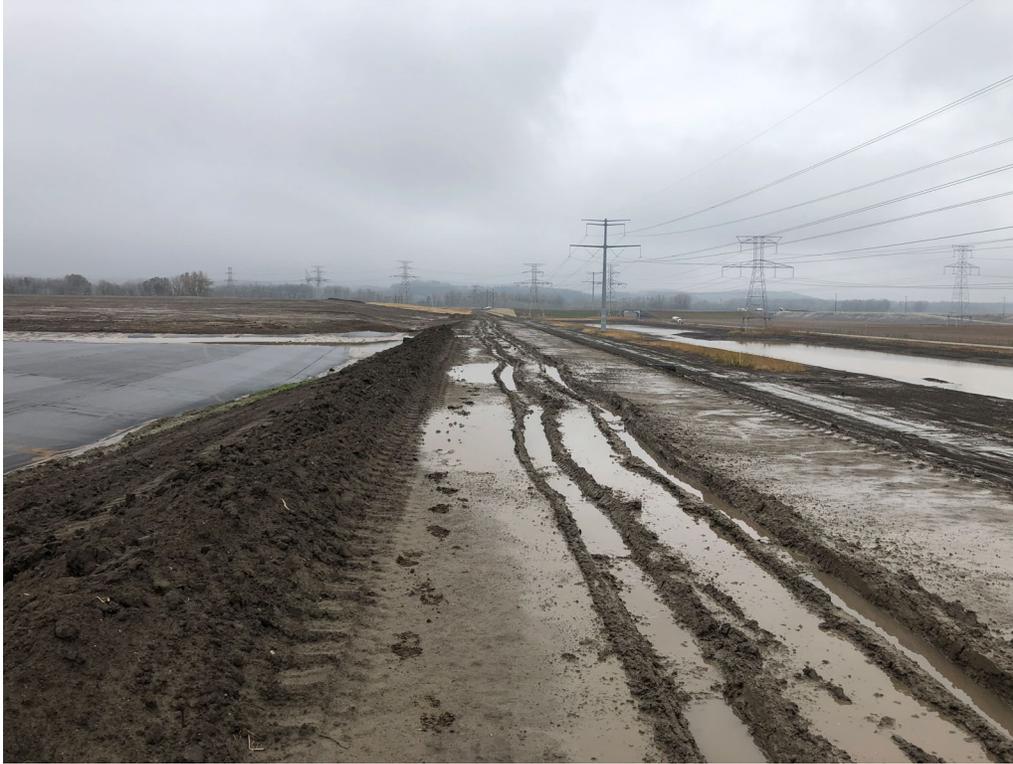
*Figure 1 –LCPB embankment crest with ruts on east side of the impoundment.*
