REPORT  
2020012463

**AMEREN MISSOURI MERAMEC ENERGY CENTER  
EVALUATION OF CCR UNITS  
40 CFR PART 257  
ST. LOUIS COUNTY, MISSOURI**

October 2021

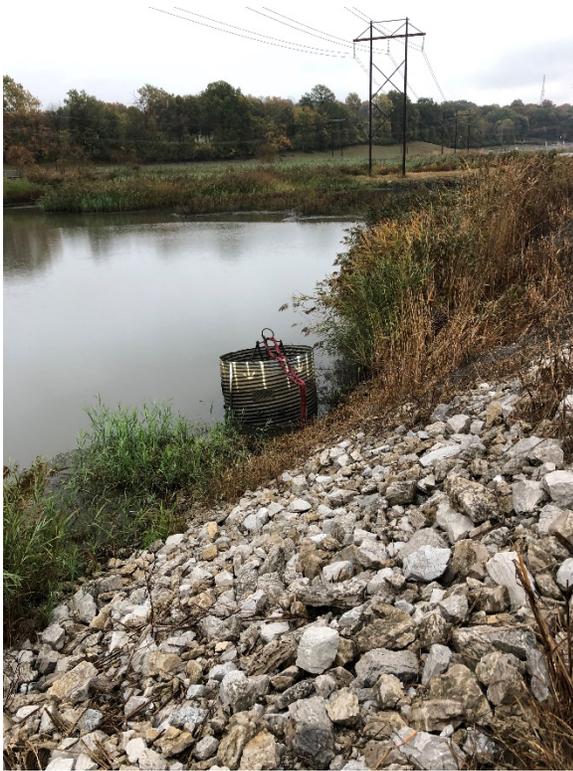
*Figure 1 – Principal spillway skimmer.*

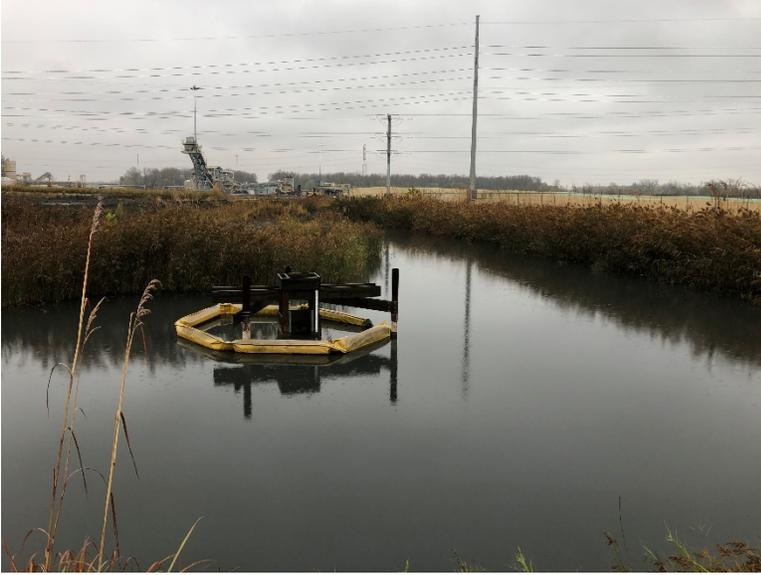
*Figure 1 – Principal spillway skimmer, pipe supports and stoplogs.*

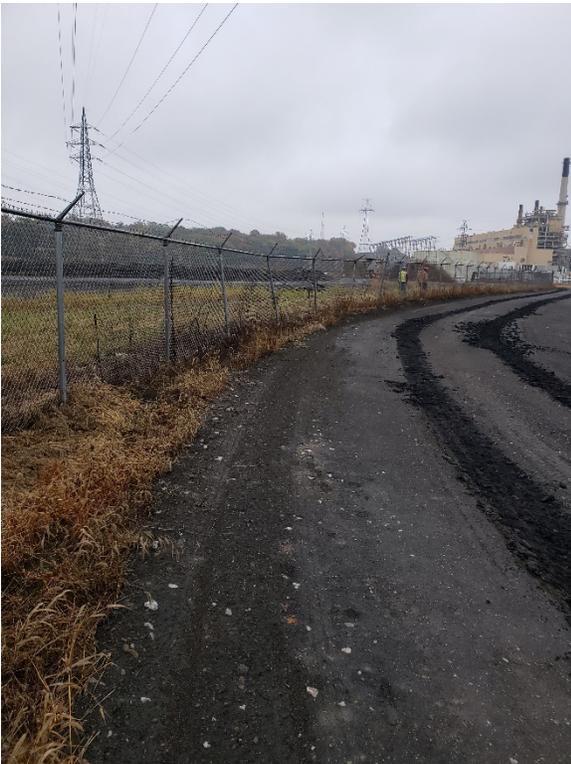
*Figure 6 – Damage to perimeter fence.*

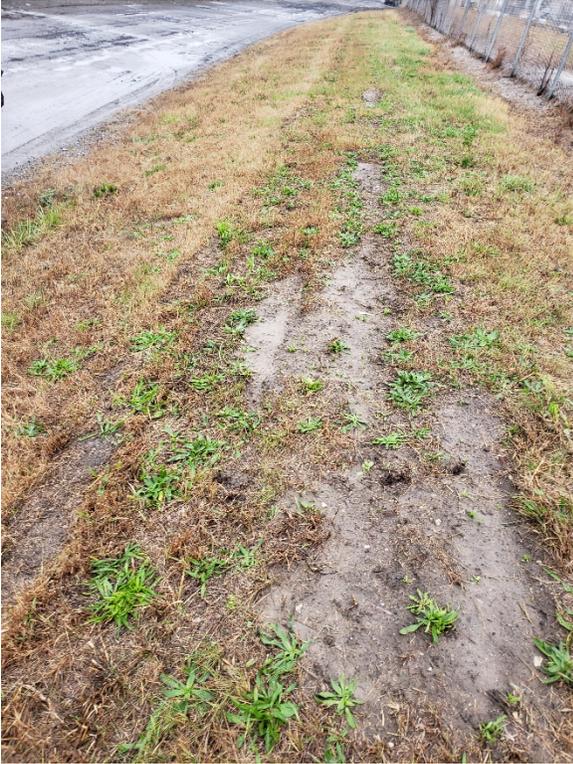
*Figure 7 – Sparse vegetative cover on downstream slope.*

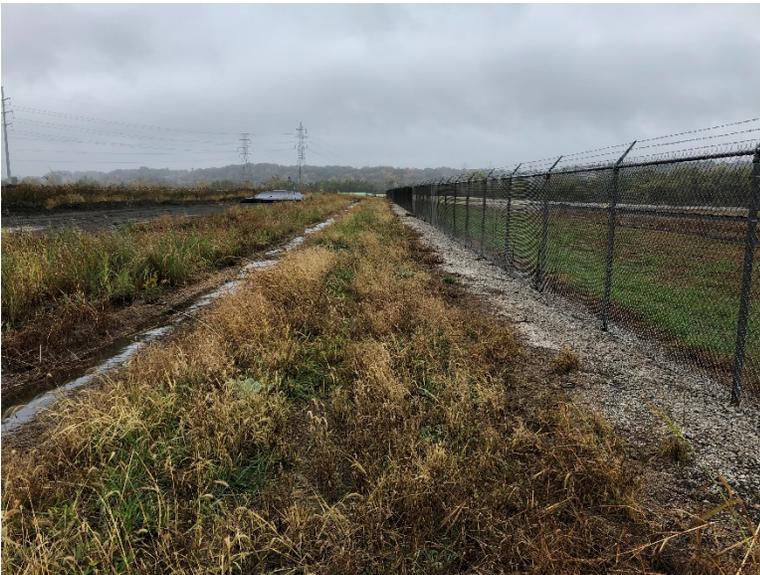
*Figure 8 – No sloughs, slides or cracks were observed.*

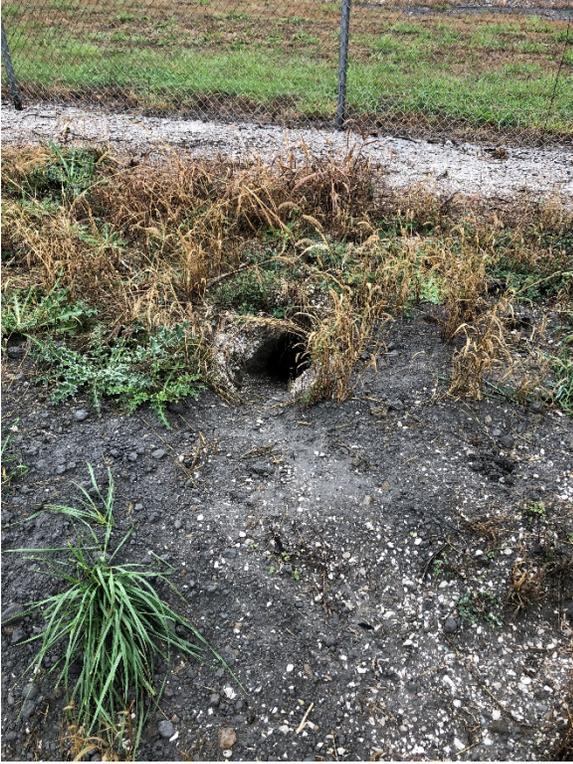
*Figure 9 – Large animal burrow was observed on the crest near the center of the north section of the embankment.*
