AMEREN MISSOURI SIOUX ENERGY CENTER EVALUATION OF CCR UNITS 40 CFR PART 257 ST. CHARLES COUNTY, MISSOURI

AMEREN MISSOURI SIOUX ENERGY CENTER EVALUATION OF CCR UNITS ST. CHARLES COUNTY, MISSOURI

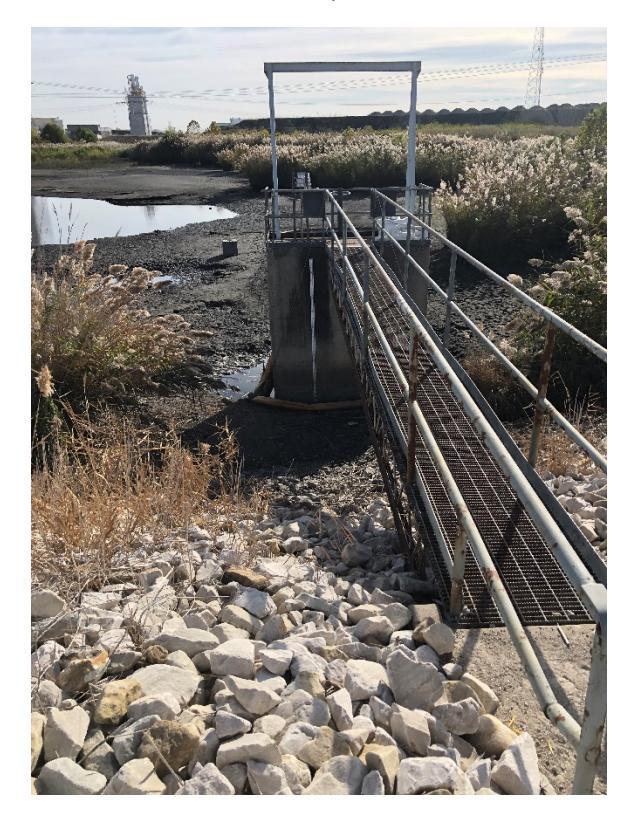
Figure 1 – Minor rust was observed on spillway bridge and other metal appurtenances.

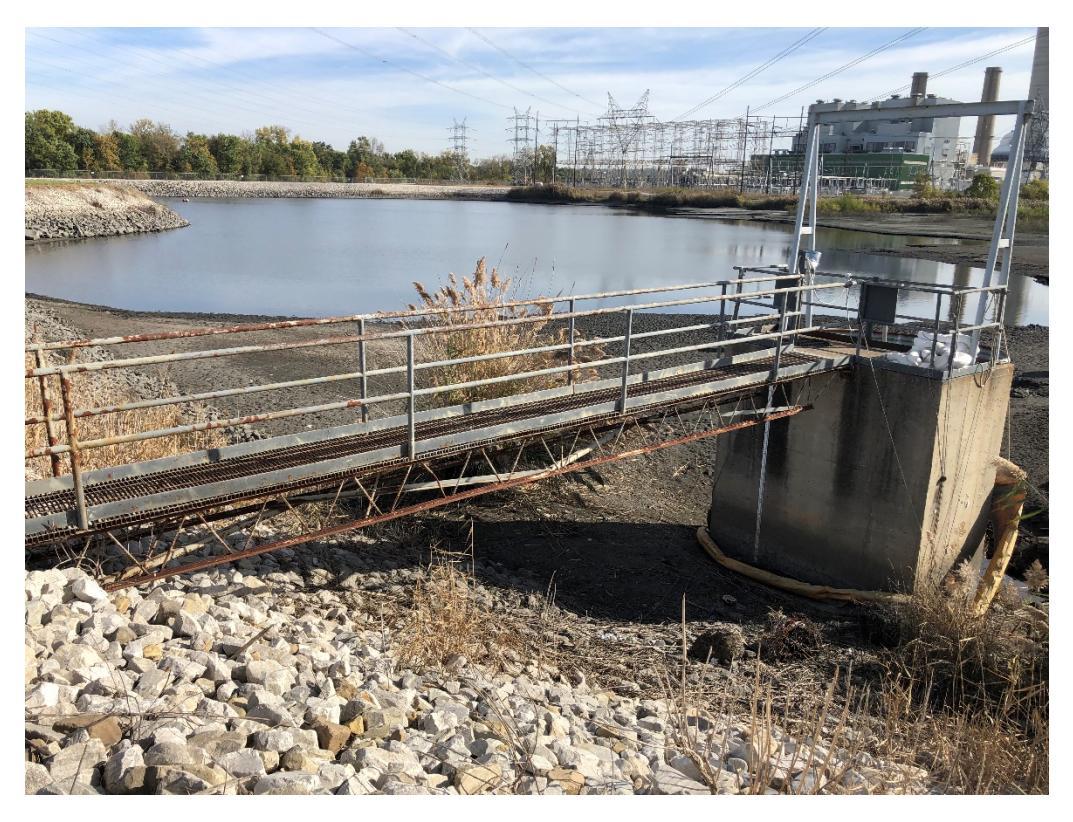
Figure 2 - Minor rust was observed on spillway bridge and other metal appurtenances.

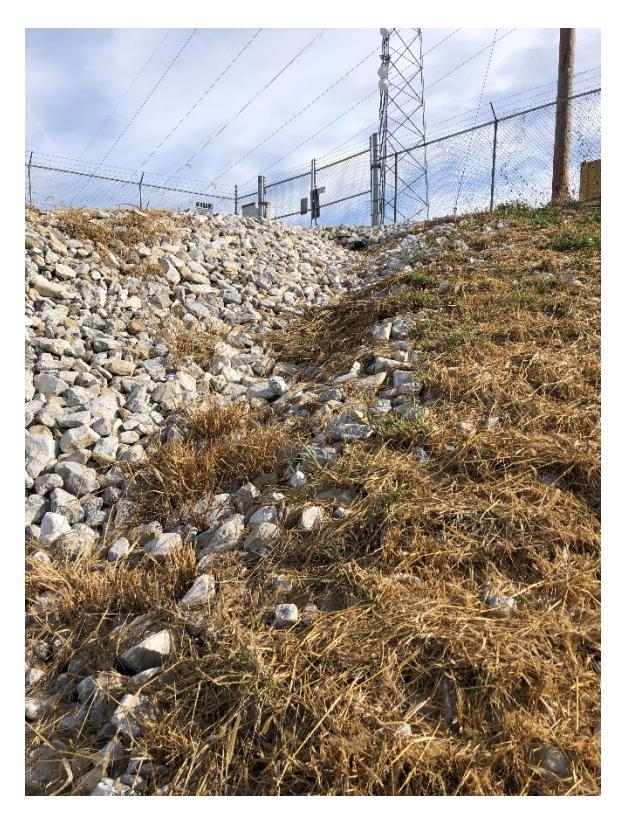
Figure 10 - Repaired erosion feature and new armored swale.

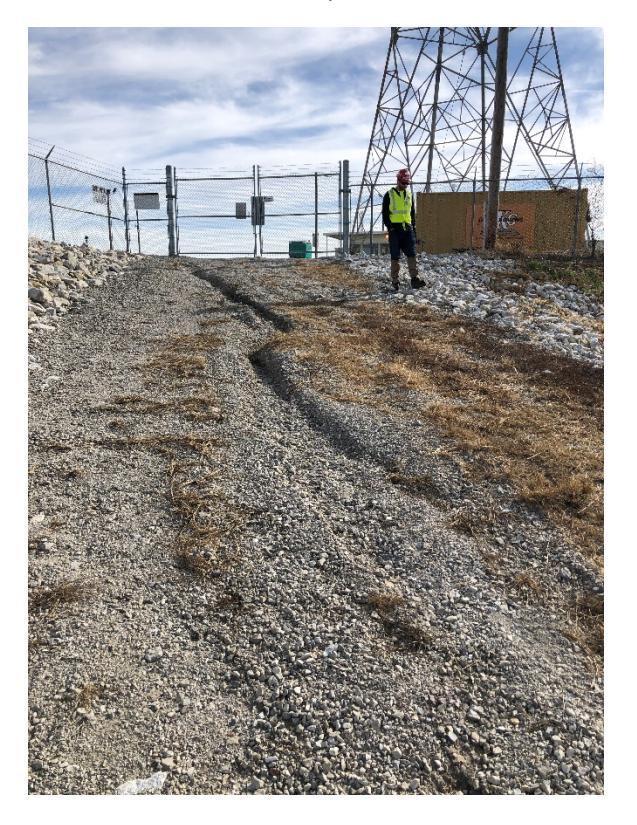
Figure 11 - Erosion feature on access ramp near the guard house.

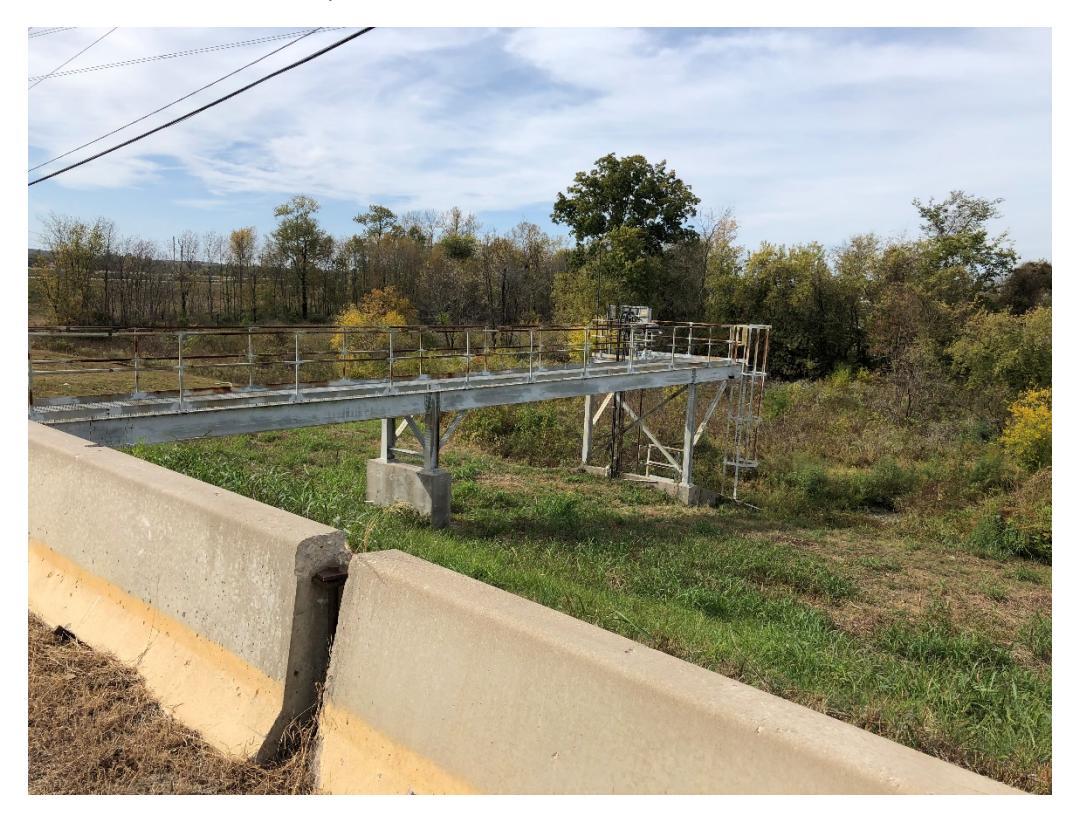
Figure 1 – Minor rust was observed on spillway bridge and other metal appurtenances.

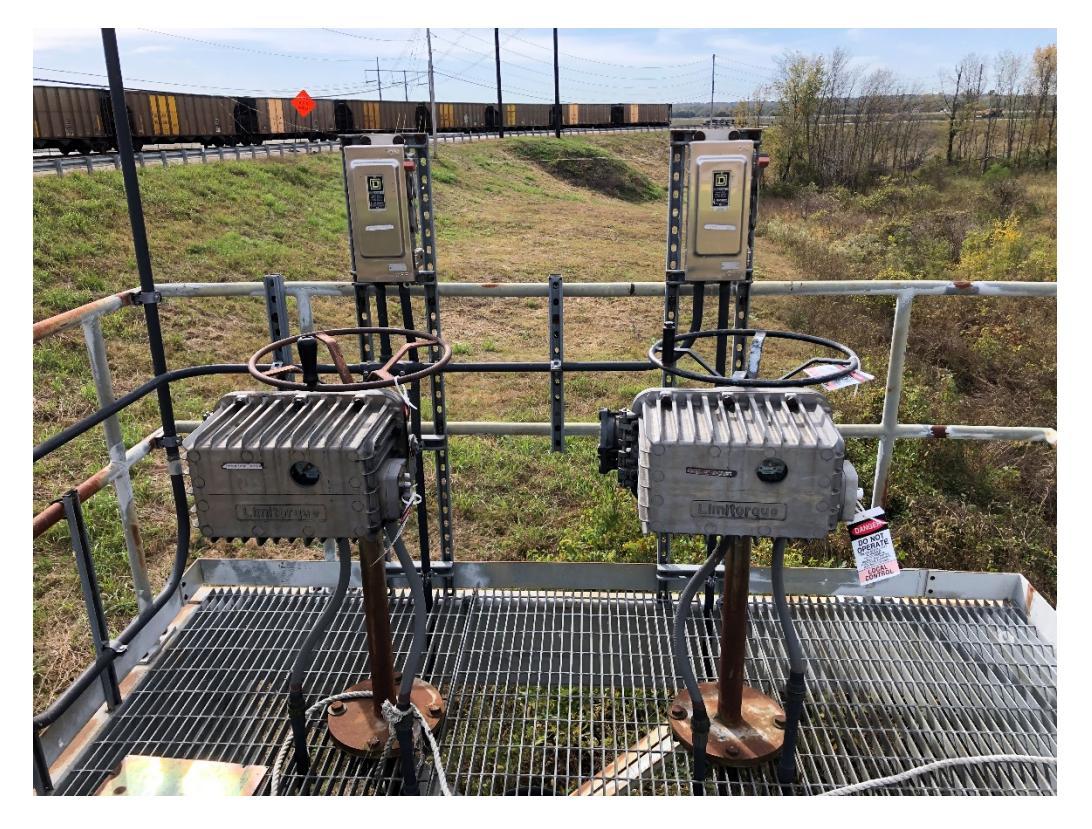
Figure 2 - Minor rust was observed on gate pedestals, housing, handwheels and conduit.

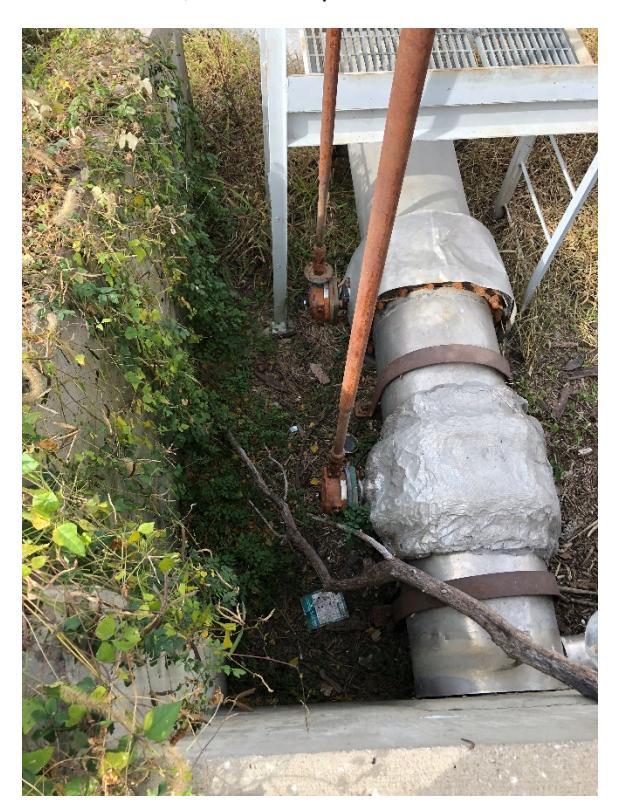
Figure 3 – Minor rust on spillway gate stems.

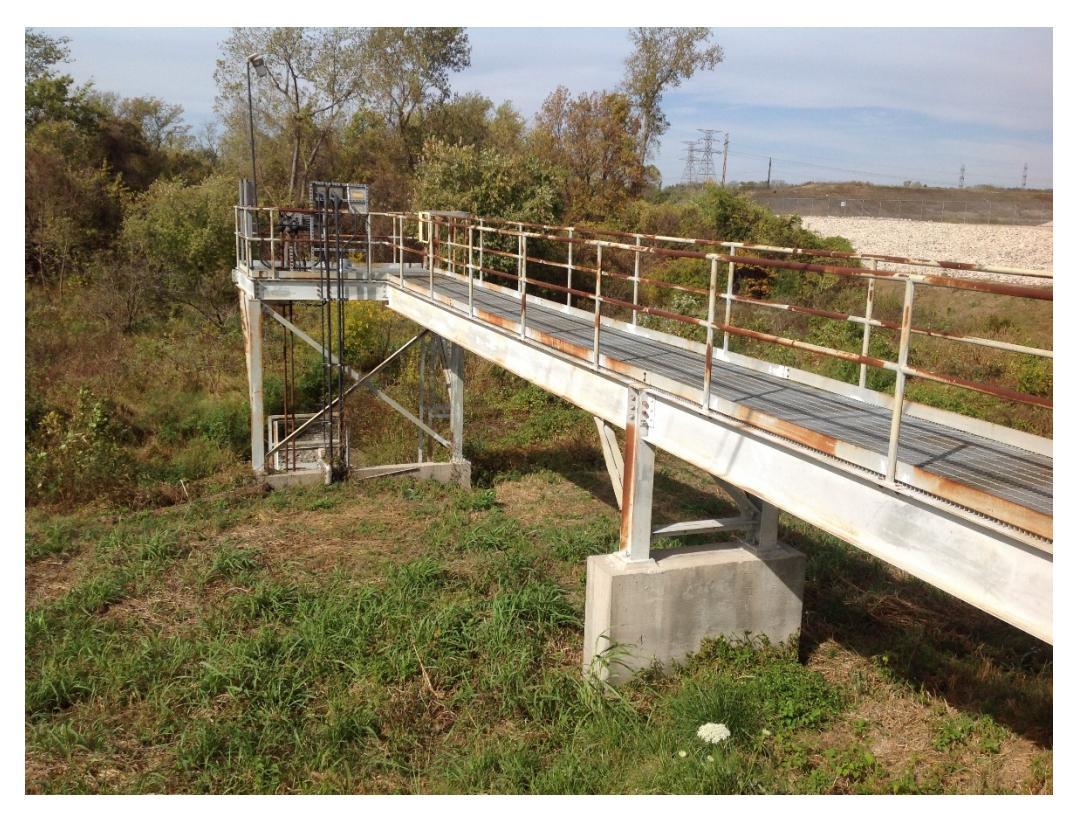
Figure 4 – Minor rust was observed on spillway bridge and other metal appurtenances.

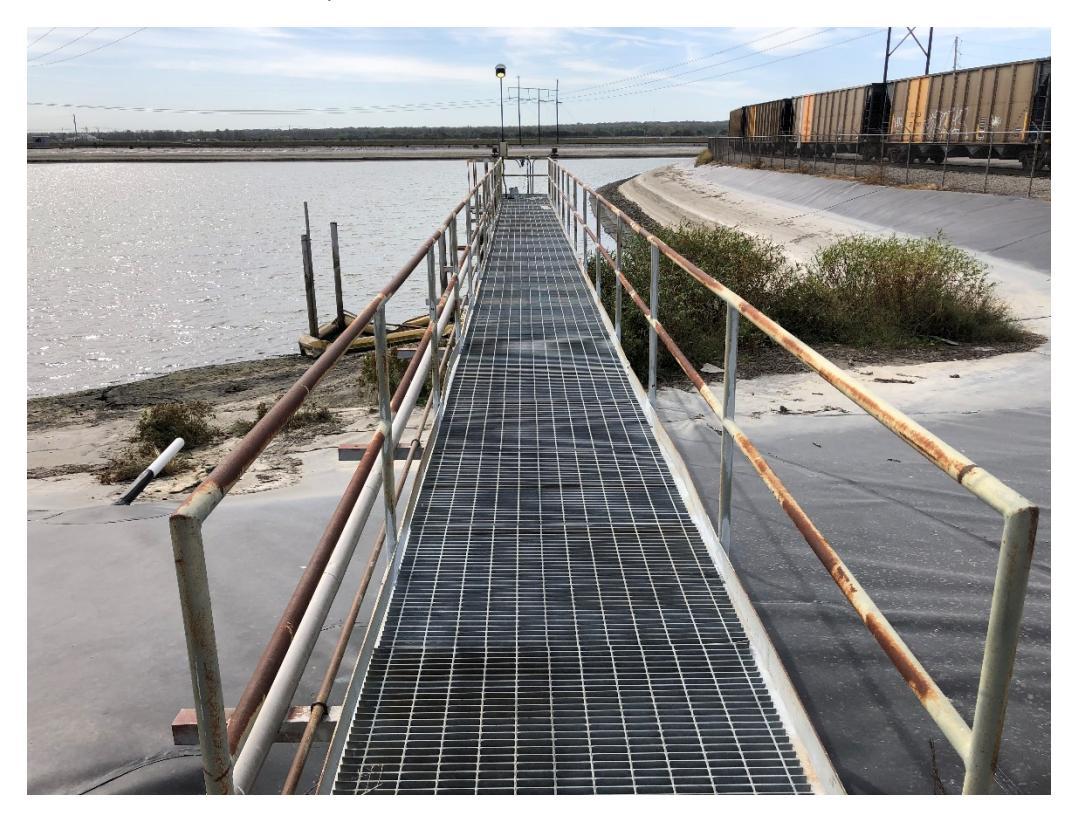
Figure 5 – Minor rust was observed on spillway bridge and other metal appurtenances.

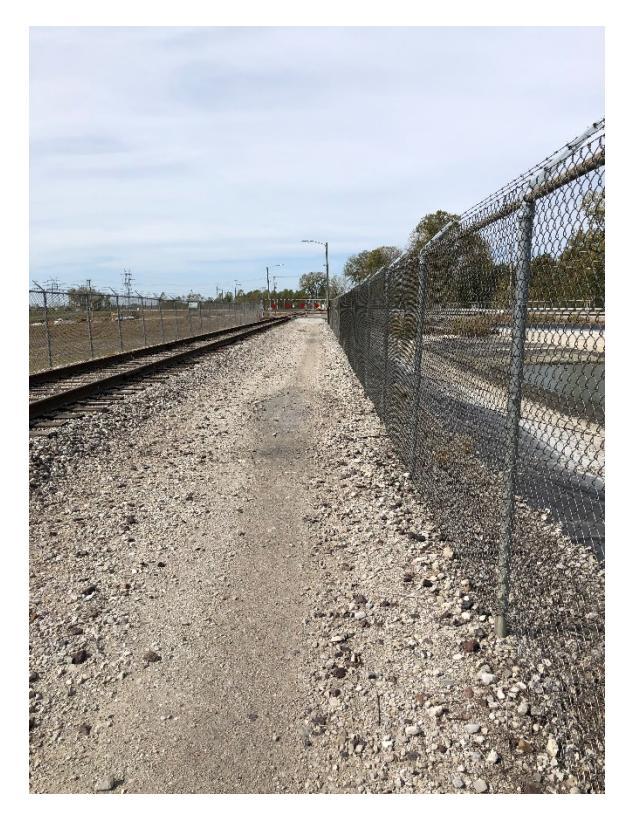
Figure 15 – The perimeter fence is in good condition.

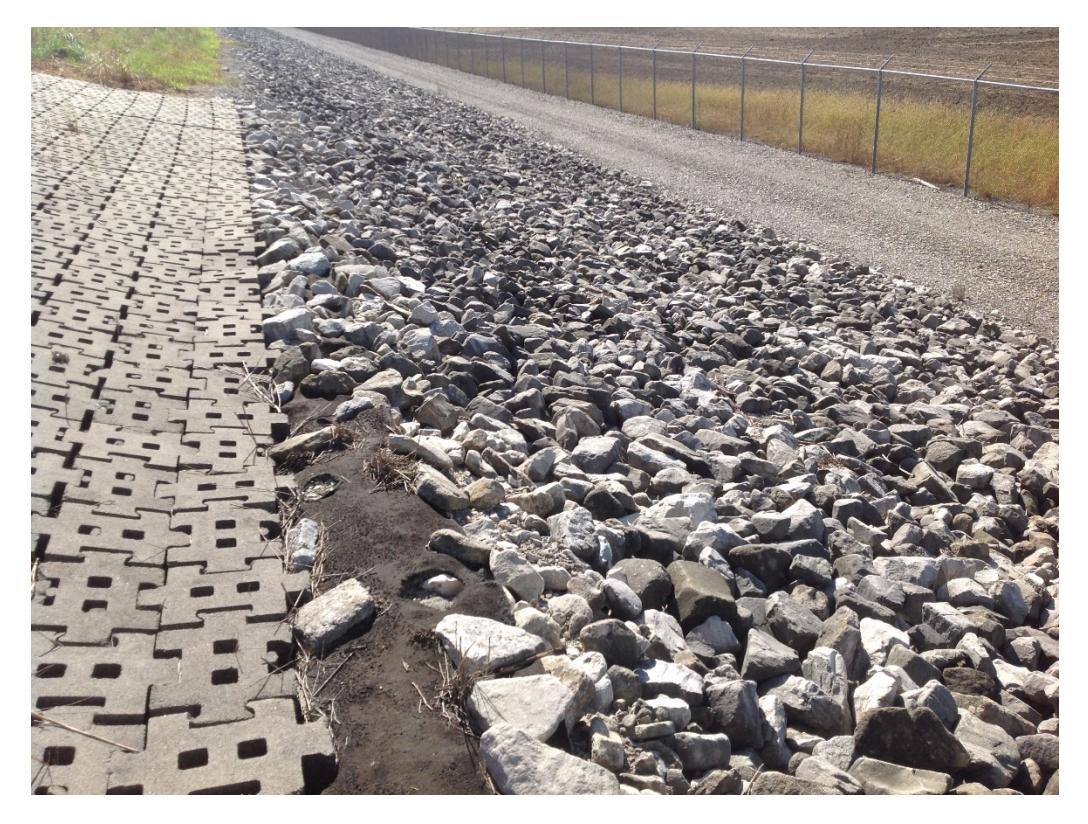
Figure 10 – Riprap is in good condition.
