RE: Evaluation of Soil Gas Data Collected at Residential Properties near Former MGP  
Site, Champaign, Illinois

# **Evaluation of Soil Gas Data Collected at Residential Properties near Former MGP Site Champaign, Illinois**

**December 2008**

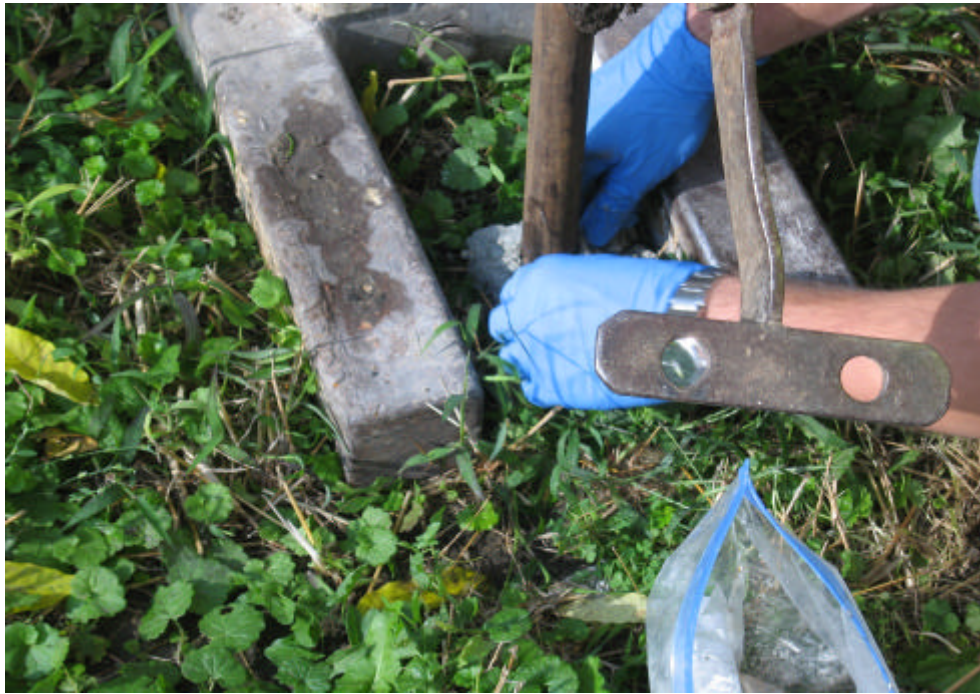
**PHOTO 1: View of packing bentonite putty seal around probe.**

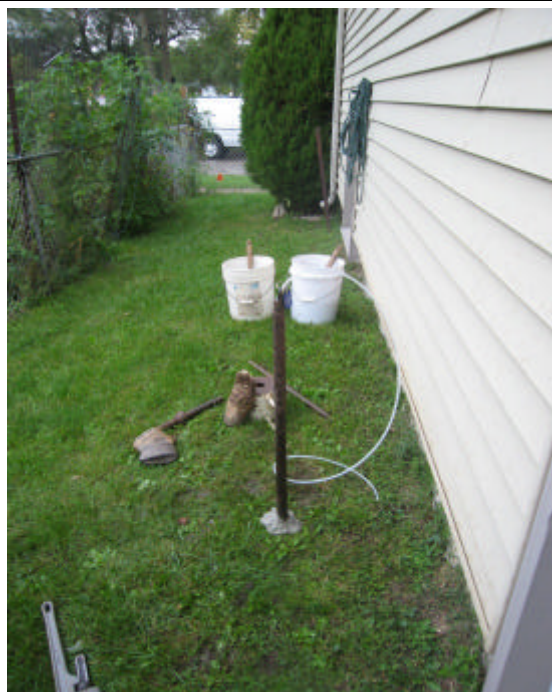
**PHOTO 2: View to North along west side of 505 E. Washington at location of VP505EWASH-2.  
Probe in ground, tubing inside probe.**

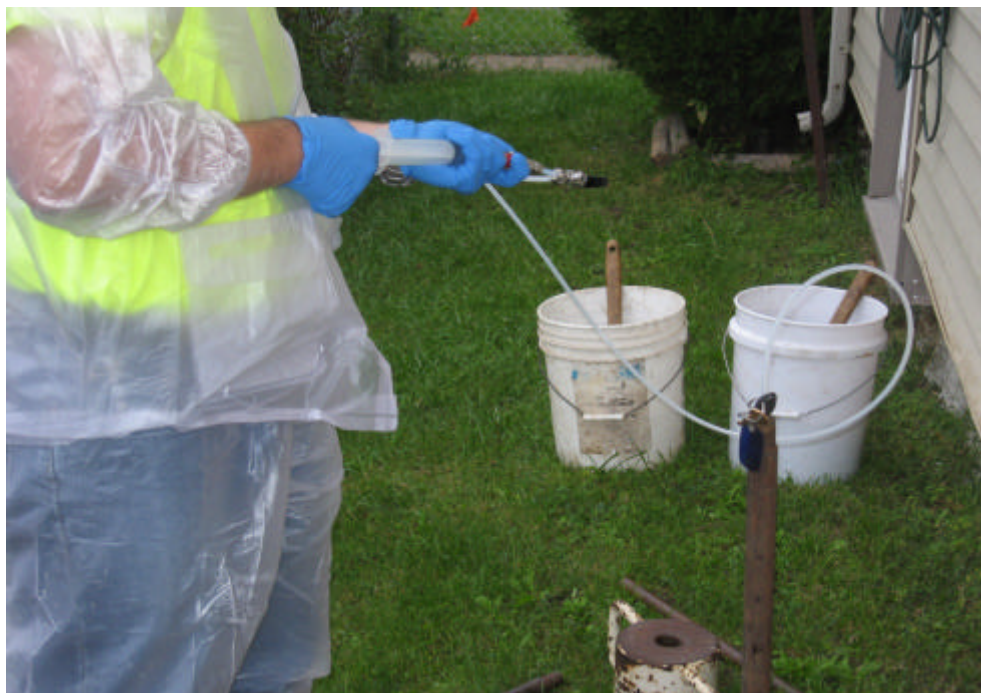
**PHOTO 3: Purging VP505EWASH-2.**

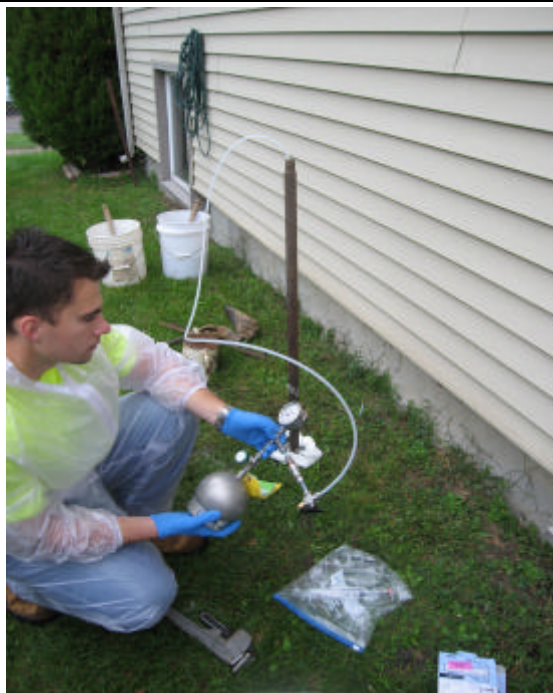
**PHOTO 4: Obtain soil vapor sample in 1-Liter Summa Canister at VP505EWASH-2.**

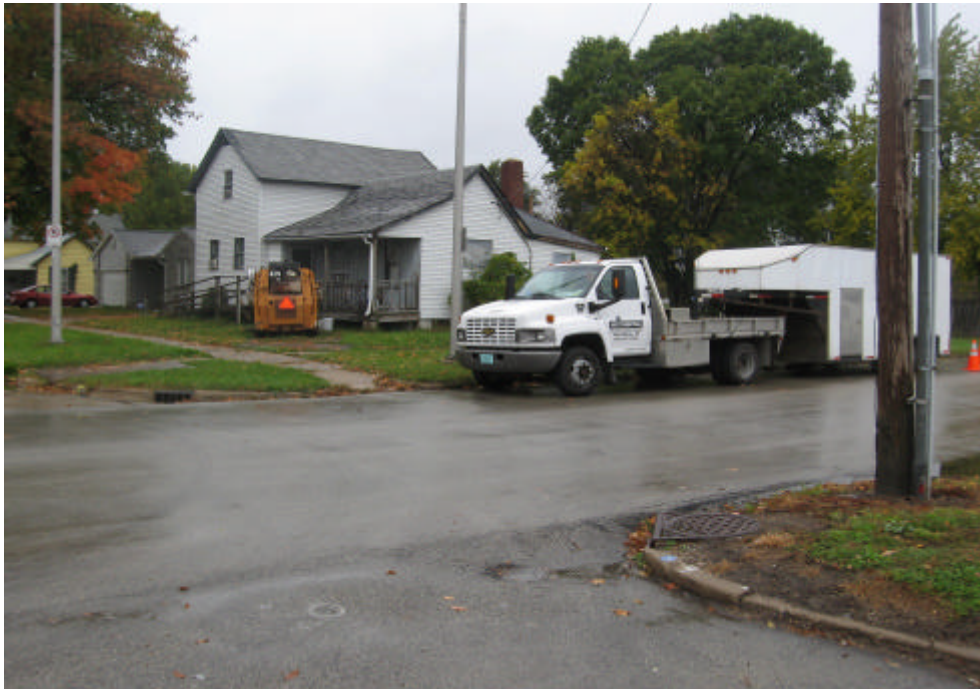
**PHOTO 5: View to NW from N. Fifth St. MGP entrance gate looking at 412 E. Hill and Soil Essentials truck & trailer and Geoprobe rig at VP412EHill-3 location.**

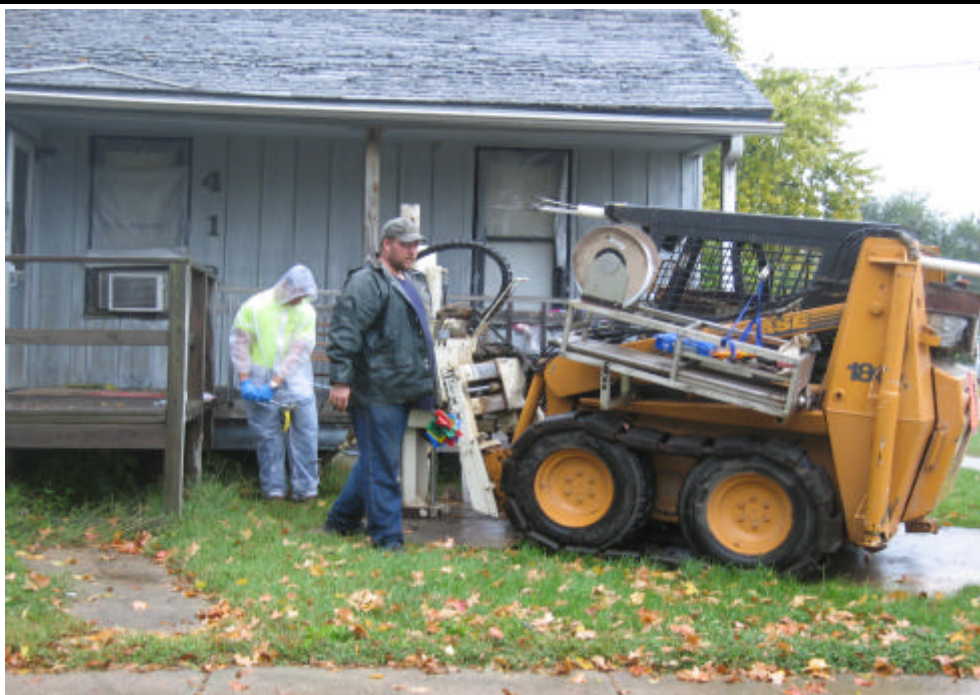
**PHOTO 6: View to north at VP412EHill-3 location. Note plywood under Geoprobe rig.**

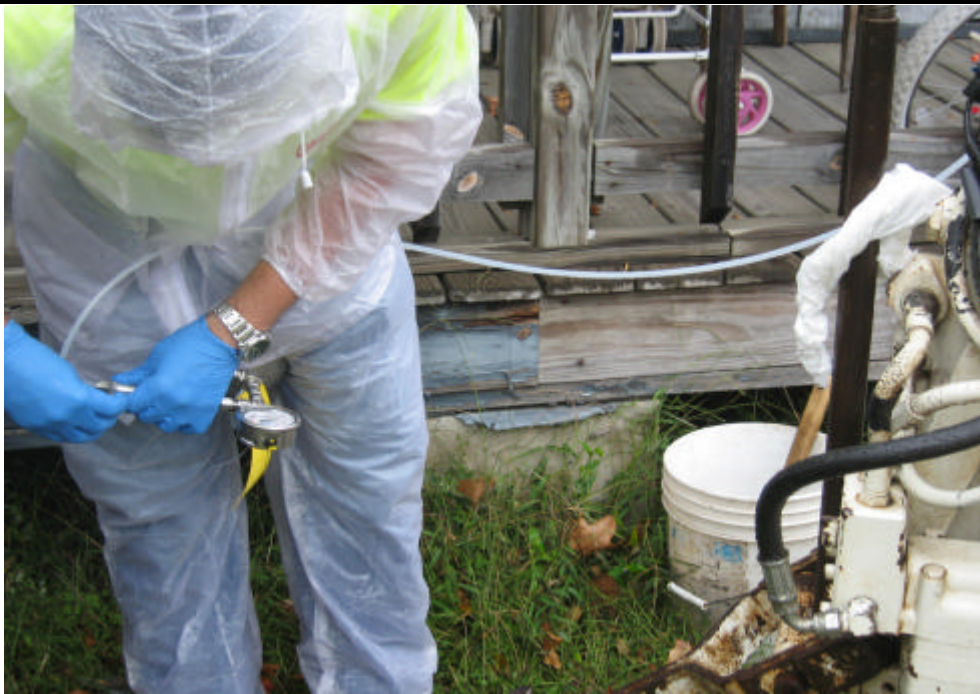
**PHOTO 7: Attaching 1-Liter SUMMA canister at VP412EHill-3 location. Note white paper towels with leak detection compound wrapped around equipment.**

A tracer test was performed using difluoroethane to check for the presence of leaks in the sampling system (i.e., short-circuiting). Household paper towels, wetted with difluoroethane, were wrapped around the steel rods at the ground surface/bentonite seal (to test for short-circuiting at the borehole annulus) and around the Teflon® tubing where the tubing exited the steel rods to test for short-circuiting across the O-ring seal in the PRT adapter.

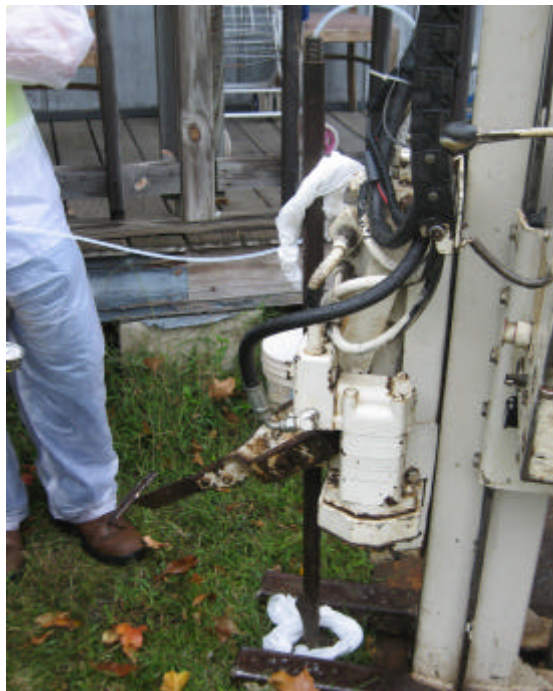
**PHOTO 8: Another view of leak detector paper towels around rod on top of bentonite putty seal at VP412EHill-3 location.**

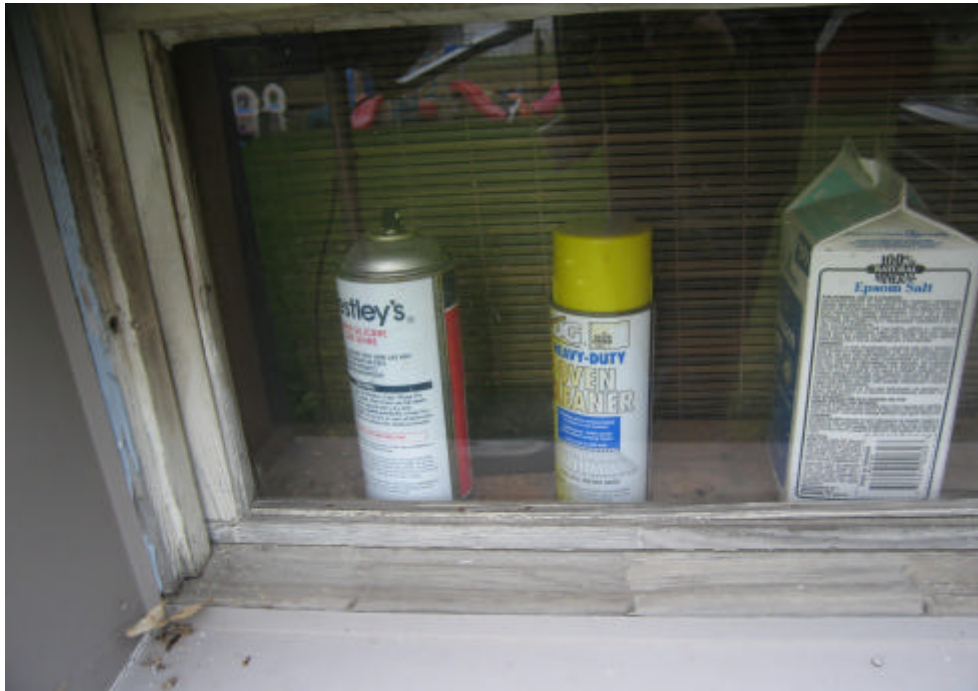
**PHOTO 9: View of oven cleaner & tire shine chemical containers on window sill of south basement wall at 505 E. Washington.**

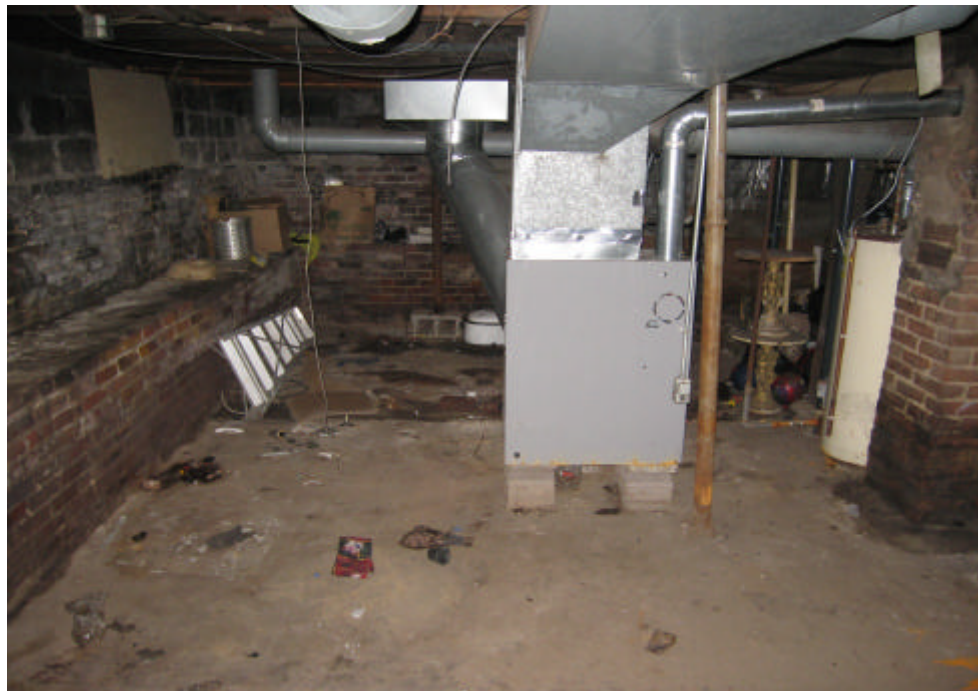
**PHOTO 10: Inside basement of 507 E. Washington looking east along north wall. Note new central heating unit and water heater, both fueled by natural gas.**

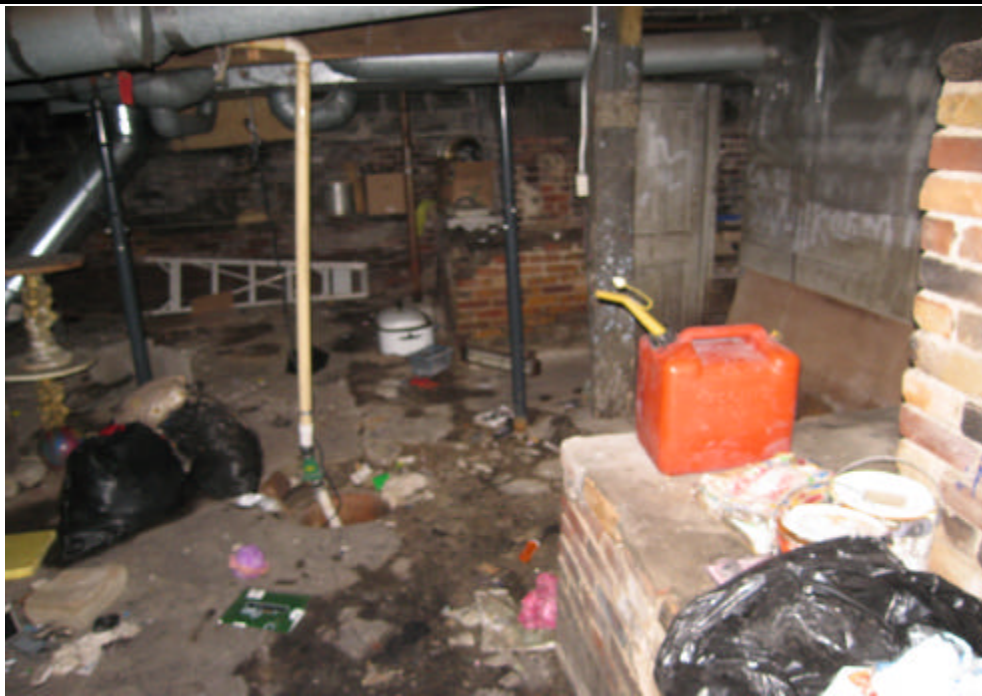
**PHOTO 11:** Inside basement of 507 E. Washington looking North from entrance on south side of house. Note gasoline container, paint cans, and floor sump.

Noted gasoline plastic containers and paint cans in basement

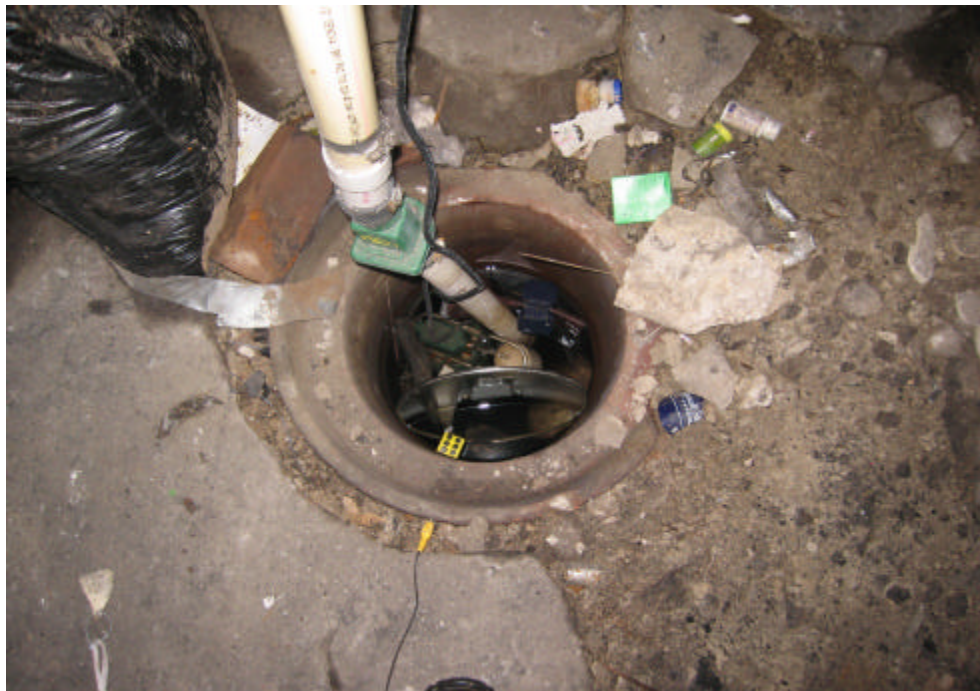
The walls have several openings due to deteriorated mortar between bricks, cinder blocks, and around window and door frames, as well as holes in the walls. The concrete floor slab is cracked and deteriorated in some areas thus exposing the underlying soil. The basement did not appear to prevent water infiltration and there was a musty odor.

**PHOTO 12:** Inside basement of 507 E. Washington looking at water in swamp. Note broken concrete floor slab and exposed soil.

Concrete slab, cracked, broken, exposed soil areas, poor condition. One sump with debris & standing water about 6-8" below floor.

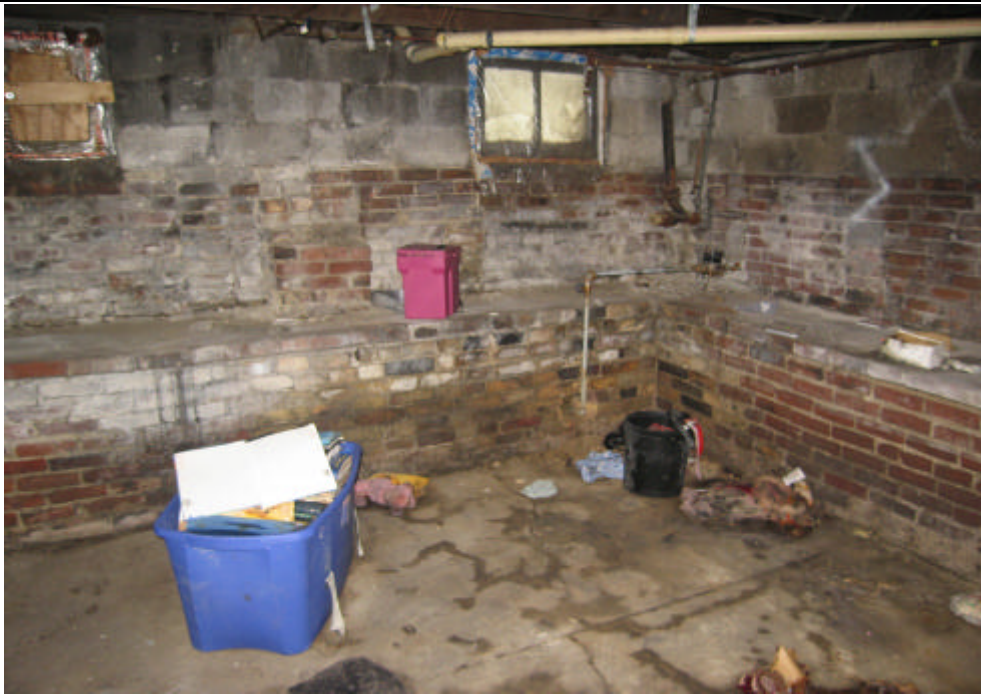
**PHOTO 13:** View of small basement room looking SE at corner of room. Left wall is outside east wall and right wall is interior wall with crawl space beyond.

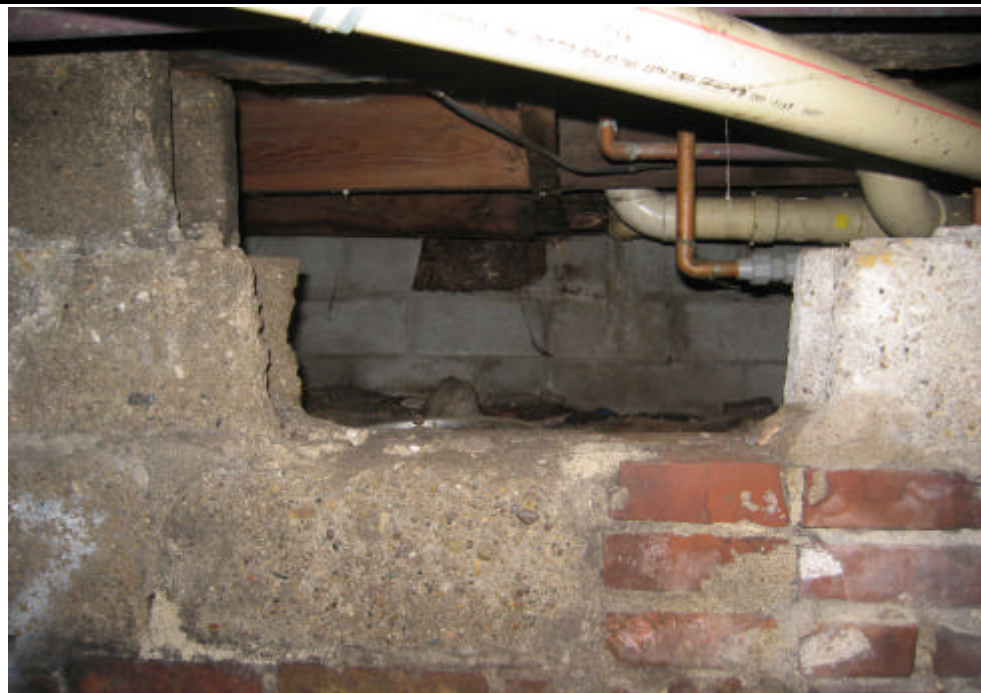
**PHOTO 14:** View from small basement room into crawl space below northeast corner of house.

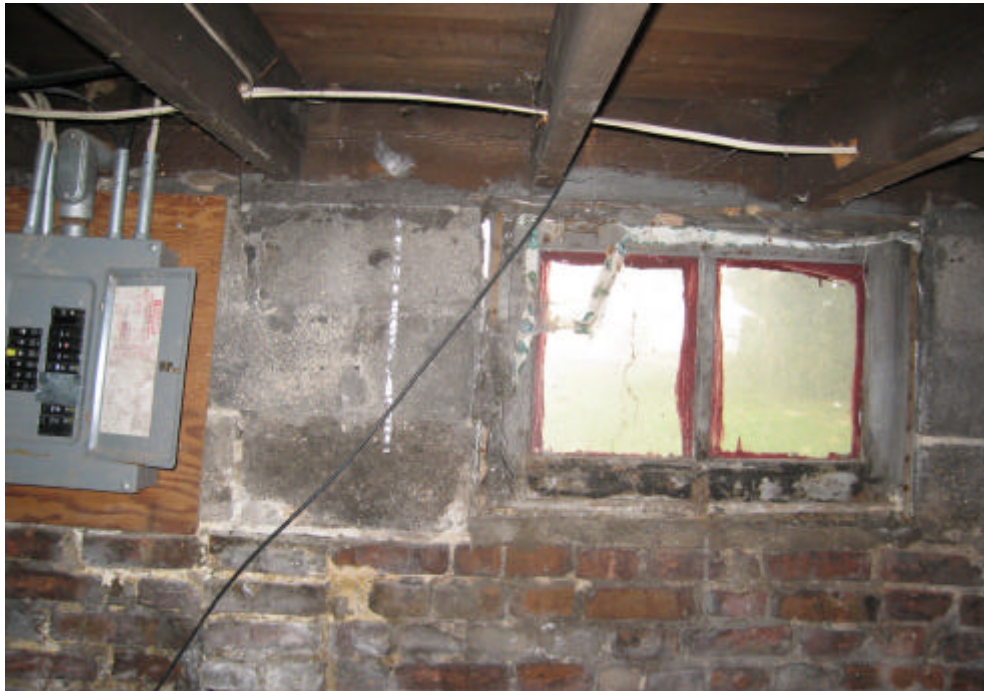
**PHOTO 15:** View of window along south wall of basement. There are several gaps between window frame and bricks & cinder blocks in this area and throughout basement.

Brick, Deteriorated, holes, gaps around window frames & outside door frame, No door, storm door with open frame, poor condition

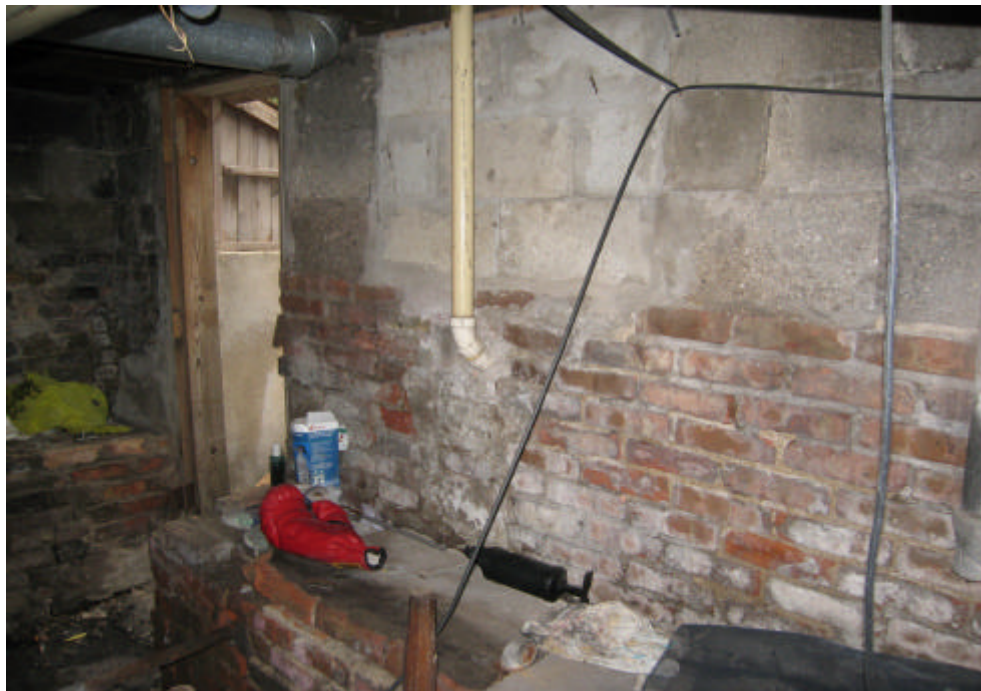
**PHOTO 16:** View of entrance to basement from south exterior of house.

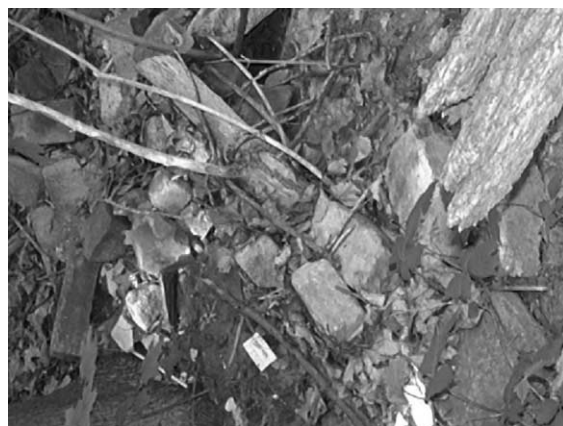
Fig. 4. Solid waste typical of the gas works dump. This riverside location displays a variety of maker-marked fire and refractory brick into which typically liquid-waste PAHs were channeled or dumped, either out of convenience to the operators or during times and conditions under which the economics of by-product recovery were considered infeasible (photograph by the author, Lansing, MI, 2001).

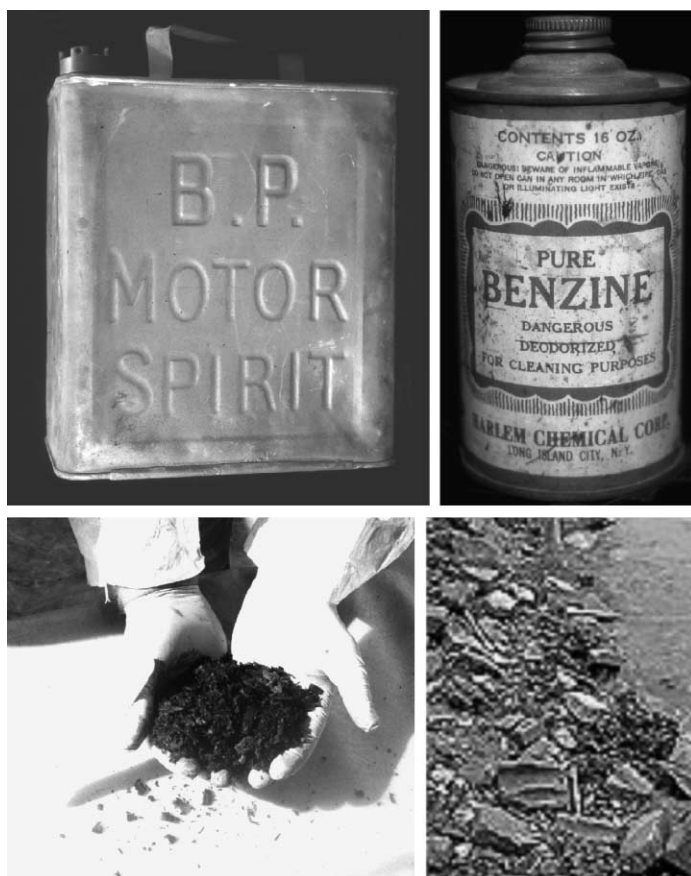
Fig. 5. Some outstanding gas works residuals. (5L) Motor spirit (a.k.a. Benzol) was the forerunner of our gasoline and benzine was a distilled derivative of the benzol. Today, these two light nonaqueous-phase liquids (LAPLs) are commonly found as groundwater contaminants, though more often not as free phase (from the Author's collection). (5L) The motor spirit can is British and holds one imperial gallon (both are from the author's collection). (5LL) Freshly excavated box-waste wood chips from the gas works dump at Sacramento FMGP no. 2, California (photographed by the author, 1999). (5RR) Typical appearance of the gas works dump at creek or riverside. This is at Manistee, MI (photographed by the author, 2001).
