REPORT  
2020012463

**AMEREN MISSOURI MERAMEC ENERGY CENTER  
EVALUATION OF CCR UNITS  
40 CFR PART 257  
ST. LOUIS COUNTY, MISSOURI**

October 2021

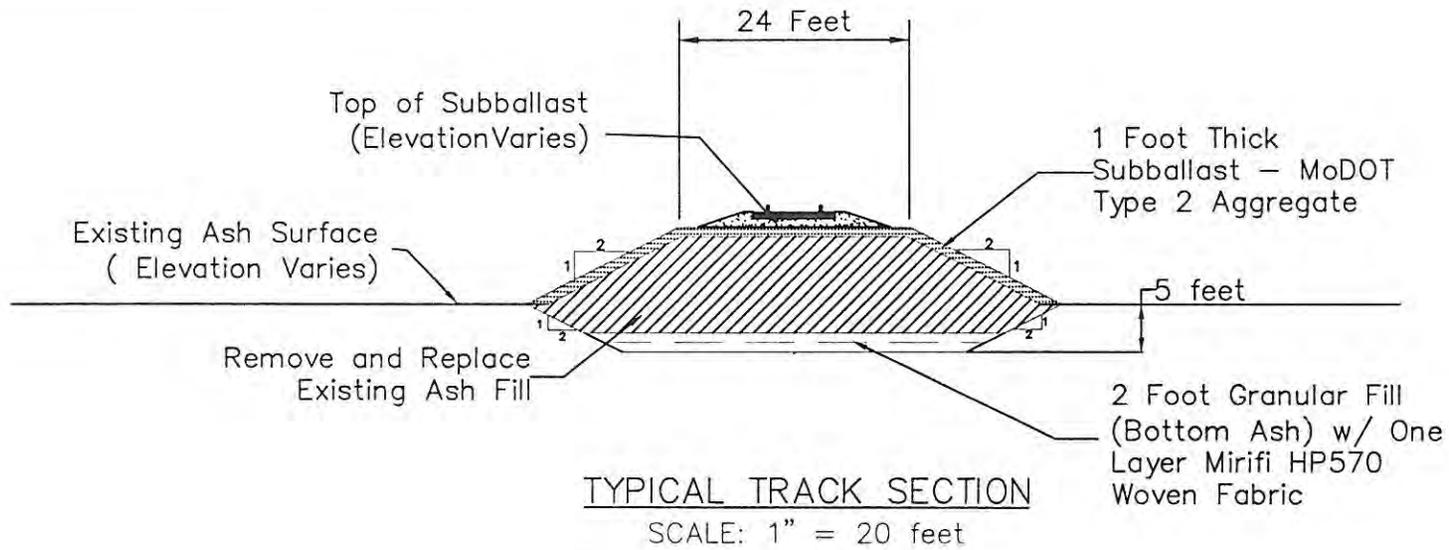
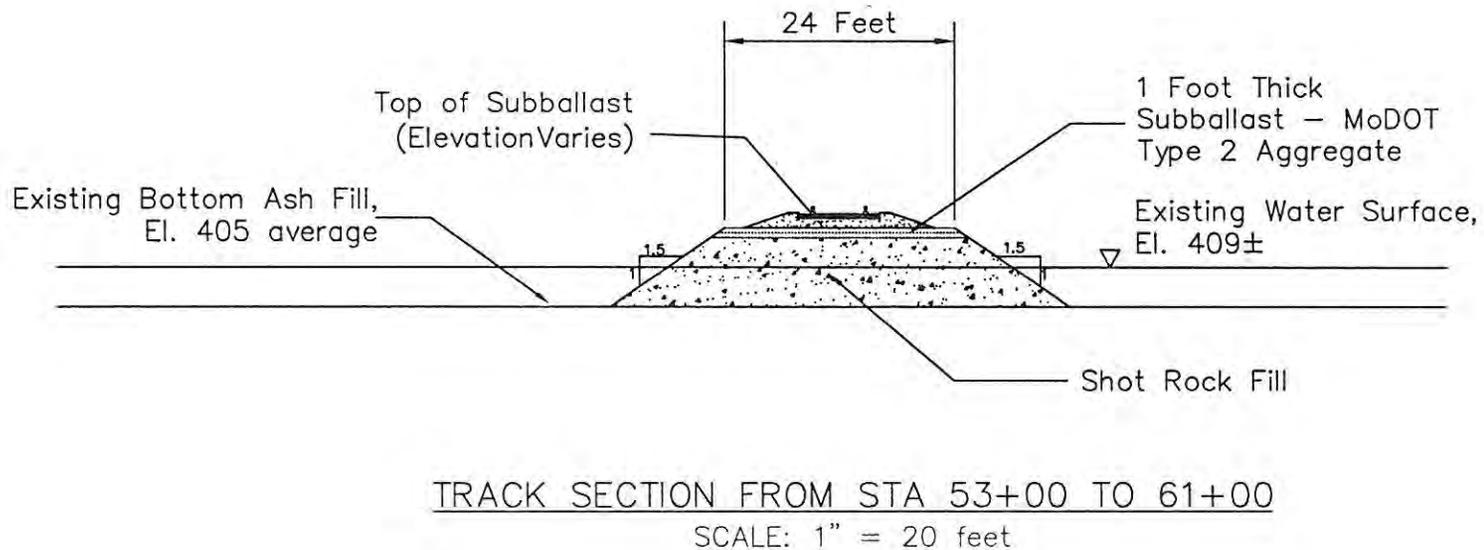
FIGURE  
9

Where the railroad loop embankment will cross the flyash ponds, we recommend removing the flyash to a depth of 5 feet. The typical track section is shown in Figure 9. The bottom of this overdig will vary between about el. 406 and el. 411, which should be above the maximum Mississippi River stage in most years. The flyash that is removed may be dried for use as fill. A 2-foot thick of compacted granular fill should be placed in the bottom of the overdig, with a woven geofabric such as Mirafi HP570 at about the center of the granular fill. This blanket will provide a base upon which to place and compact the flyash to build the embankment. The fill should be compacted as recommended under "Fill Materials and Placement."

Where the embankment will cross the bottom ash ponds, we recommend constructing the embankment using coarse "shot rock" fill. The bottom ash is coarser than the flyash, so it should not be necessary to overexcavate the bottom ash to create a base. A typical track section is shown in Figure 9.

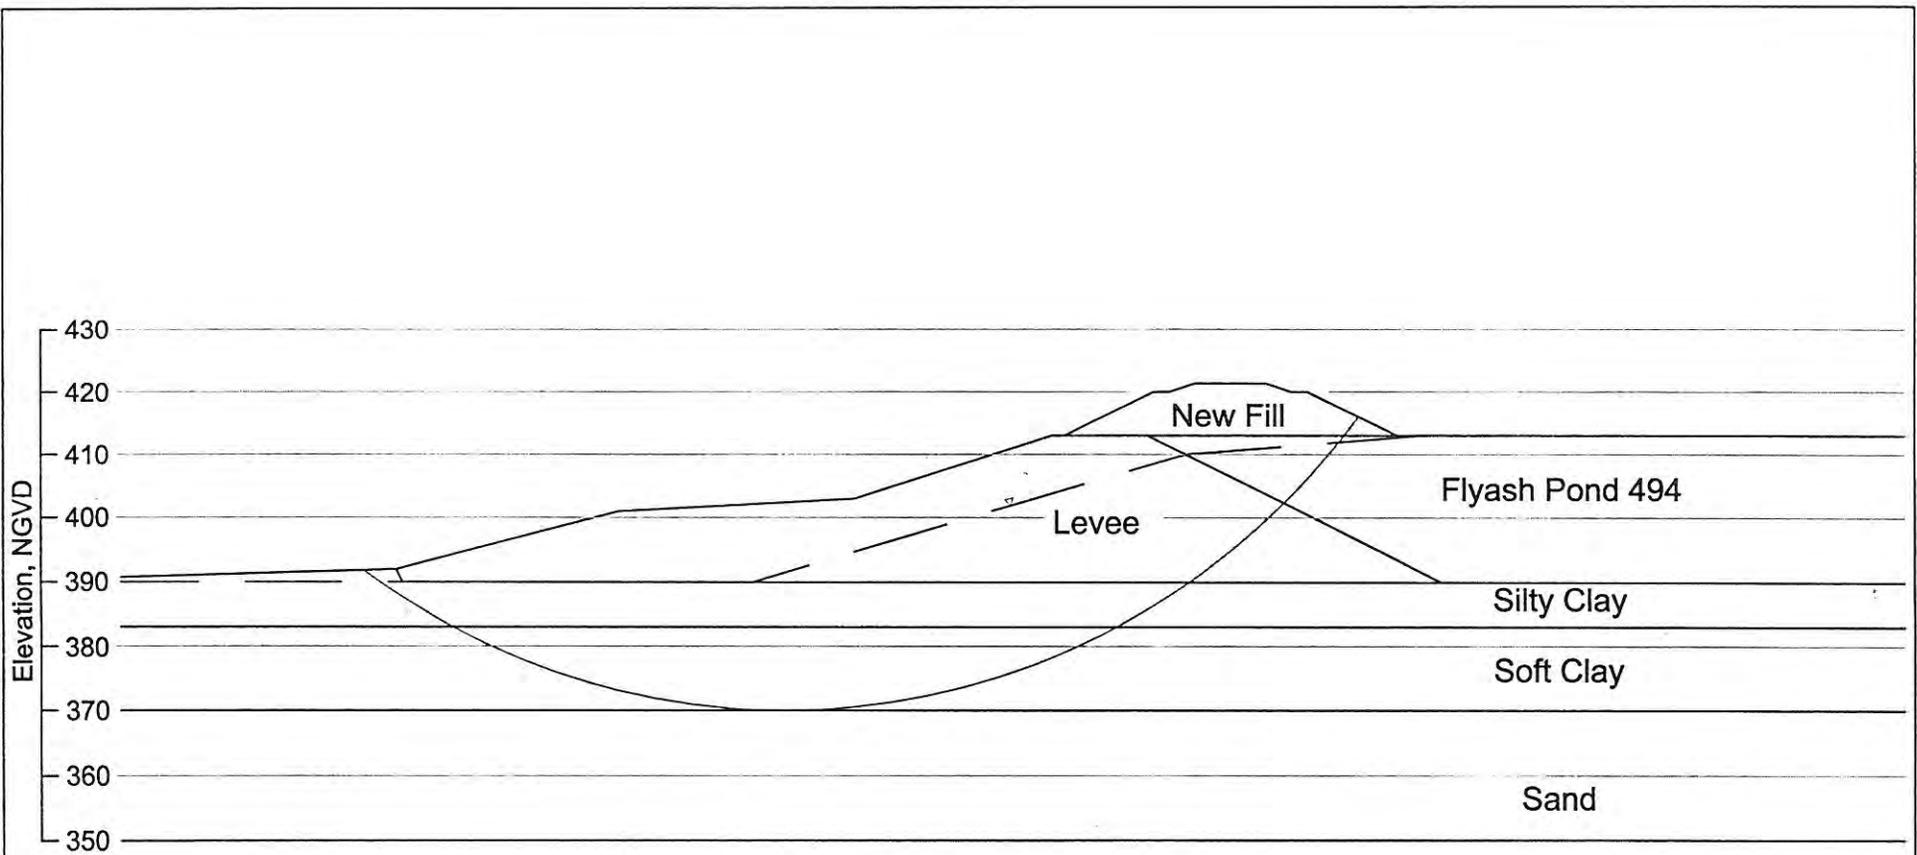
FIGURE  
10

An example of the stability analyses at Sta. 29+00 is shown in Figure 10. The calculated factors of safety indicate that the static condition should be stable. The factors of safety less than 1.0 for the seismic event required calculation of the required shear strengths needed for the soft clays at depth to provide a factor of safety equal to 1.0, and inversely what seismic acceleration can be tolerated for the existing strength of the soils. The soft clay soils need to have a shear strength of about 610 psf, versus the indicated strength of 450 psf. The present soils can resist a seismic acceleration of about 0.096g.

**Section at Sta. 29+00**

Minimum Factor of Safety = 1.53 (without seismic)

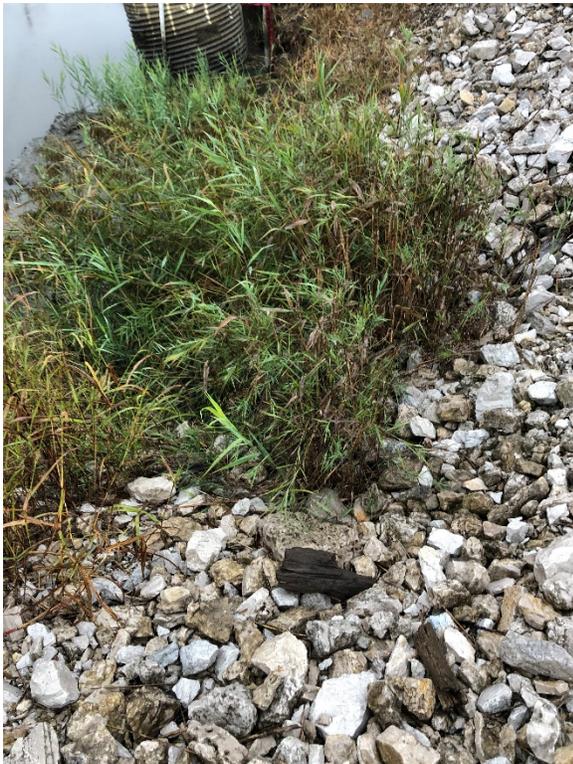
*Figure 2 - Excess vegetation around secondary spillway inlet.*

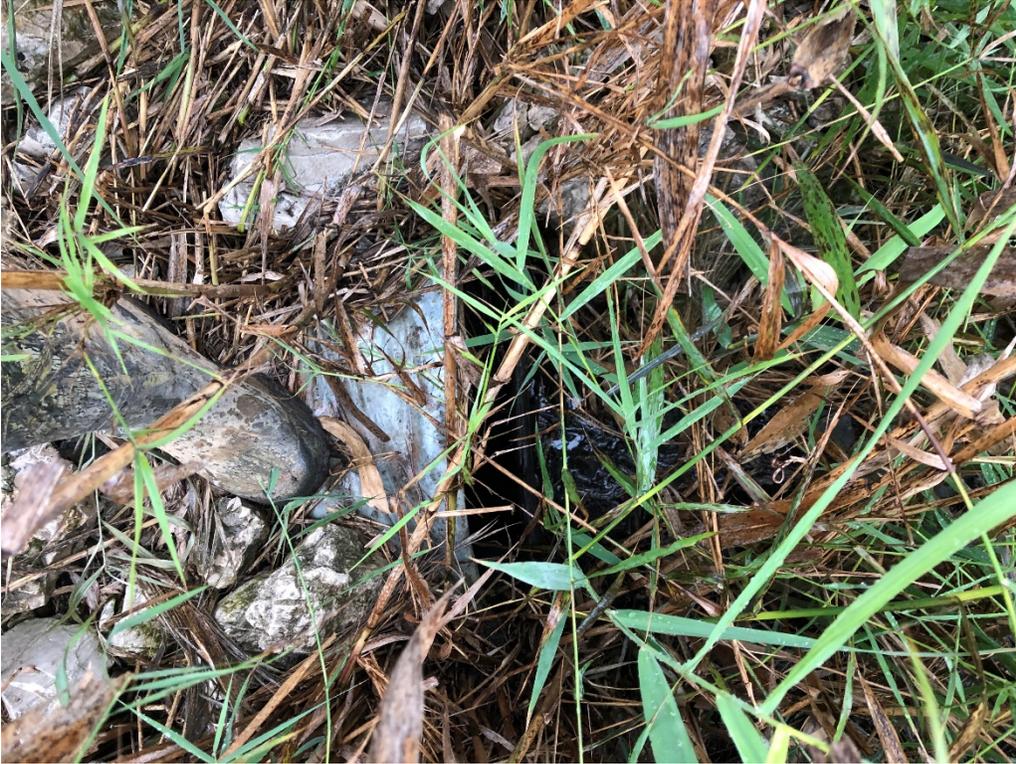
*Figure 3 - Excess vegetation around secondary spillway inlet.*

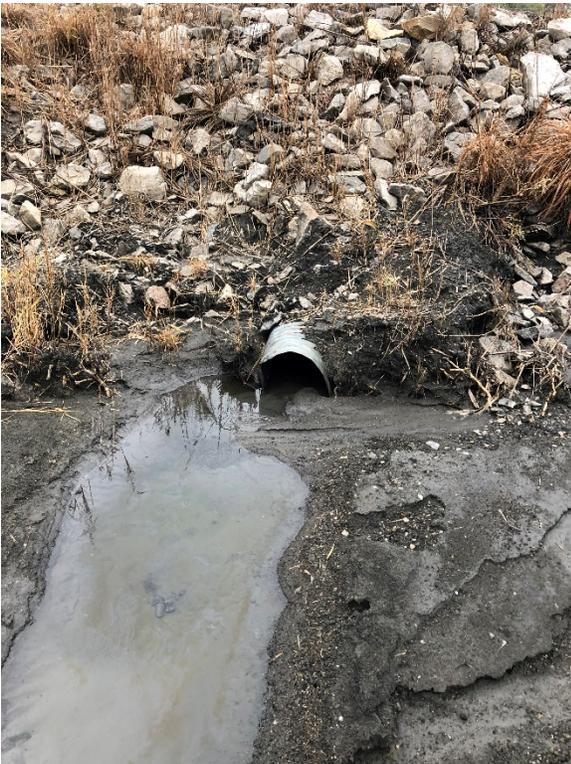
*Figure 4 - Secondary spillway approximately 1/4 to 1/3 full of sediment.*

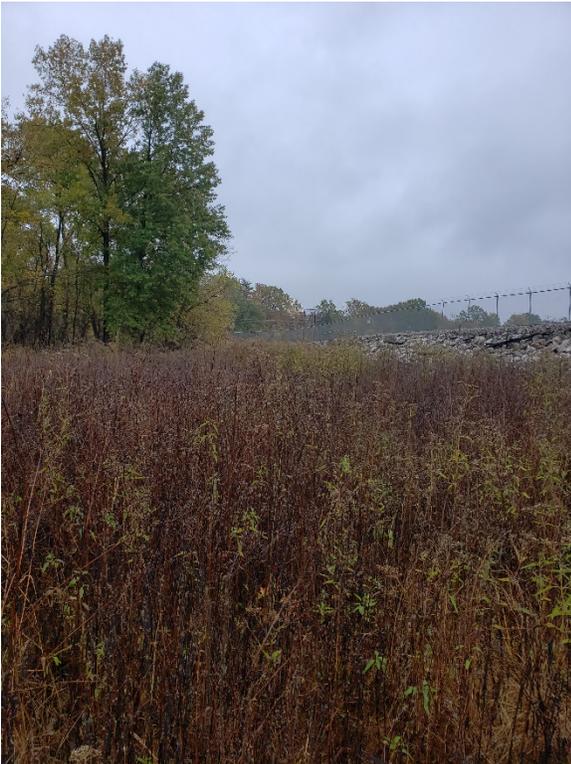
*Figure 8 - Minor ponding approximately 30-50 feet north of the perimeter embankment.*

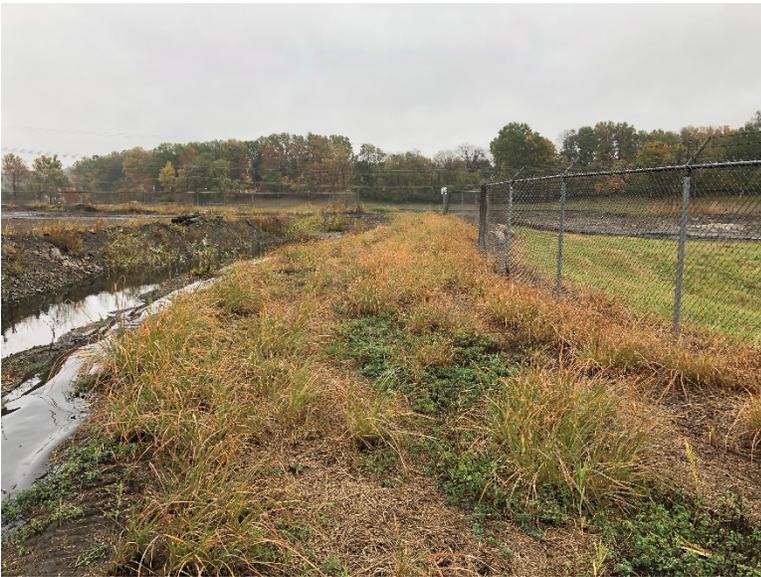
*Figure 4 – Area on inside of pond that has no apparent drainage.*

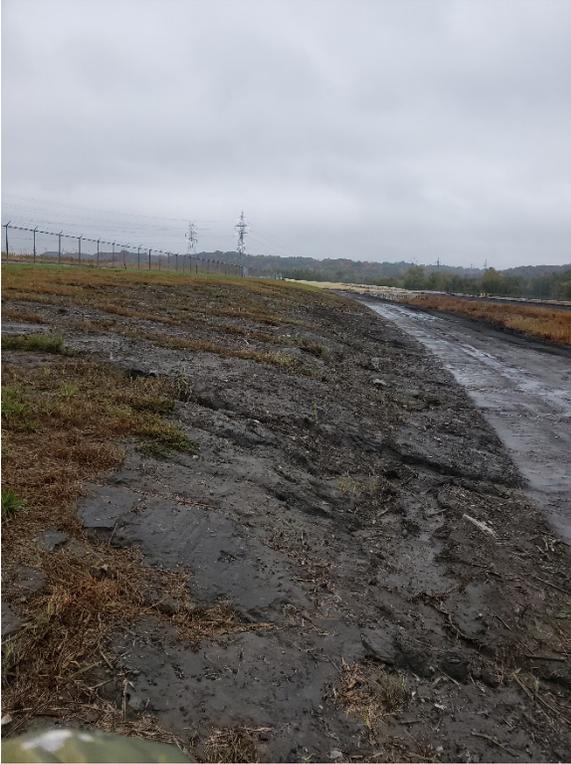
*Figure 5 – Minor erosion and poor sod cover on the north side of the impoundment.*

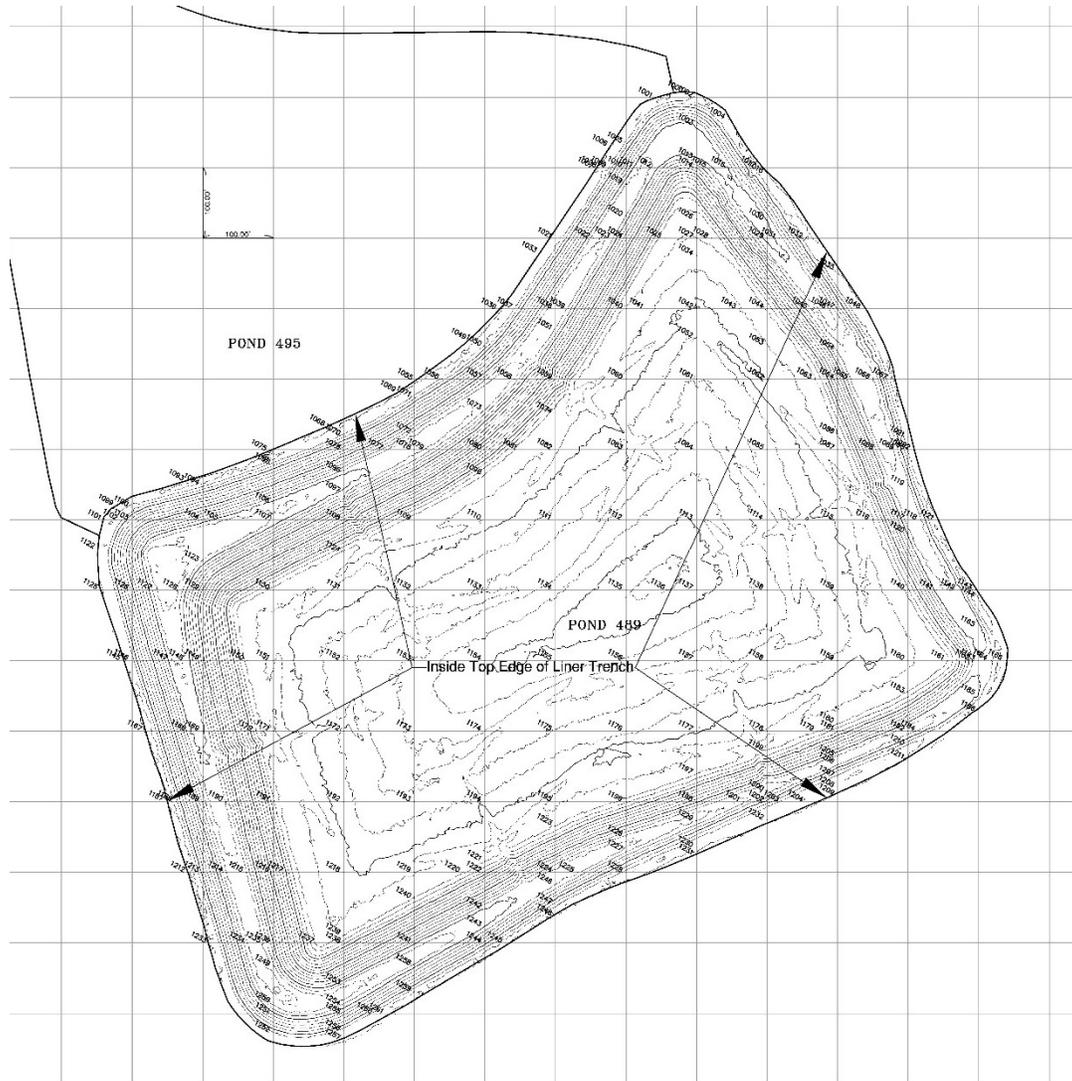
MERAMEC ENERGY CENTER  
Pond 489  
Annual Inspection Check Sheet

<b>Item</b>	<b>Condition Code</b>	<b>Comments</b>
<b>Outlet Condition</b>	GC	
<b>Outfall Pipe Condition</b>	GC	
<b>Outlet Channel</b>	GC	
<b>Discharge (color and/or sediment)</b>	NI	No discharge.
<b>Obstructions</b>	GC	
<b>Leakage</b>	GC	No leakage noted.
<b>Other</b>	-

Item	Condition Code	Comments
<b>Vertical &amp; Horizontal Alignment of Crest</b>	GC	
<b>Seepage/Wetness/Ponding Areas</b>	OB	Ponded water noted just off the west toe of the levee. The water was due to recent rain events. No flowing water was observed.
<b>Erosion/Rutting</b>	GC	
<b>Fencing</b>	GC	
<b>Vegetation</b>	GC	Vegetation has been cleared
<b>Sloughs/Slides/Cracks</b>	GC	
<b>Rip Rap Revetments</b>	GC	
<b>Animal Control</b>	GC	No burrows present.
<b>Other</b>	-

1. Ponded water was noted just off the west toe of the levee. The water was due to recent rain events. The plant should continue to inspect this area during routine weekly inspections.
2. Continue to clear the vegetation in the downstream rip rap.

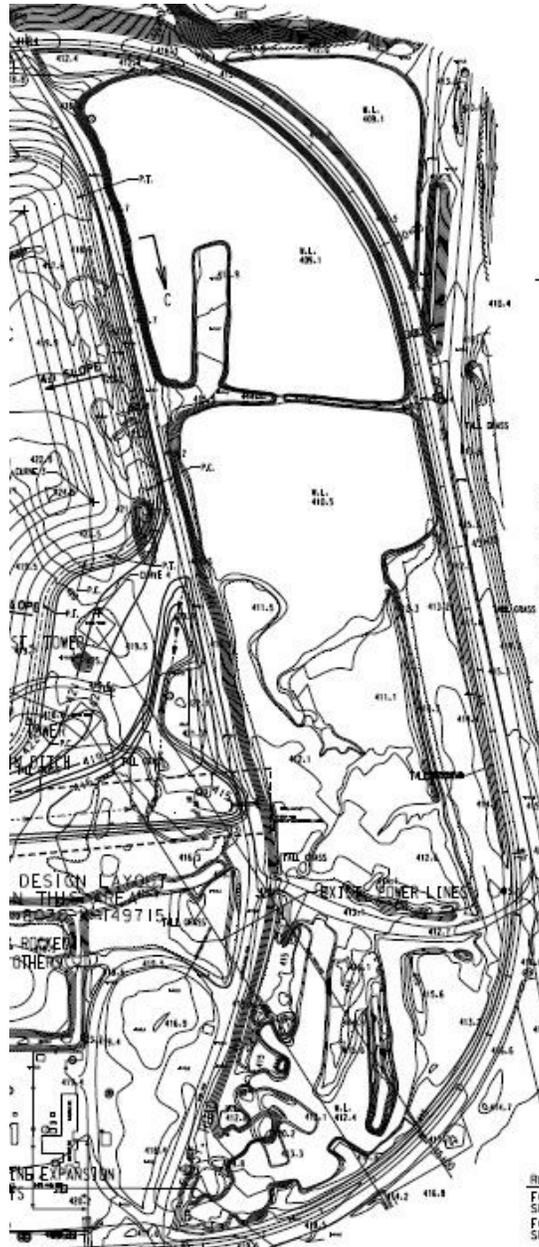
MERAMEC ENERGY CENTER  
MCPA (Pond 492), MCPB (Pond 493) and MCPC (Pond 496)  
Annual Inspection Check Sheet

Item	Condition Code	Comments
<b>Outlet Pipe Condition</b>	OB	No deficiencies noted.
<b>Discharge (color and/or sediment)</b>	NO	No discharge.
<b>Obstructions</b>	OB	No obstructions.
<b>Inlet Piping/ Supports Condition</b>	GC	
<b>Leakage</b>	GC	No leakage was observed.
<b>Other</b>

Item	Condition Code	Comments
<b>Vertical &amp; Horizontal Alignment of Crest</b>	GC	There was no visible misalignment of the crest.
<b>Rip Rap Revetments</b>	GC	
<b>Seepage/Wetness/ Ponding Areas</b>	OB	Small areas of ponded water downstream north side of the BAP. The water was due to recent rainfall events.
<b>Erosion/Rutting</b>	GC	
<b>Fencing</b>	GC	
<b>Vegetation</b>	OB	Continue to spray and clear vegetation as needed.
<b>Sloughs/Slides/ Cracks</b>	GC	No sloughs, slides, or cracks were observed.
<b>Animal Control</b>	GC	No animal burrows observed.
<b>Other</b>	MM	Clean the staff gage.

<b>Item</b>	<b>Condition Code</b>	<b>Comments</b>
		Lower the staff gage so that weekly readings can be taken.

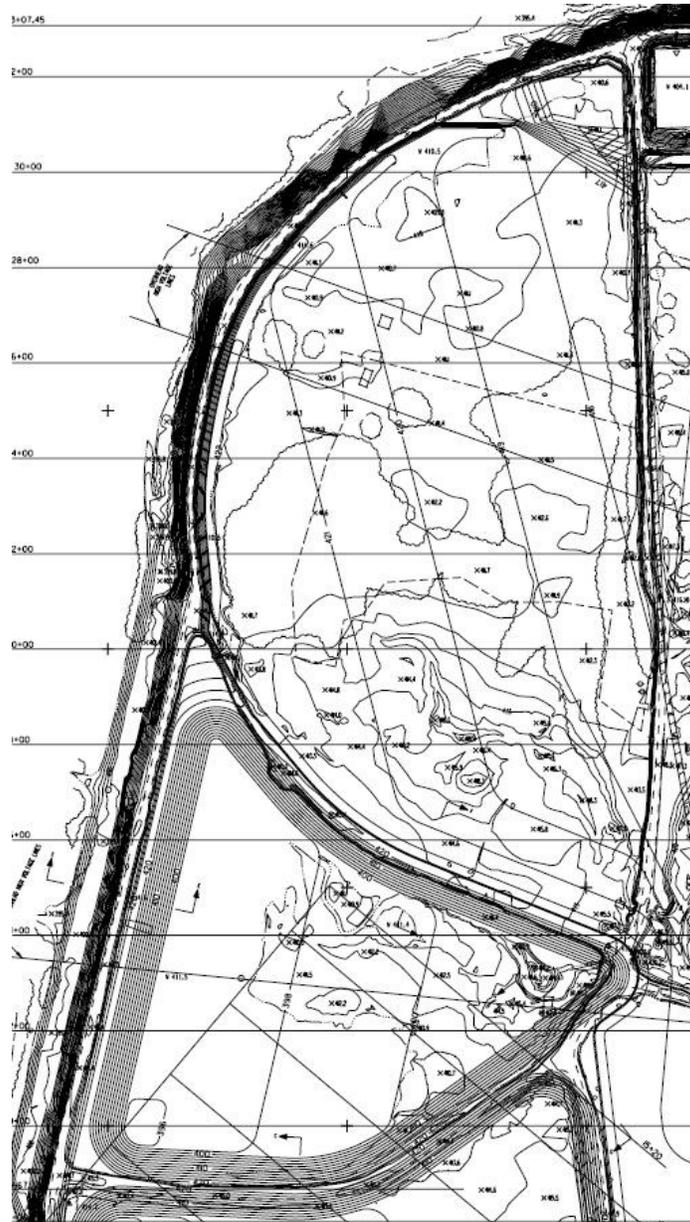
MERAMEC ENERGY CENTER  
 Pond 494 and 495  
 Annual Inspection Check Sheet

<b>Item</b>	<b>Condition Code</b>	<b>Comments</b>
<b>Vertical &amp; Horizontal Alignment of Crest</b>	GC	There was no visible misalignment of the crest.
<b>Rip Rap Revetments</b>	GC	
<b>Seepage/Wetness/Ponding Areas</b>	OB	Small areas of ponded water were noted at multiple locations downstream of Pond 494 and Pond 495. The water was located in ruts from vehicle traffic. The water was due to recent rainfall events.
<b>Erosion/Rutting</b>	OB	Rutting was observed on the downstream side of the levee just off the toe of the embankment.
<b>Fencing</b>	GC	Fencing was repaired as part of the rip rap project in 2017.
<b>Vegetation</b>	GC	Vegetation has been cleared.
<b>Sloughs/Slides/Cracks</b>	GC	
<b>Interior Drainage/Culverts</b>	GC	
<b>Animal Control</b>	GC	No animal burrows were observed.
<b>Other</b>

1. Continue to clear the downstream vegetation in the rip rap.
2. Areas of standing water were present along the downstream toe of Pond 494 and 495. The water was located in ruts from vehicle traffic. The plant should continue to inspect this area during routine weekly inspections.
3. The ruts along the downstream toe should be repaired to allow positive drainage.

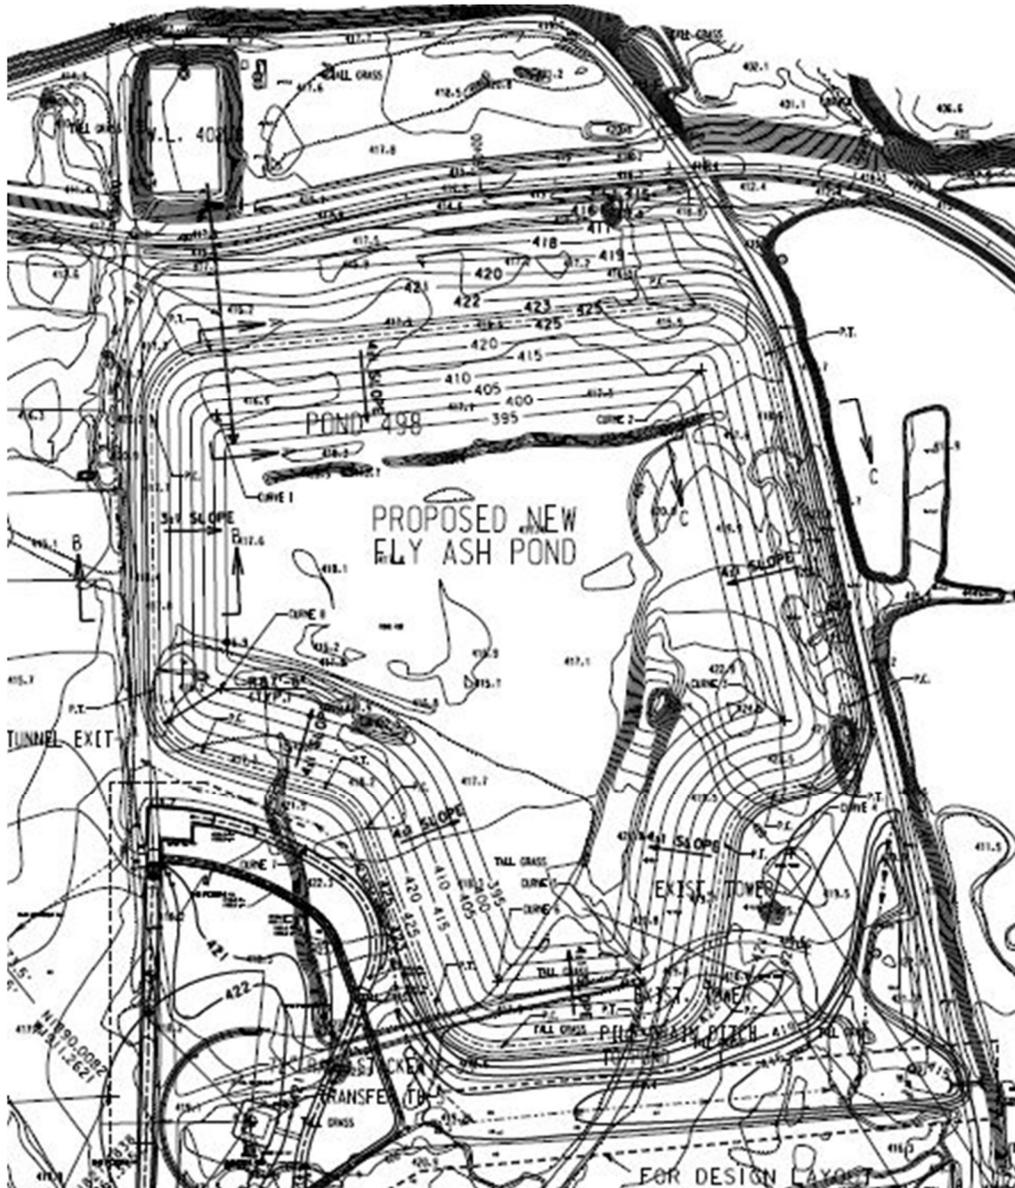
MERAMEC ENERGY CENTER  
MCPD (Pond 498)  
Annual Inspection Check Sheet

Item	Condition Code	Comments
Outlet Condition	GC	
Skimmer/Pipe Supports Condition	GC	
Valve Condition/ Operability	NI	The valve was not inspected, but it is functional.
Discharge (color and/or sediment)	NI	No Discharge.
Obstructions	GC	No obstructions observed.
Inlet Piping/Supports Condition	GC	
Leakage	GC	No leakage observed
Other

Item	Condition Code	Comments
Vertical & Horizontal Alignment of Crest	GC	No deficiencies noted.
HDPE Liner	GC	Visible portion of the liner was in good condition.
Seepage/Wetness/ Ponding Areas	GC	No seepage, wetness, or ponding observed.
Erosion/Rutting	OB	No rutting or erosion observed.
Fencing	GC	
Vegetation	MM	Bare areas on the north downstream slope. Recommend seeding.

<b>Item</b>	<b>Condition Code</b>	<b>Comments</b>
<b>Sloughs/Slides/ Cracks</b>	GC	No sloughs, slides, or cracks observed.
<b>Animal Control</b>	GC	No animal burrows noted.
<b>Other</b>	MM	Clean the staff gage.

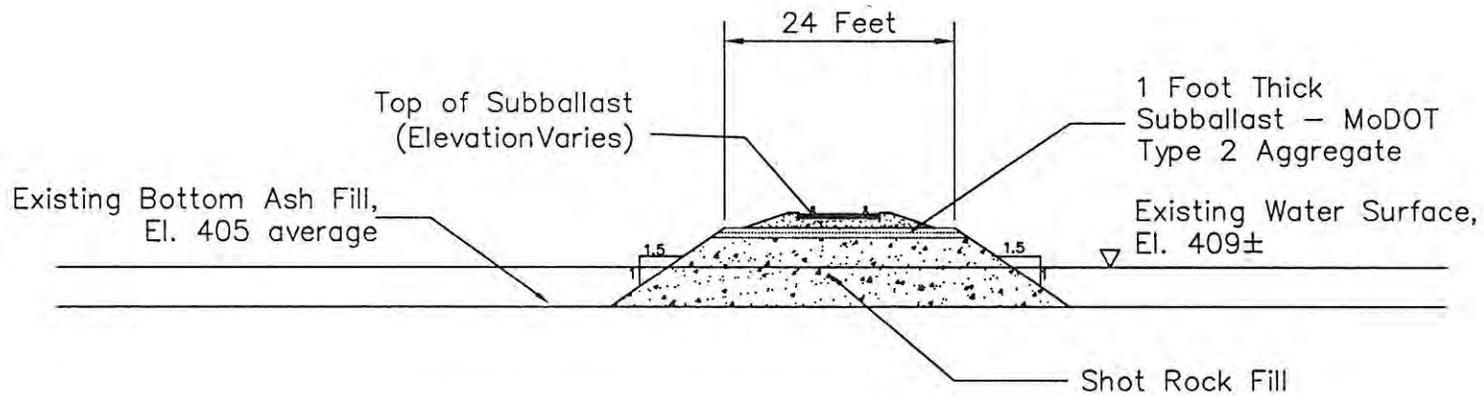
FIGURE  
9

Where the railroad loop embankment will cross the flyash ponds, we recommend removing the flyash to a depth of 5 feet. The typical track section is shown in Figure 9. The bottom of this overdig will vary between about el. 406 and el. 411, which should be above the maximum Mississippi River stage in most years. The flyash that is removed may be dried for use as fill. A 2-foot thick of compacted granular fill should be placed in the bottom of the overdig, with a woven geofabric such as Mirafi HP570 at about the center of the granular fill. This blanket will provide a base upon which to place and compact the flyash to build the embankment. The fill should be compacted as recommended under "Fill Materials and Placement."

Where the embankment will cross the bottom ash ponds, we recommend constructing the embankment using coarse "shot rock" fill. The bottom ash is coarser than the flyash, so it should not be necessary to overexcavate the bottom ash to create a base. A typical track section is shown in Figure 9.
