**STRUCTURAL INTEGRITY
CRITERIA & HYDROLOGIC/
HYDRAULIC
CAPACITY ASSESSMENT
MERAMEC ENERGY CENTER**

*Meramec Energy Center
8200 Fine Road
St. Louis, MO 63129*

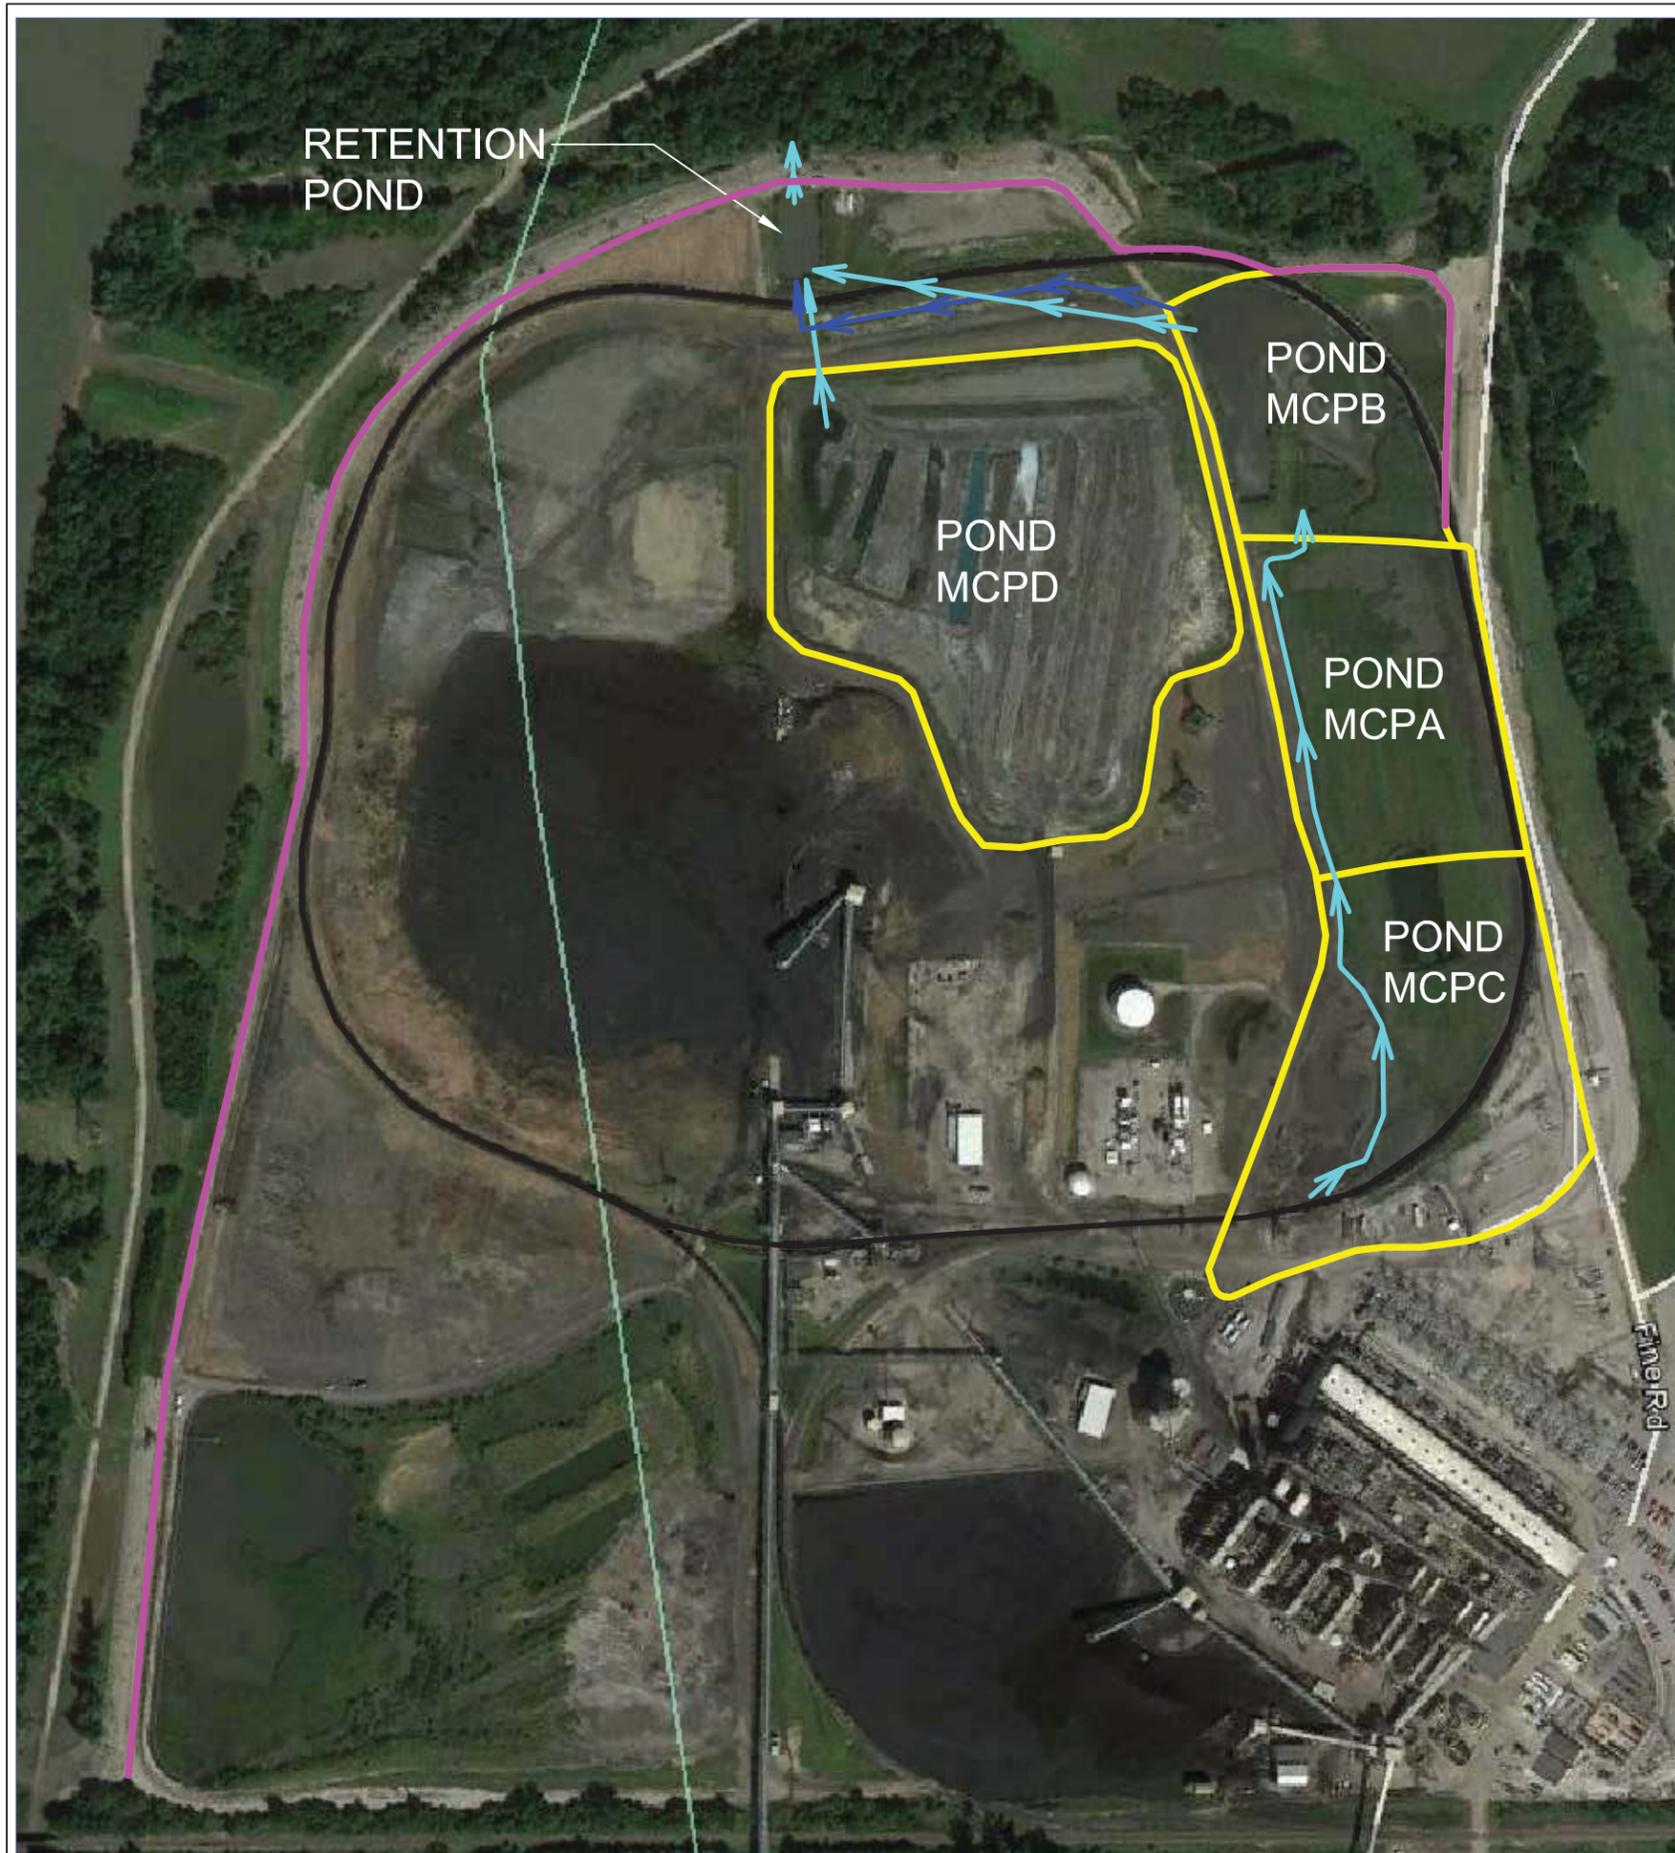
Ameren Missouri
 Meramec Energy Center
 CCR Unit Evaluation
 Figure 2 - Operational Data

CCR UNIT	MAXIMUM SURFACE ELEVATION (ACRES)	DAM CREST ELEVATION (FEET)	CREST LENGTH (FEET)	NORMAL POOL ELEVATION (FEET)	MAXIMUM SURCHARGE POOL (FEET)	UPSTREAM SLOPE STEEPNESS (H:V)	DOWNSTREAM SLOPE STEEPNESS (H:V)
MCPD	13.5	423.0	3320	418.0	420.0	3H:1V & 4H:1V	3H:1V
MCPB	6.9	413.2	1200	409.5	411.3	UNKNOWN	2H:1V
MCPA	6.1	INCISED	NA	410.3	412.7	NA	NA
MCPC	5.9	INCISED	NA	410.3	412.7	NA	NA

1, United States Geological Services (“USGS”) topographical quadrangle map. Various design and operational features of the CCR units, including water flow path, is set forth on Figure 2.

In 2000, Ameren Missouri constructed a rail line adjacent and parallel to the perimeter embankment. The rail loop bifurcates a portion of MCPB. The embankment and rail line are depicted on Figure 2. The height of the perimeter embankment varies, but in the vicinity of the bottom ash ponds is approximately 24.7 feet from the toe to the crest. All active impoundments are offset at least 1,400 feet from the Meramec River and further separated from the river by out-of-service impoundments. No residential homes, businesses or lifeline facilities are located down gradient of the ponds. Meramec’s nearest neighbor is the Metropolitan Sewer District wastewater treatment plant located upstream (north) of the facility.
