**STRUCTURAL INTEGRITY
CRITERIA & HYDROLOGIC/
HYDRAULIC
CAPACITY ASSESSMENT
SIOUX ENERGY CENTER**

*Sioux Energy Center
8501 North State Route 94
West Alton, MO 63386*

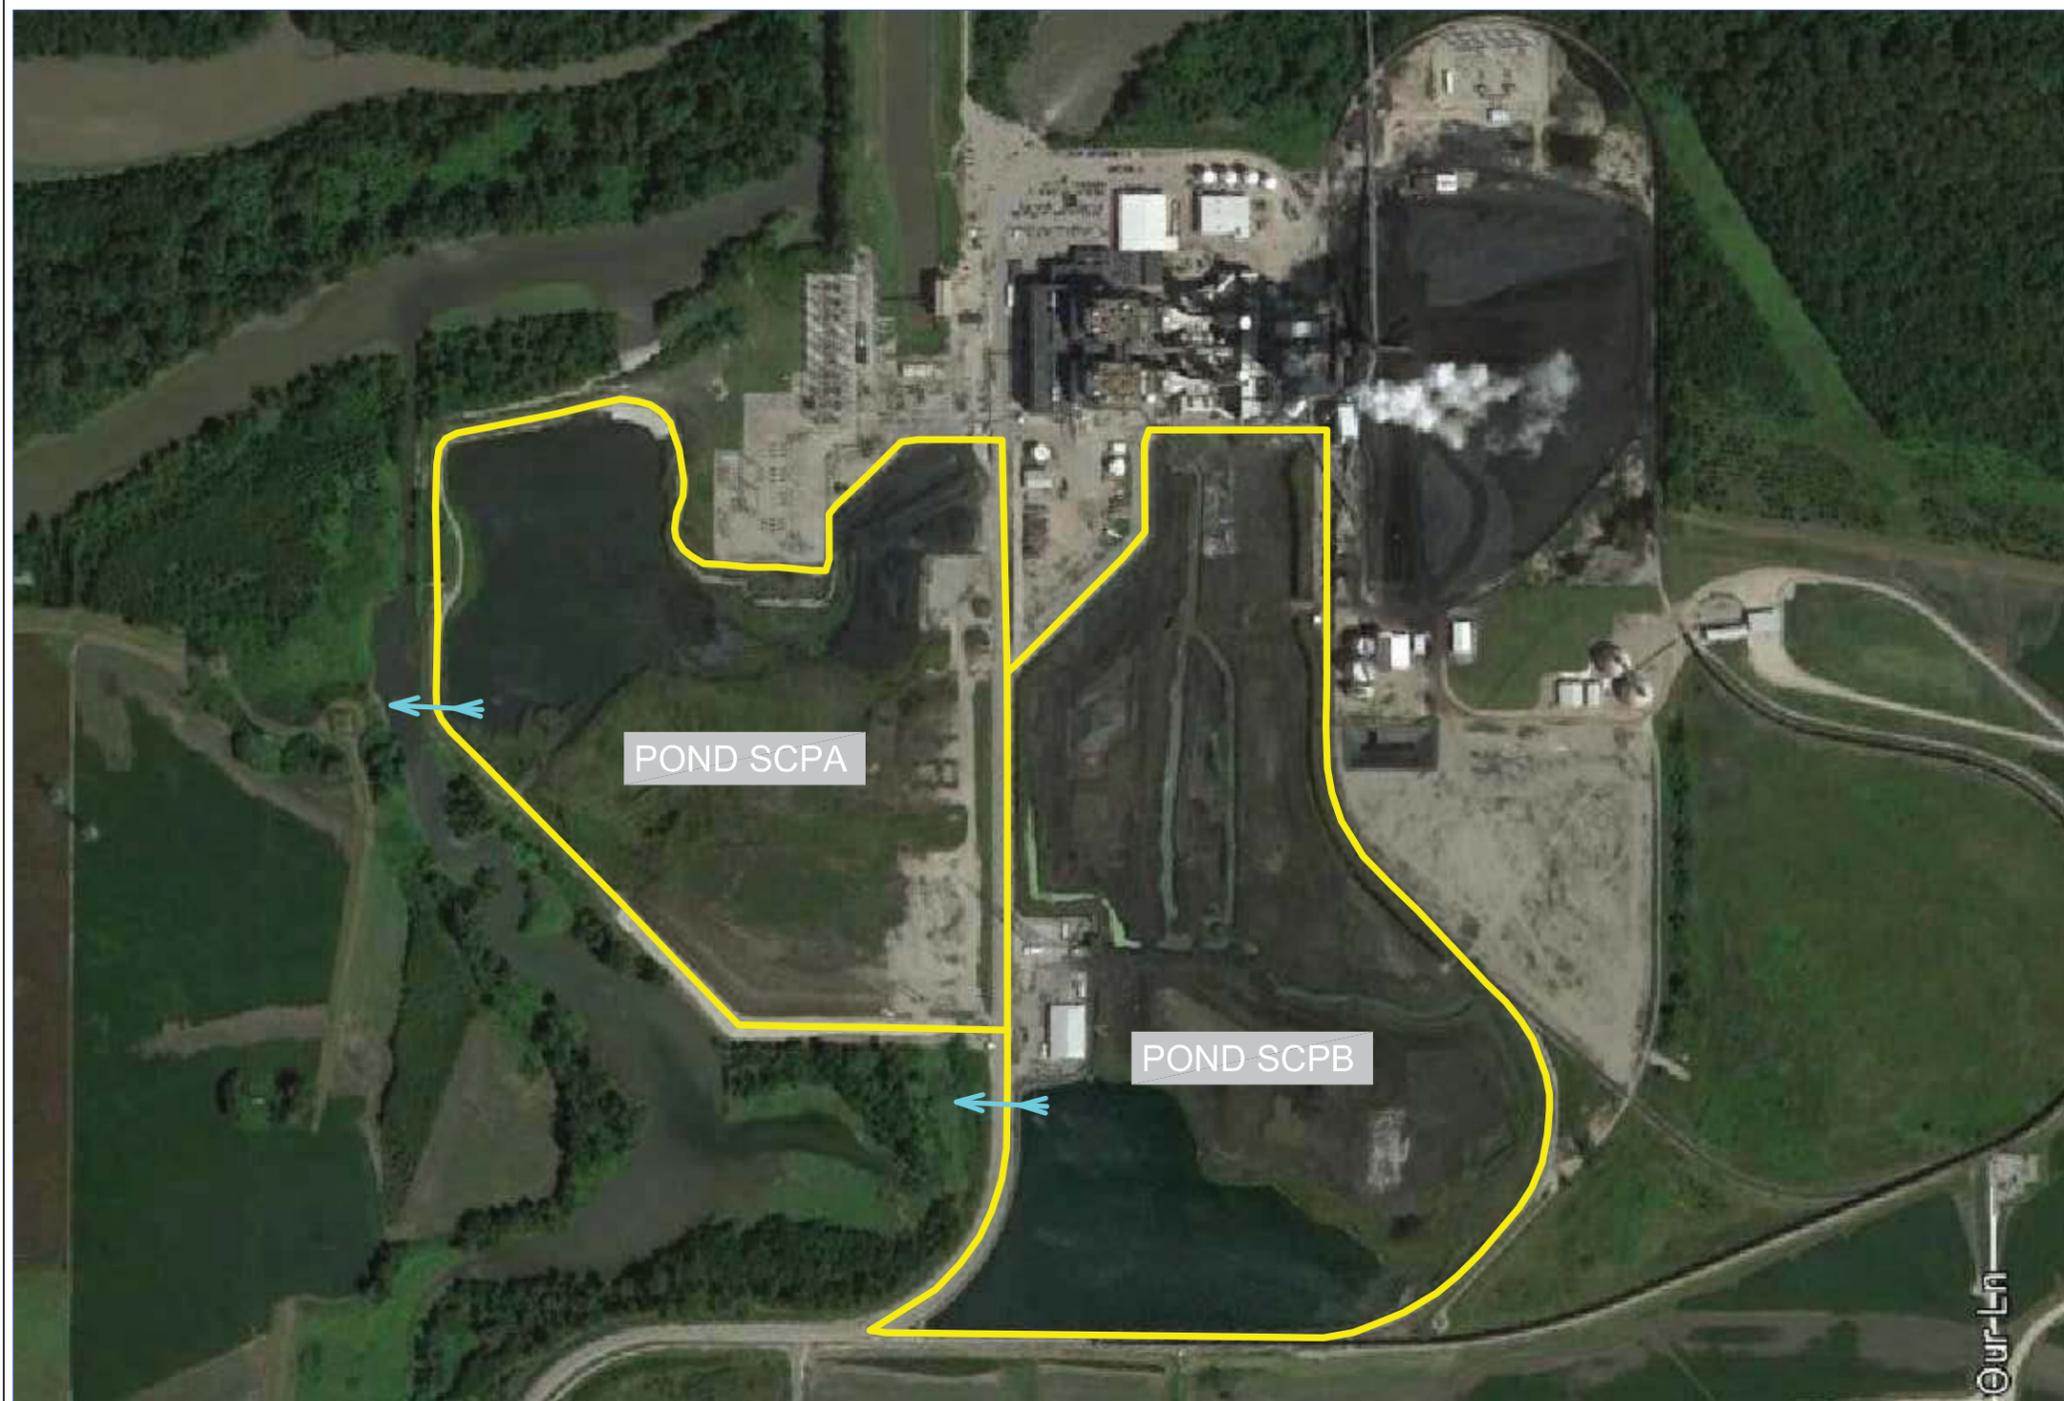
Ameren Missouri
 Sioux Energy Center
 CCR Unit Evaluation
 Figure 2 - Operational Data
 SCPA & SCPB

- Pond Footprint
- ⇨ Primary Flow Path

CCR UNIT	MAXIMUM SURFACE ELEVATION (ACRES)	DAM CREST ELEVATION (FEET)	CREST LENGTH (FEET)	NORMAL POOL ELEVATION (FEET)	MAXIMUM SURCHARGE POOL (FEET)	UPSTREAM SLOPE STEEPNESS (H:V)	DOWNSTREAM SLOPE STEEPNESS (H:V)
SCPA	49.0	442.5	6700	438.0	440.3	2H:1V	2H:1V & 2.5H:1V
SCPB	62.0	441.5	7900	439.2	441.0	3H:1V	2H:1V to 3H:1V

The location of the Sioux Energy Center is depicted on Figure 1, United States Geological Services (USGS) topographical quadrangle map. Various design and operational features of the CCR units, including water flow path, is set forth on Figures 2 and 3.

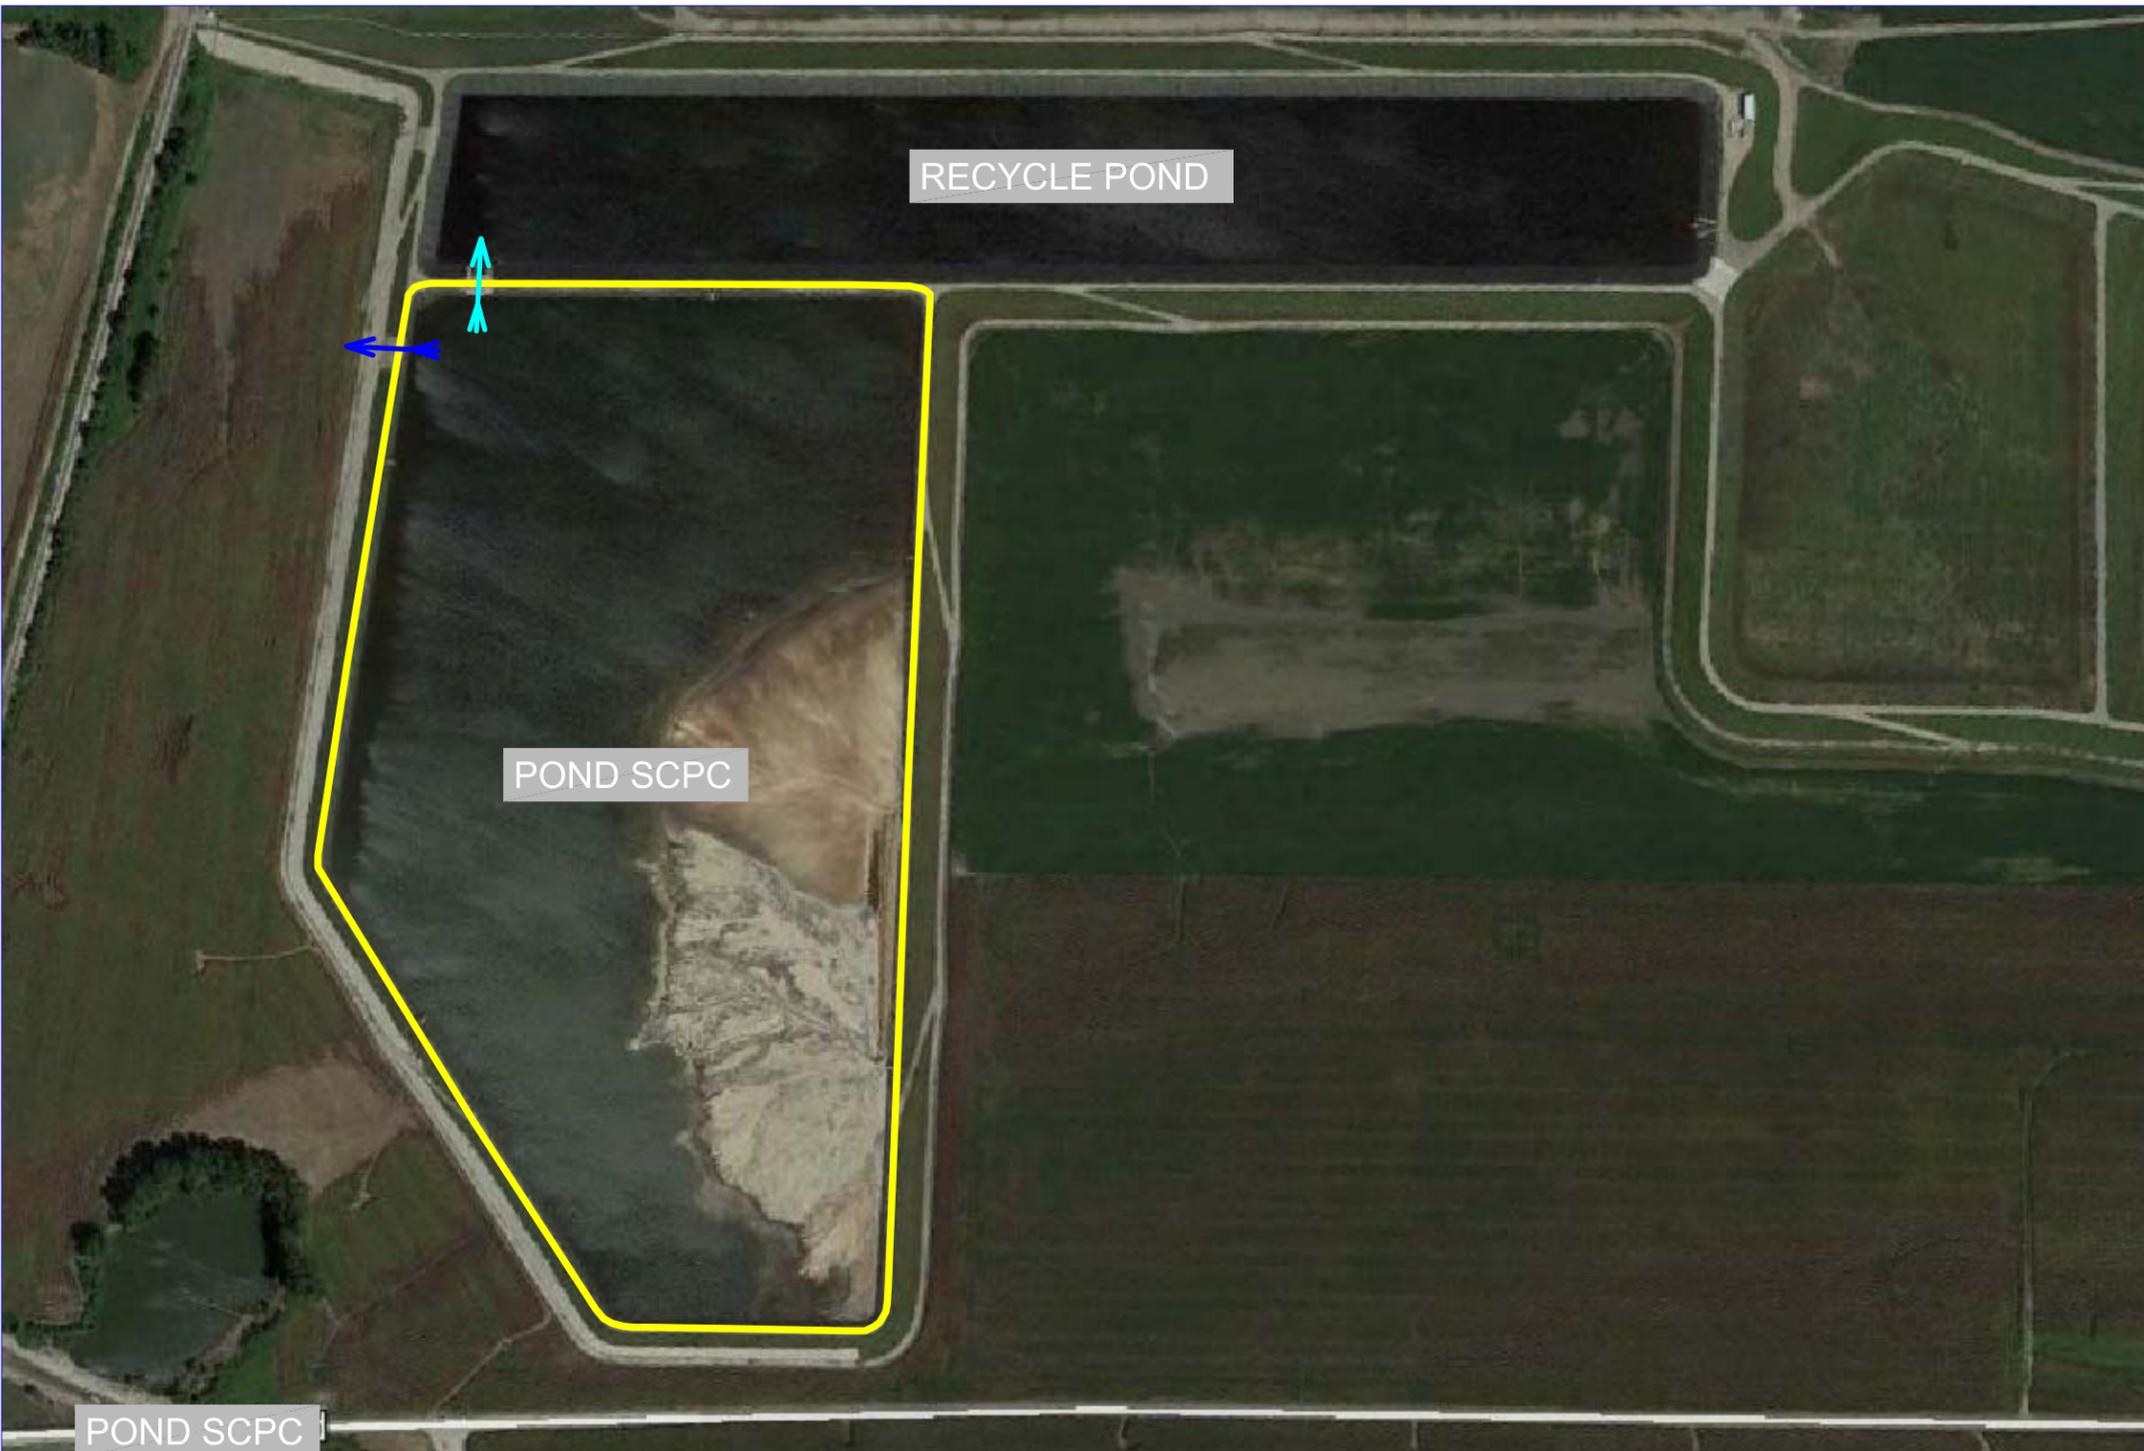
- Pond Footprint
- ⇨ Primary Flow Path
- ⇨ Emergency Spillway Flow Path
