**POST-CLOSURE CARE PLAN
FLY ASH POND AND BOTTOM ASH POND
MEREDOSIA POWER STATION
800 SOUTH WASHINGTON STREET
MEREDOSIA, ILLINOIS**

AMERENENERGY MEDINA VALLEY COGEN, LLC
St. Louis, Missouri

GEOTECHNOLOGY, INC.
St. Louis, Missouri

March 12, 2018

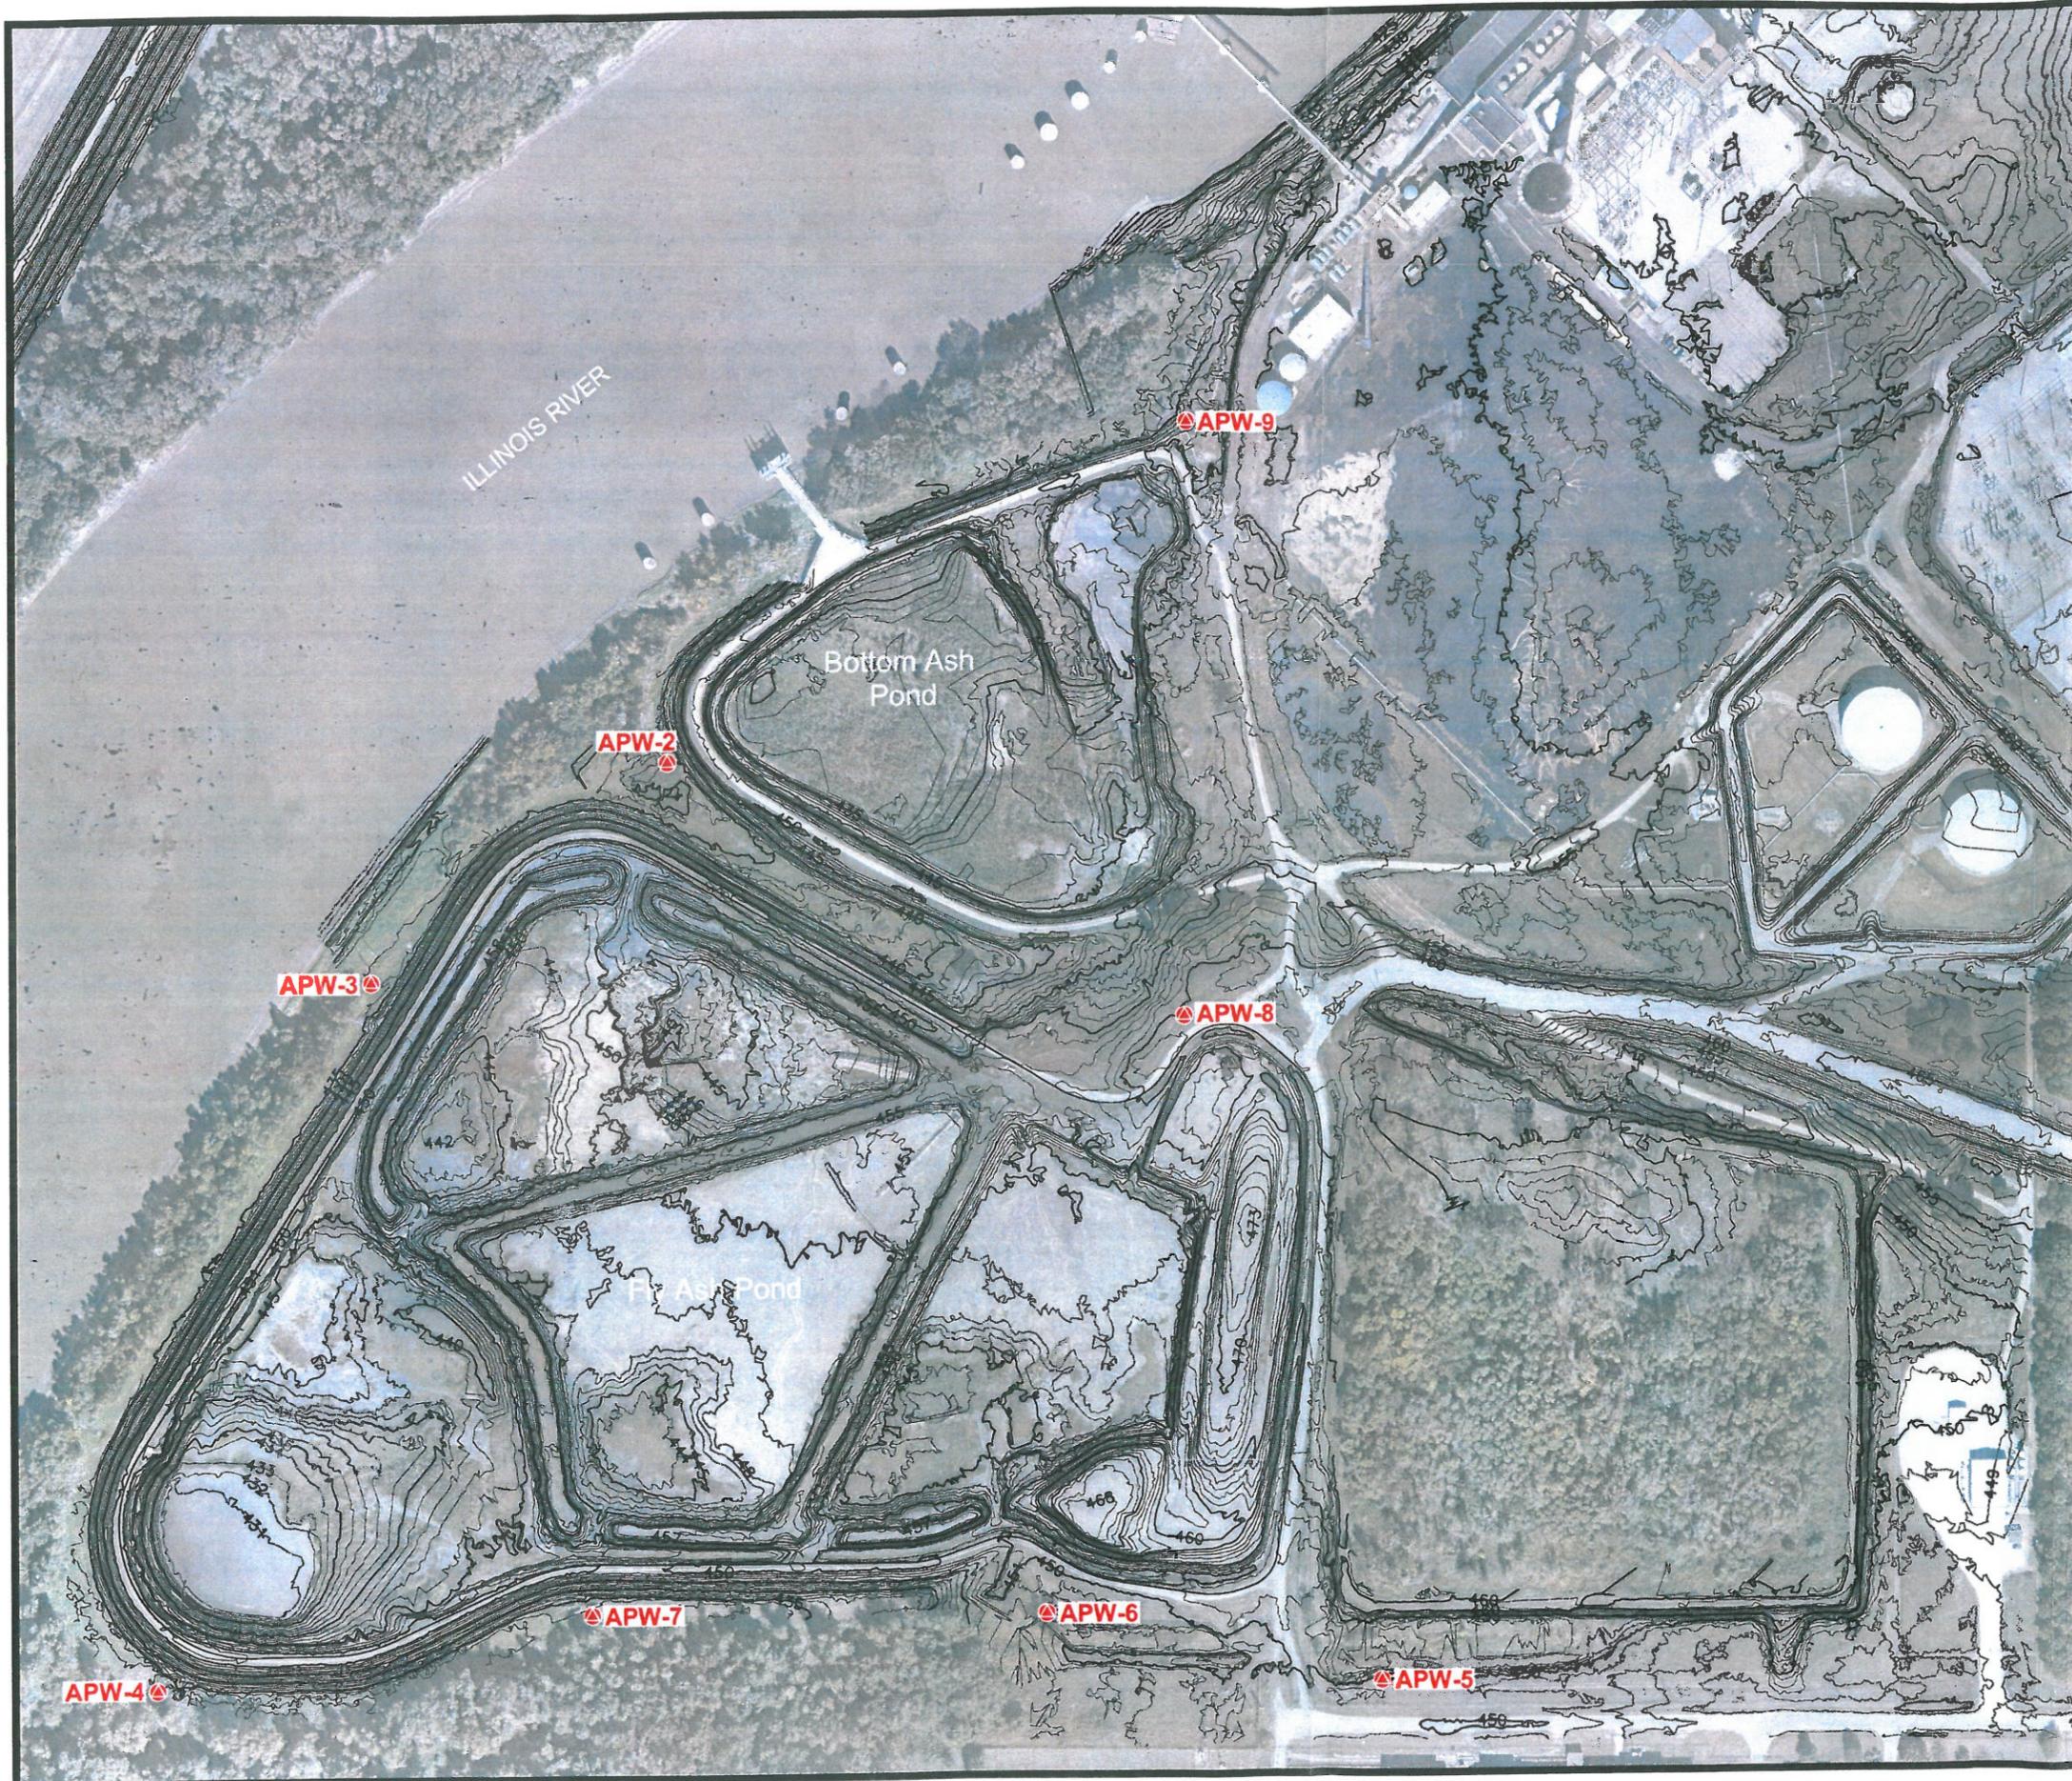
1. Plan adapted from drawings based on topography obtained by AeroView in October 2015 and supplied by the client.
2. Monitoring wells were located by the project surveyor.
3. Monitoring Well APW-1 is located beyond the limits of this map and is approximately 2000-feet east of Monitoring Well APW-5.

Monitoring Well Location

The Meredosia Power Station is located at 800 South Washington Street, Meredosia, Illinois. The facility will be decommissioned and will be demolished. The Fly Ash and Bottom Ash Ponds are located southwest of the coal pile and plant facilities. The site location and topography are shown on Plate 1. The structures and ash ponds are shown on Plate 2.
