AMEREN MISSOURI SIOUX ENERGY CENTER EVALUATION OF CCR UNITS 40 CFR PART 257 ST. CHARLES COUNTY, MISSOURI

AMEREN MISSOURI SIOUX ENERGY CENTER EVALUATION OF CCR UNITS ST. CHARLES COUNTY, MISSOURI

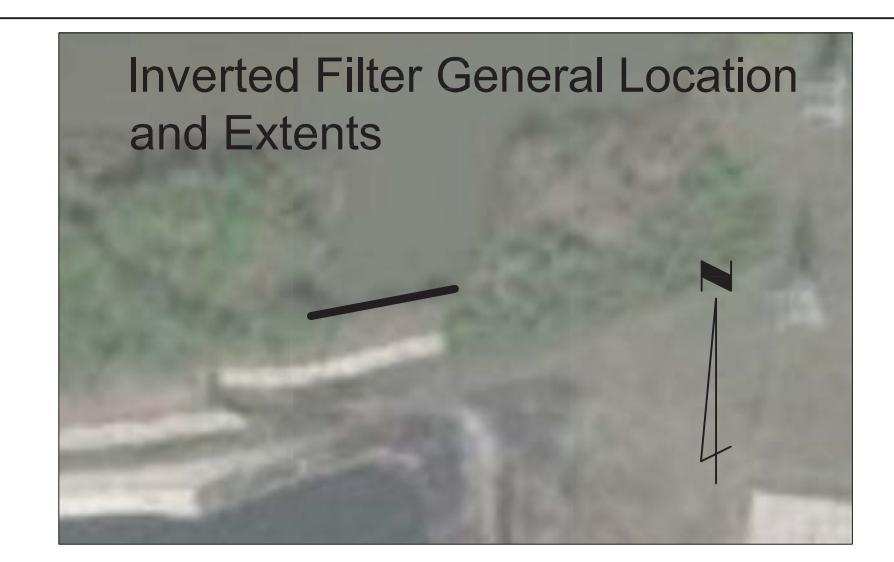
Inverted Filter General Location and Extents Cross-section

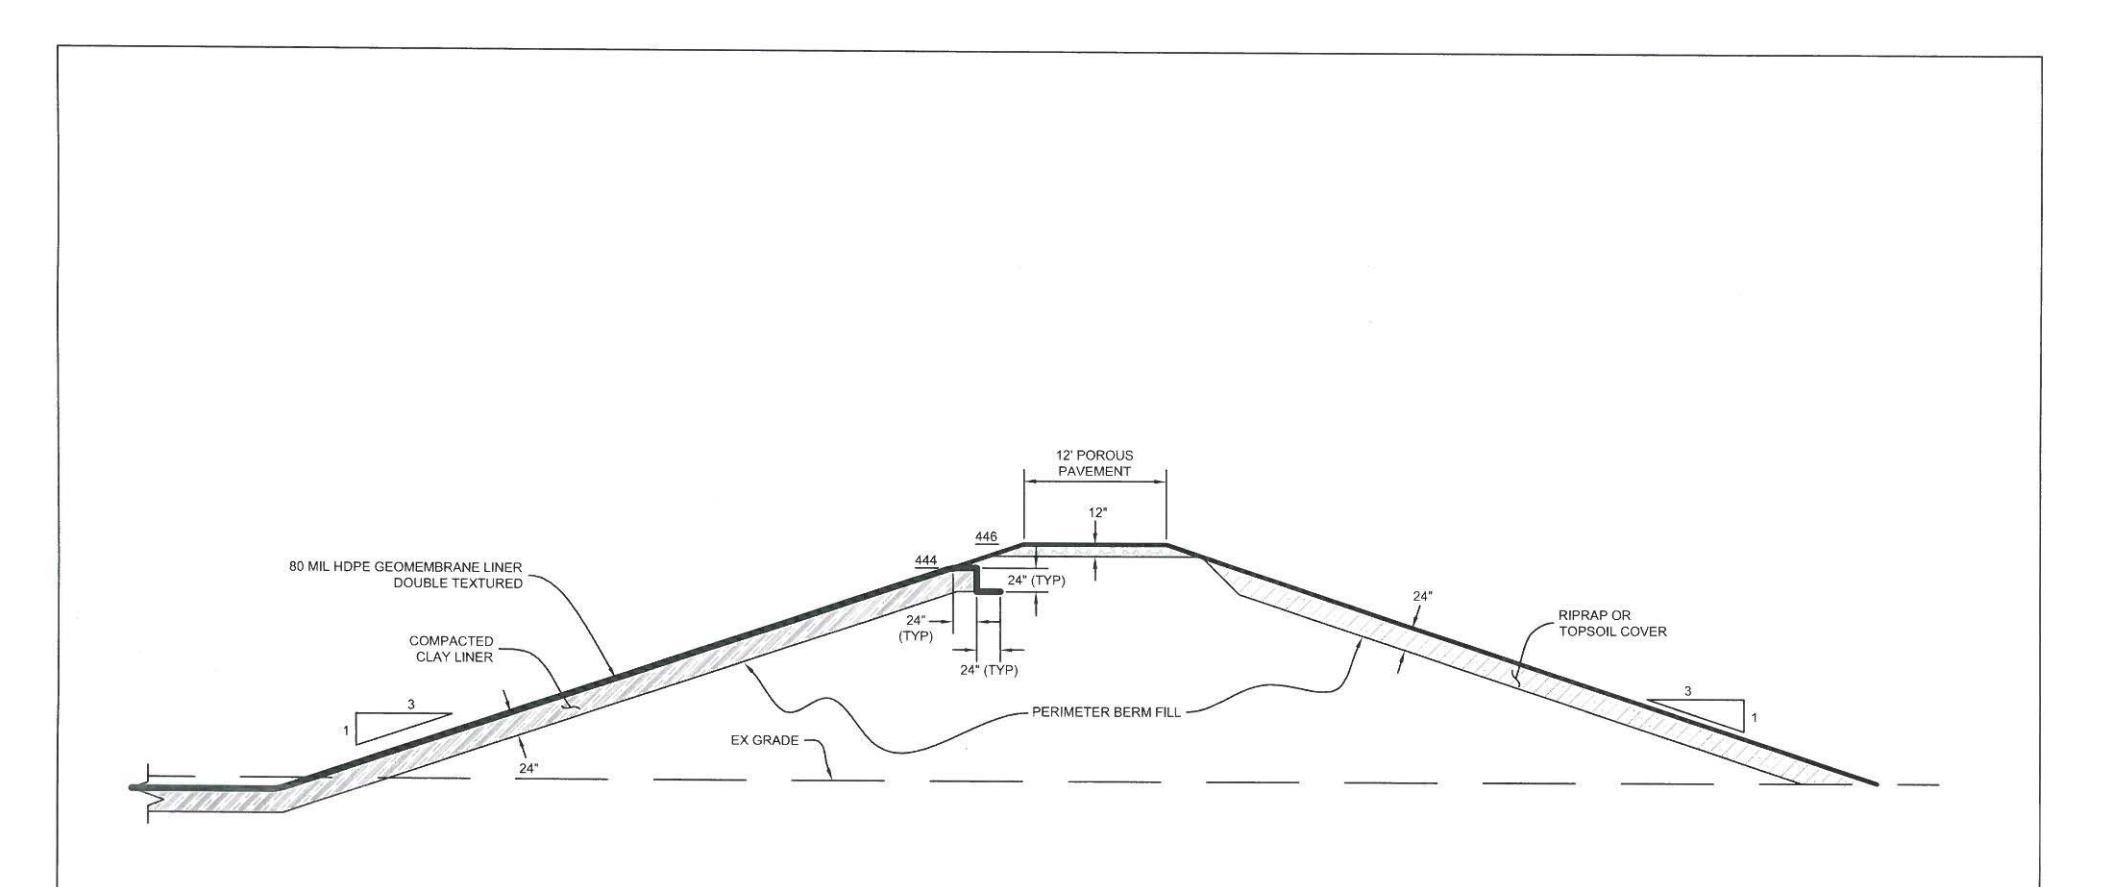
Figure 3

Ameren Sioux Energy Center UWL TYPICAL CROSS-SECTION OF CELL 1 AND RECYCLE POND PERIMETER BERM

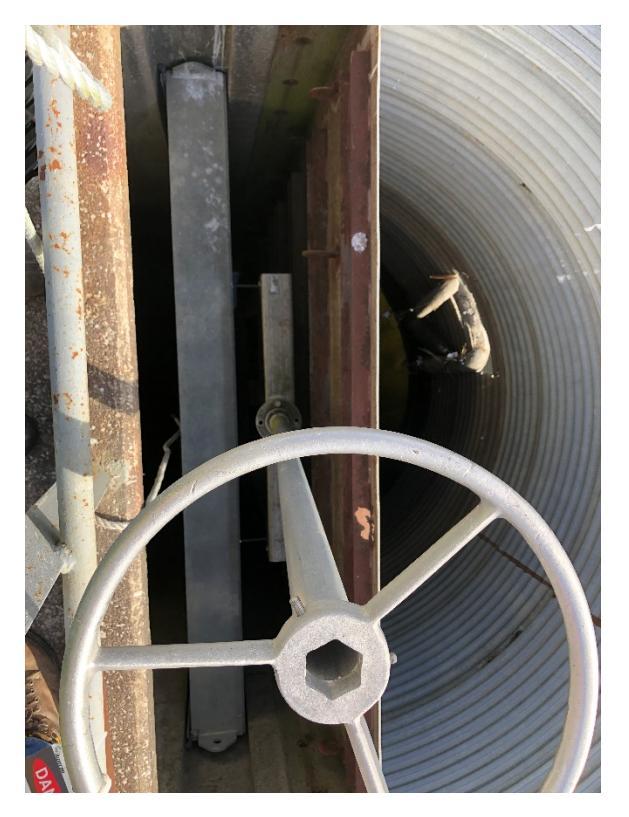
Figure 3 – Principal spillway gate.

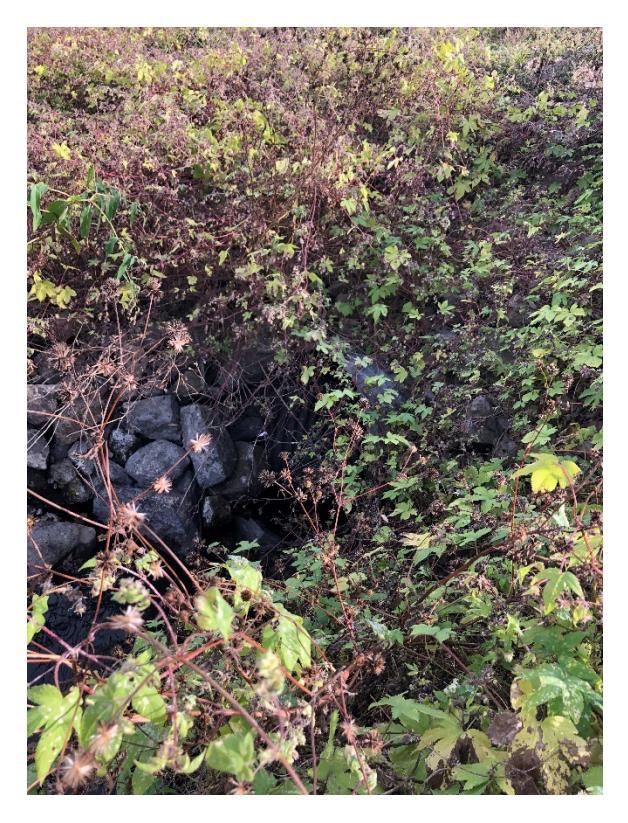
Figure 4 – Outlet channel riprap.

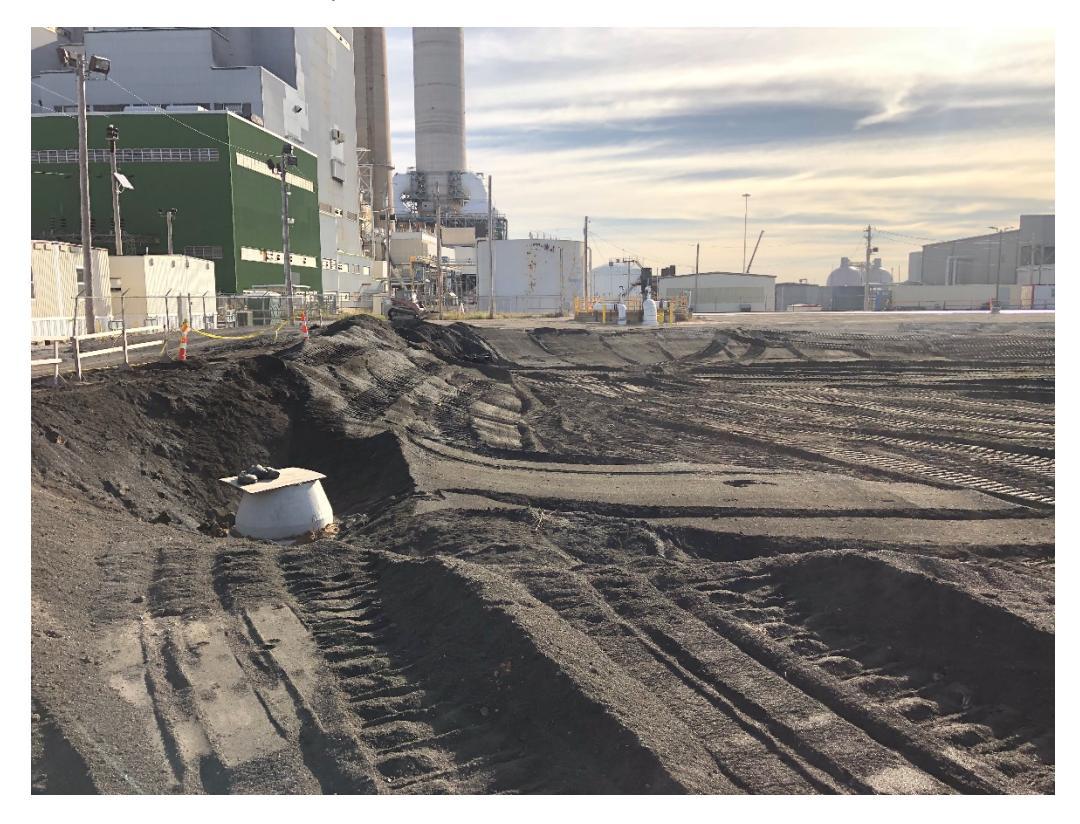
Figure 5 – The inlet pipes are no longer in use and the outfall channel for these pipes was being filled.

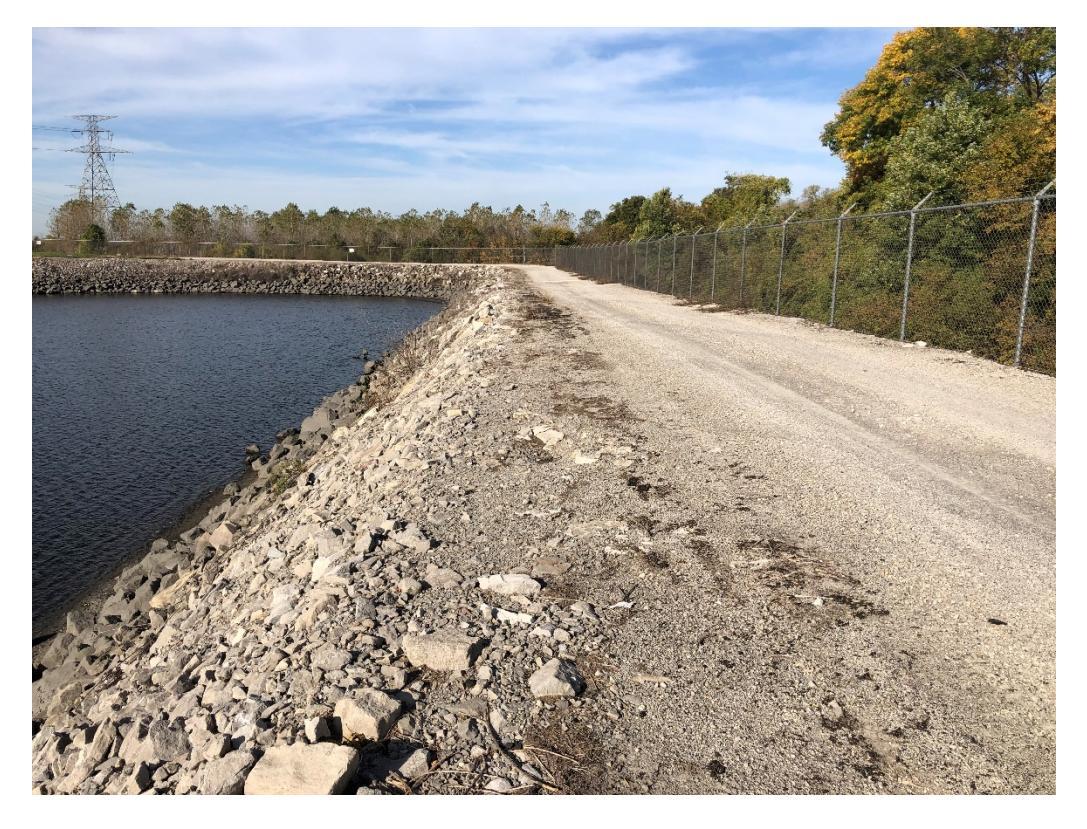
Figure 6 - Perimeter embankment crest and upstream slope on north side of impoundment.

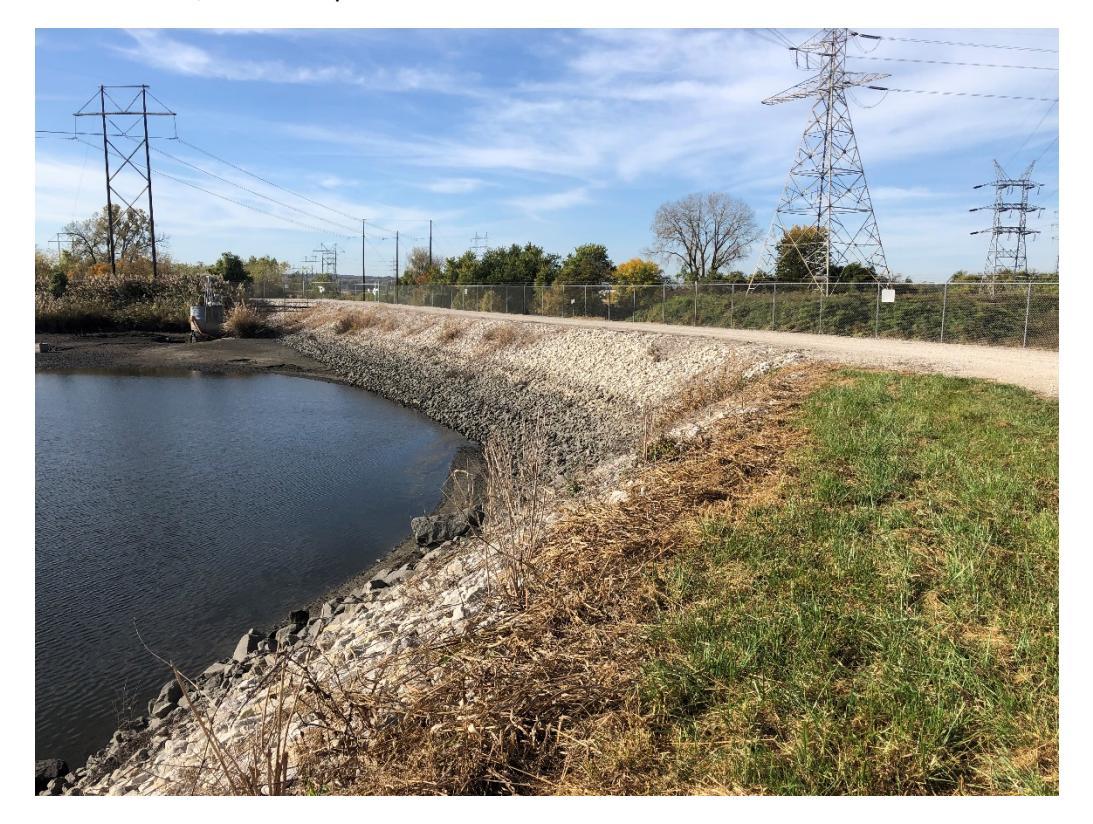
Figure 7 – Perimeter embankment upstream slope on west side of impoundment.

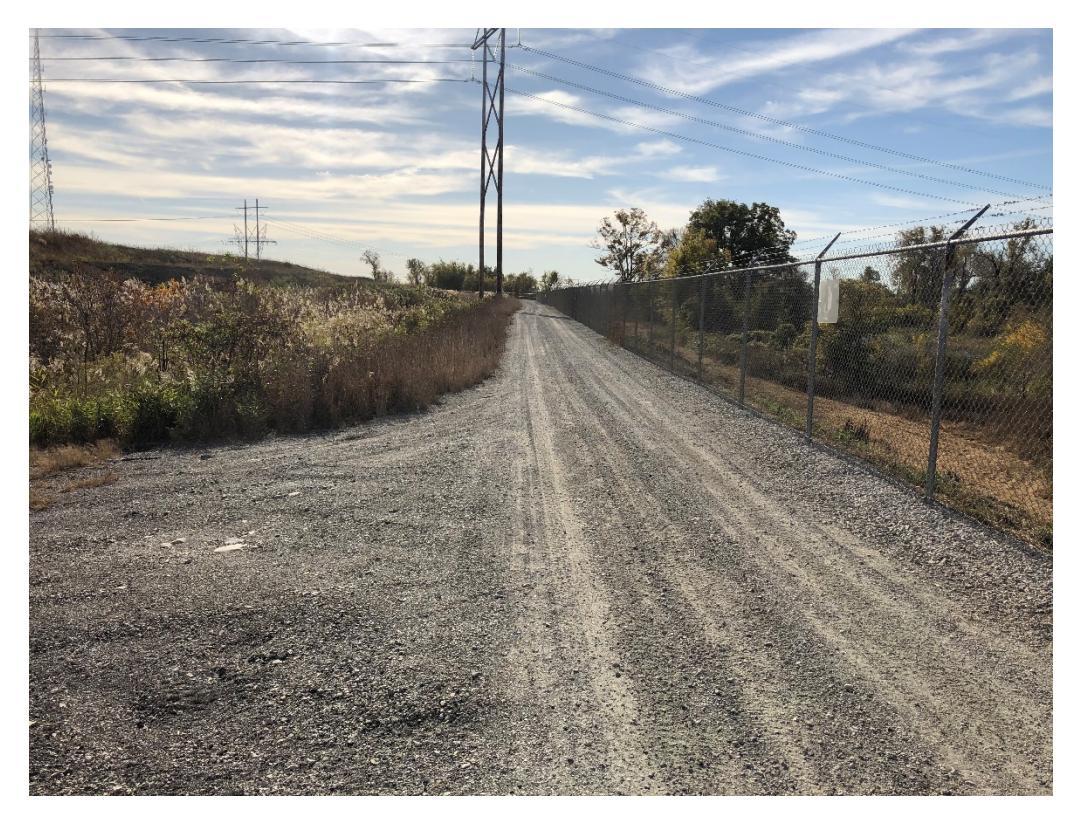
Figure 8 – Perimeter embankment crest on west side of impoundment.

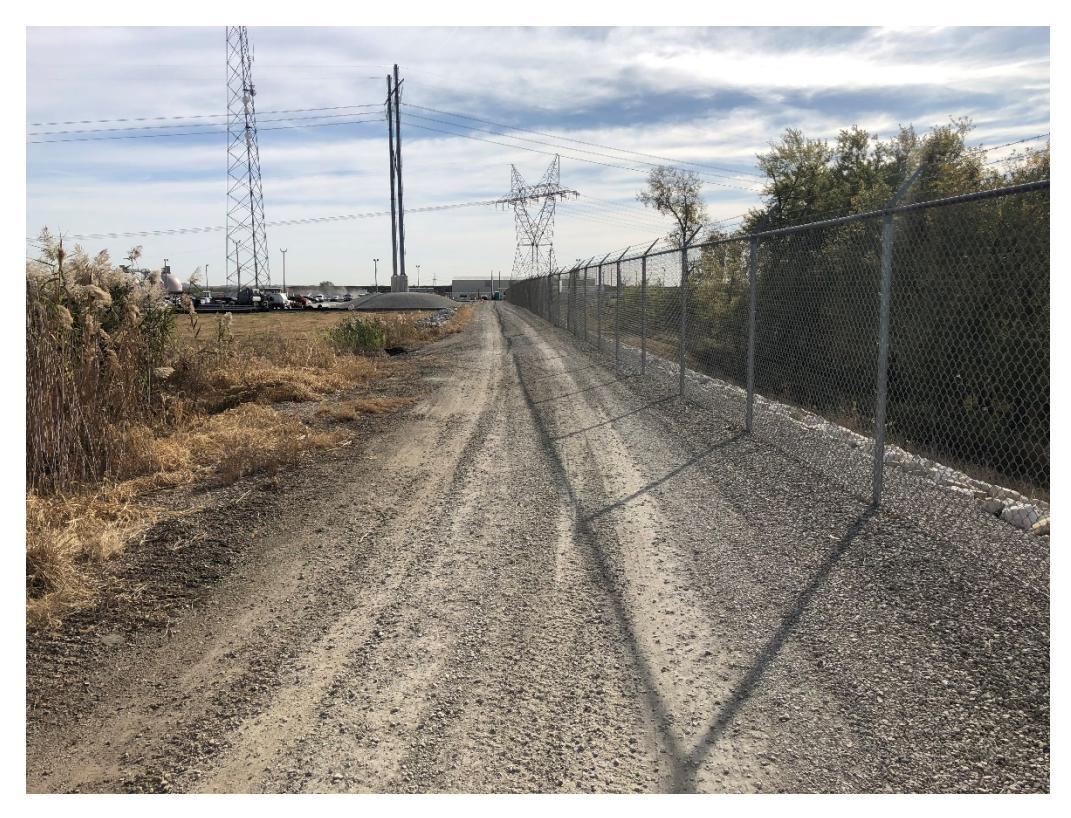
Figure 9 - Perimeter embankment crest on south side of impoundment.

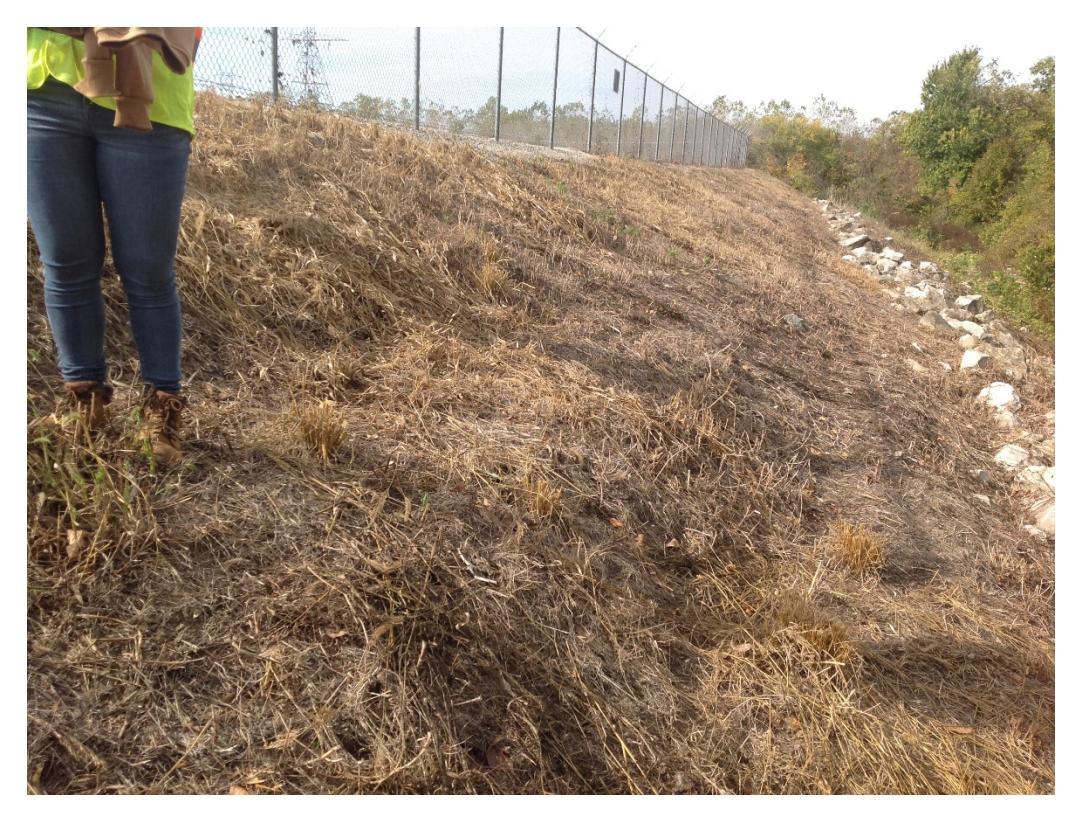
Figure 12 - Vegetation on downstream slope on north side of impoundment is sparse.

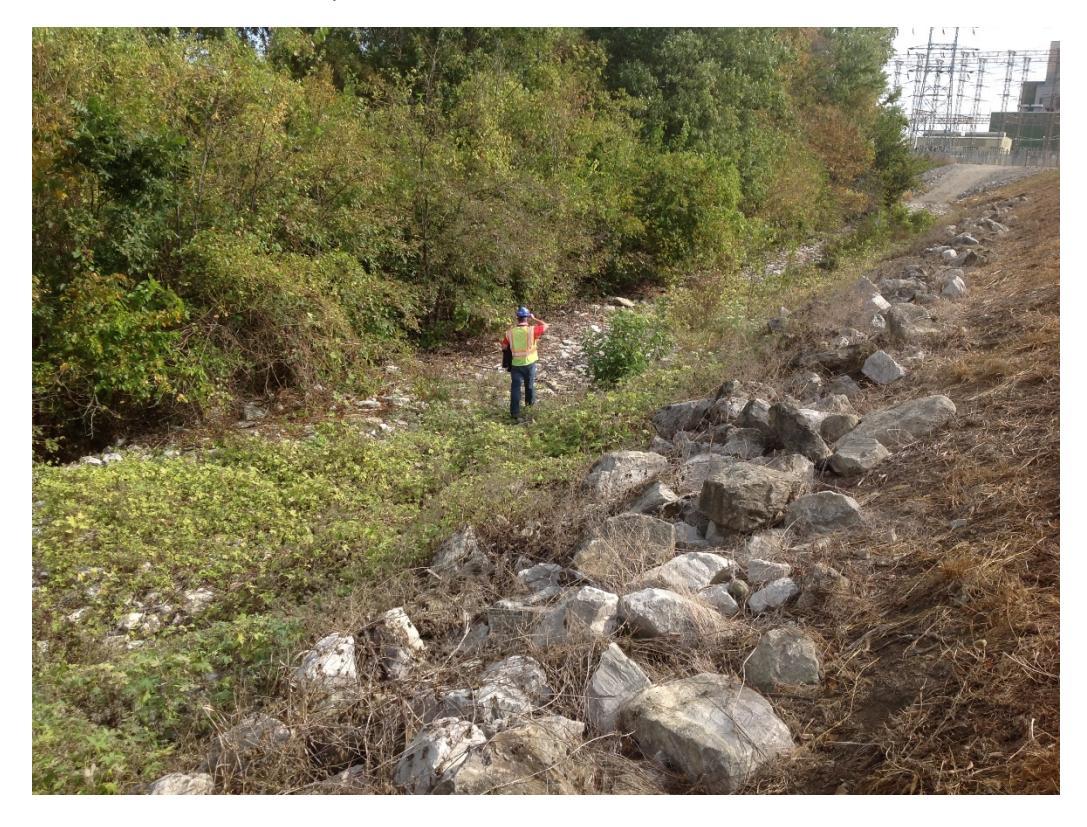
Figure 13 - Riprap on north side of pond has some excessive non-woody and emerging woody growth.

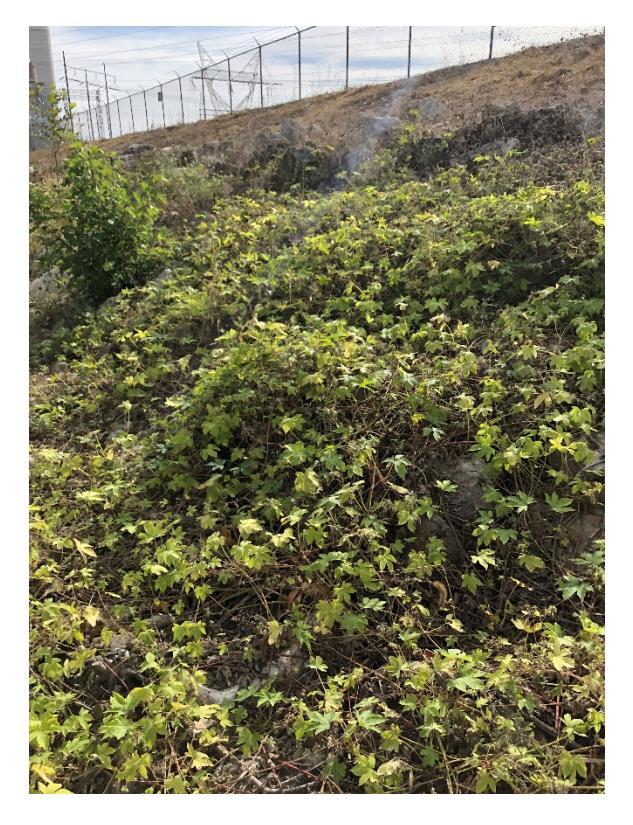
Figure 14 - Riprap on north side of pond has some excessive non-woody and emerging woody growth.

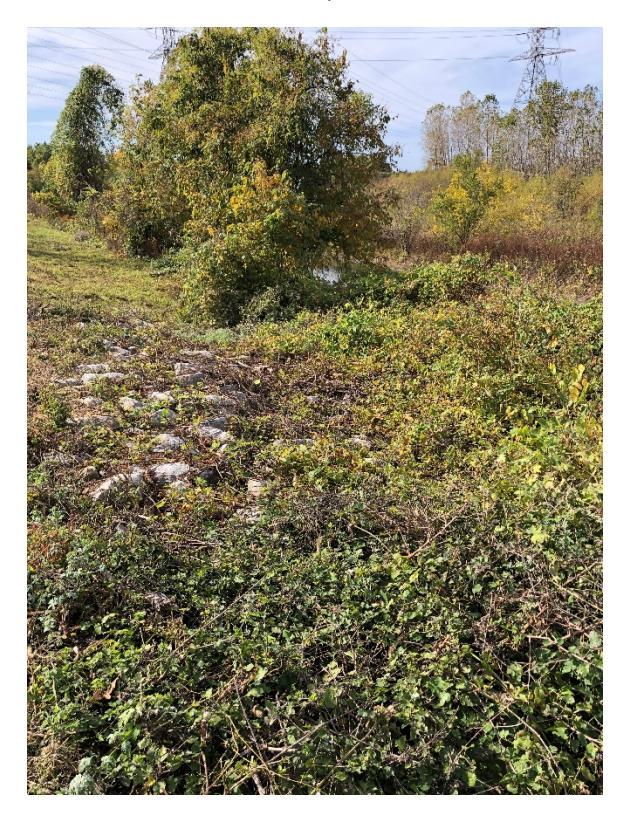
Figure 15 - Riprap along channel bank on the west side of the impoundment should be monitored to determine if any movement is occurring.

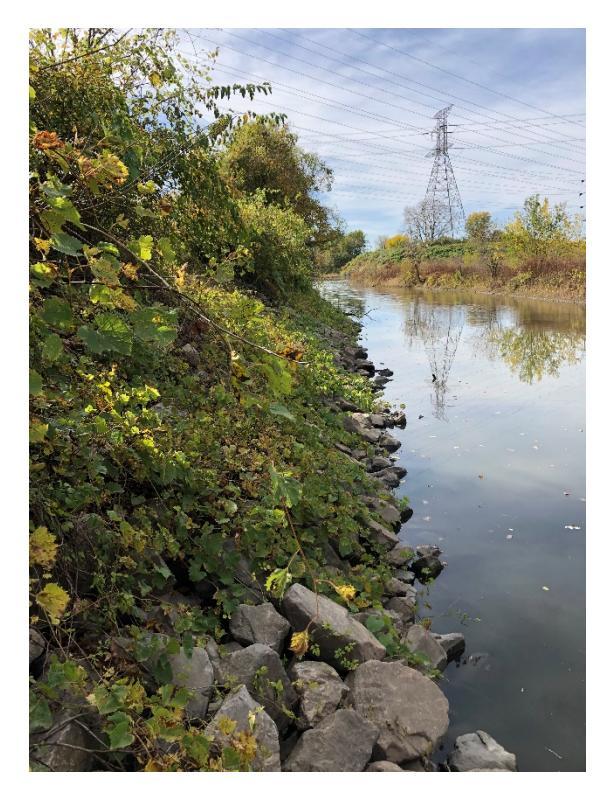
Figure 16 - Riprap along channel bank on the west side of the impoundmente should be monitored to determine if any movement is occurring.

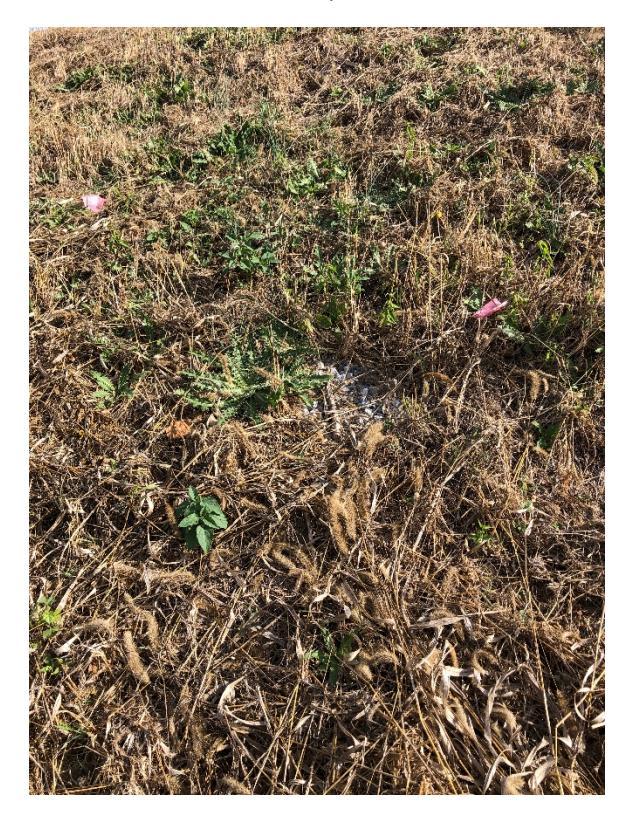
Figure 17 - Animal burrow backfilled with crushed limestone.

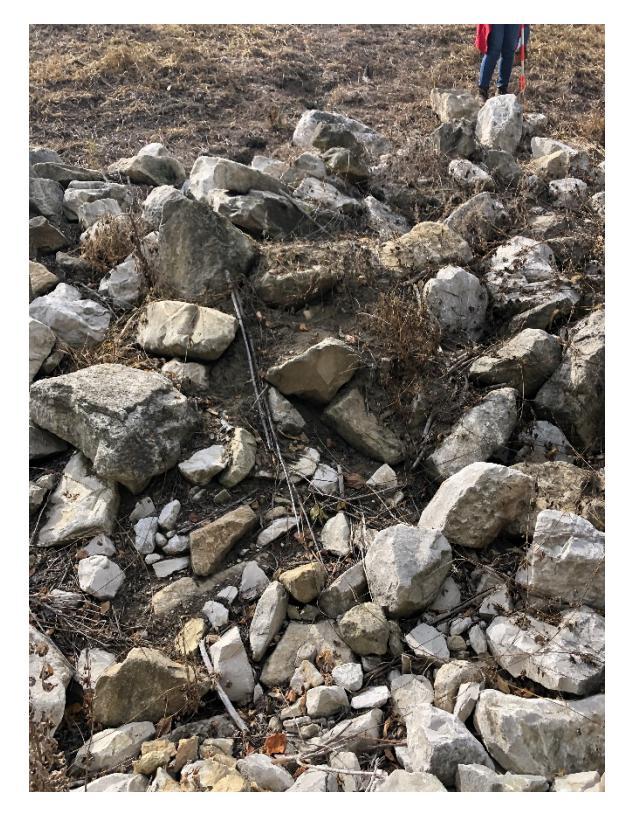
Figure 18 - Large animal burrow with a significant volume of soil removed from the embankment on the north side of the pond.

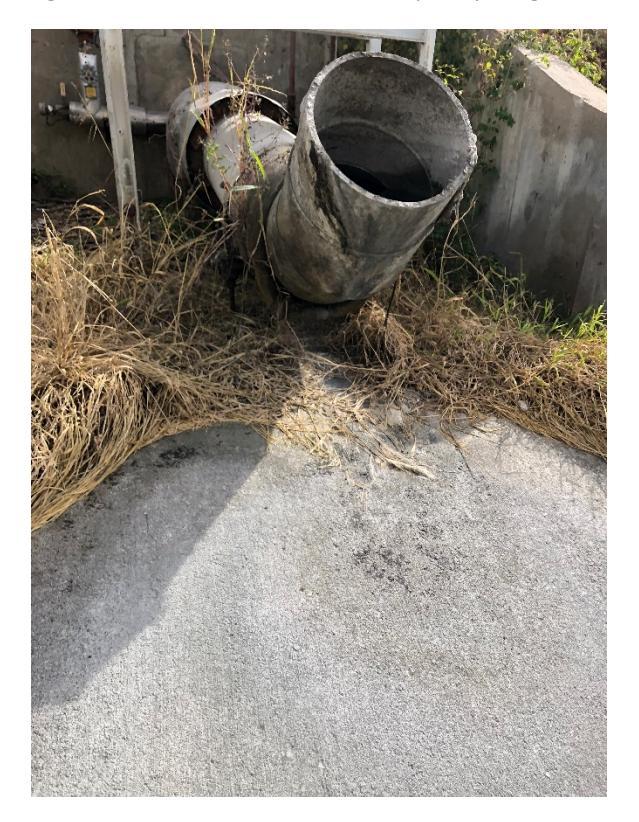
Figure 6 – Principal spillway outlet.

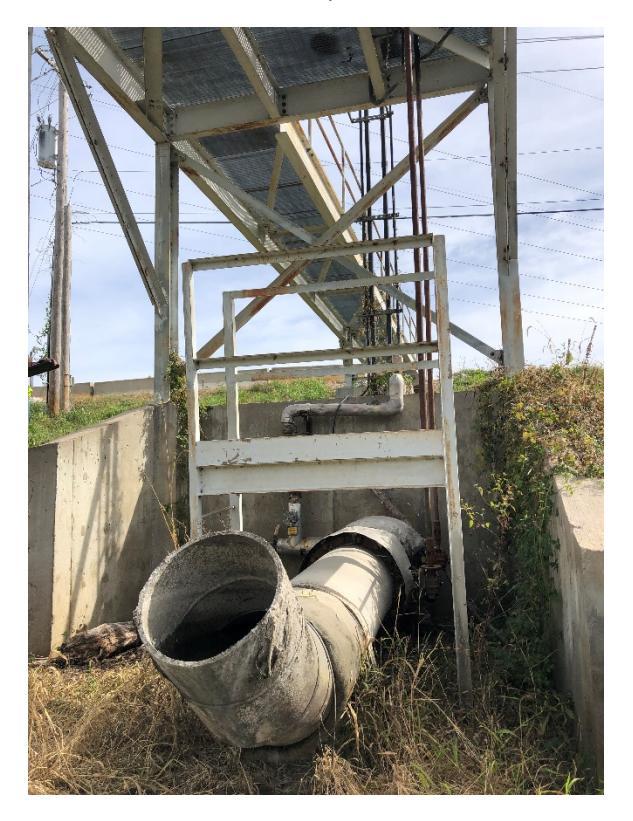
Figure 7 – Principal spillway outlet.

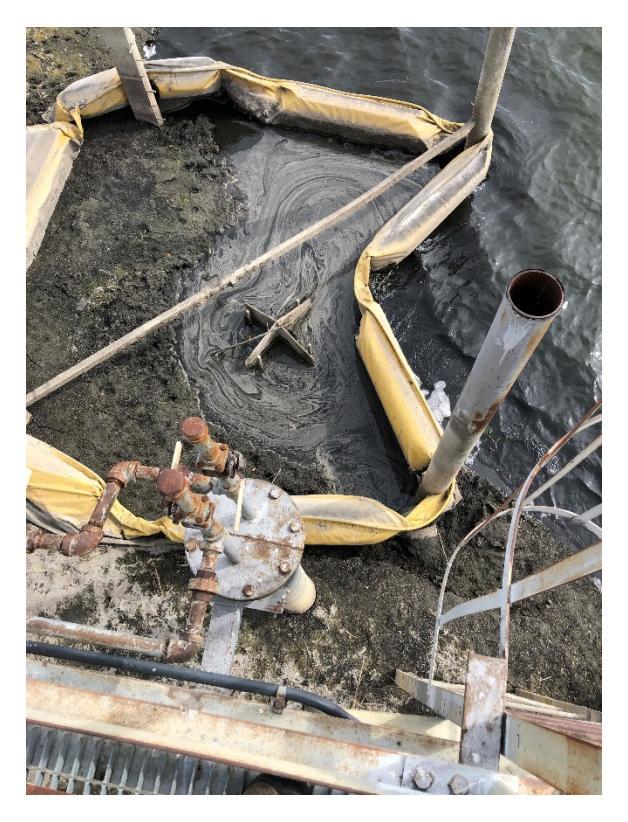
Figure 8 – Principal spillway inlet.

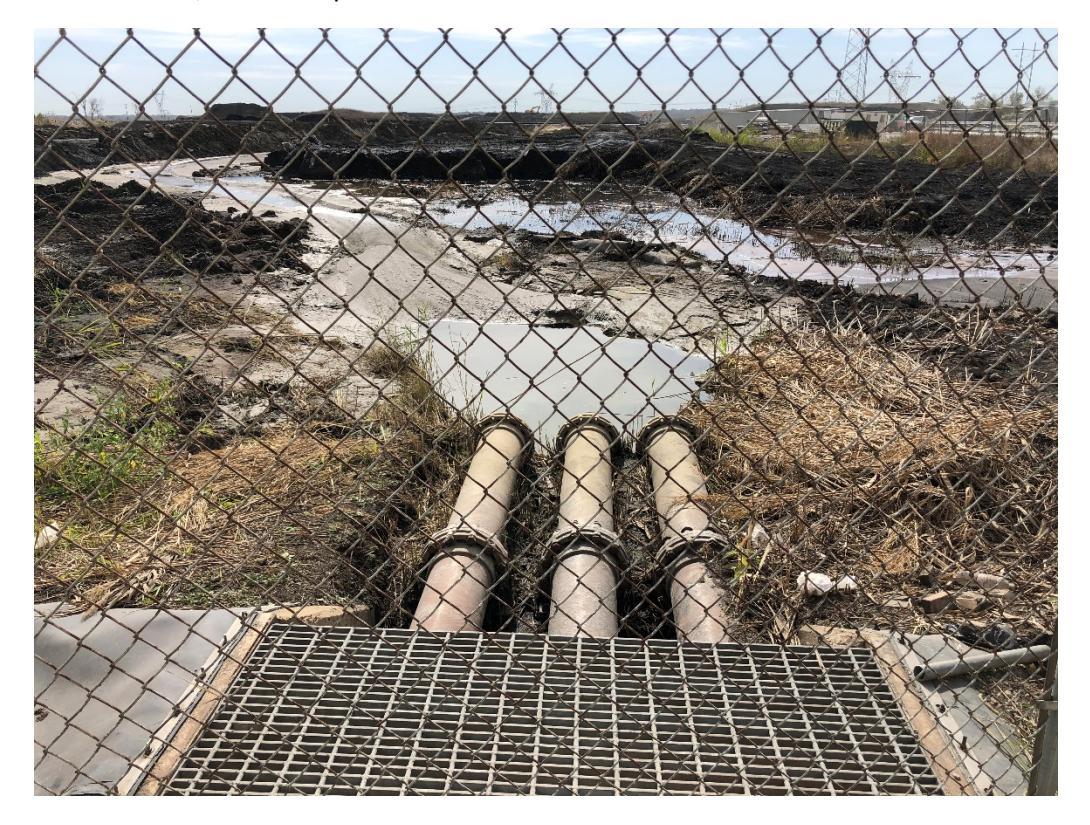
Figure 9 – Inlet piping, fly ash is no longer sluiced to the pond.

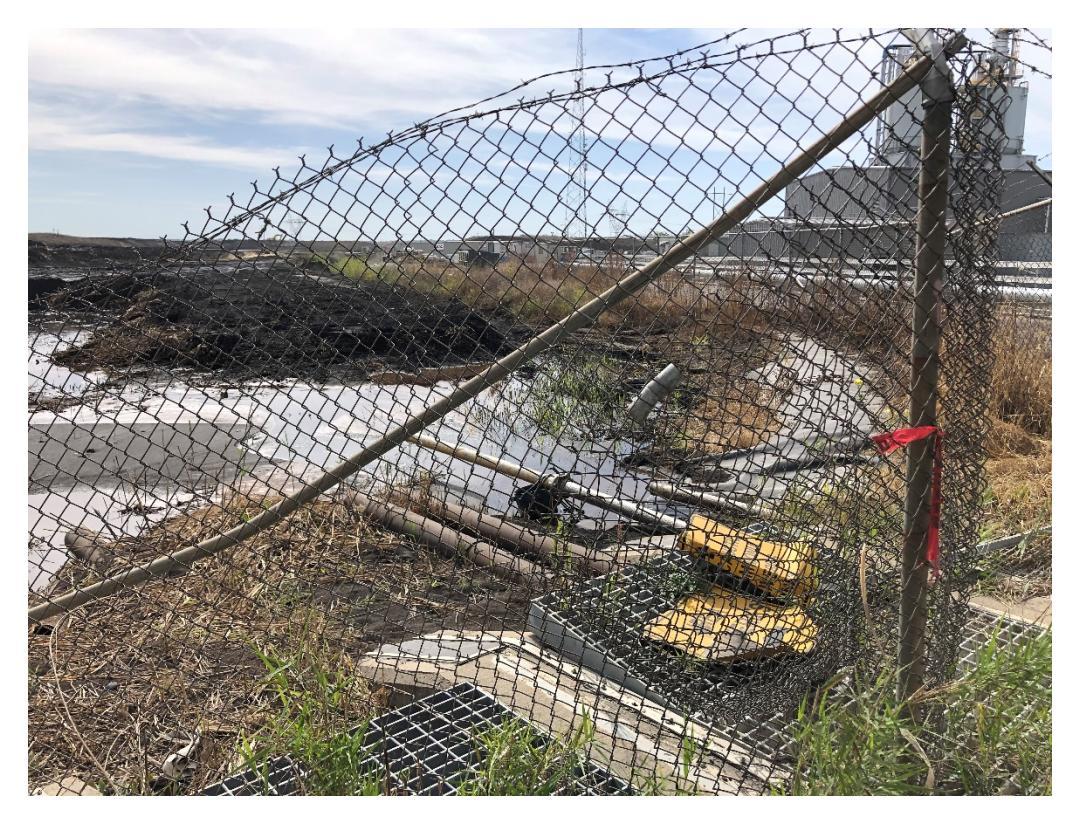
Figure 10 - Inlet piping, fly ash is no longer sluiced to the pond.

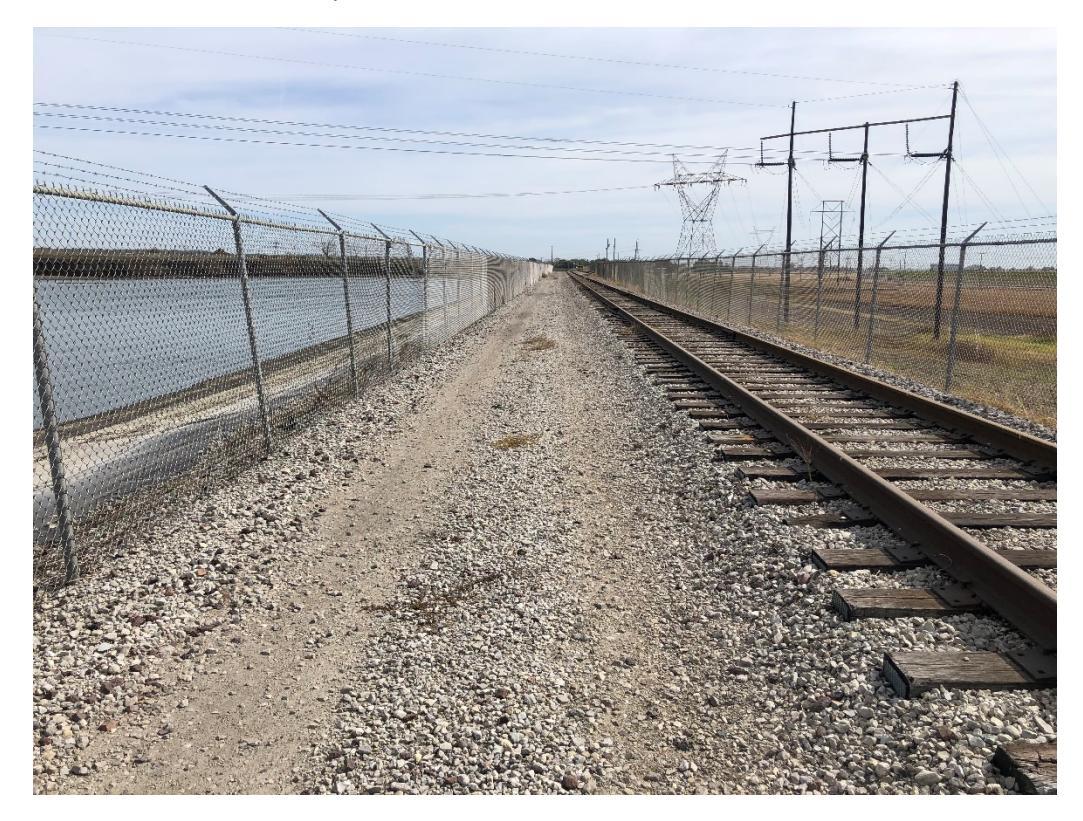
Figure 11 – Embankment crest on south side of pond.

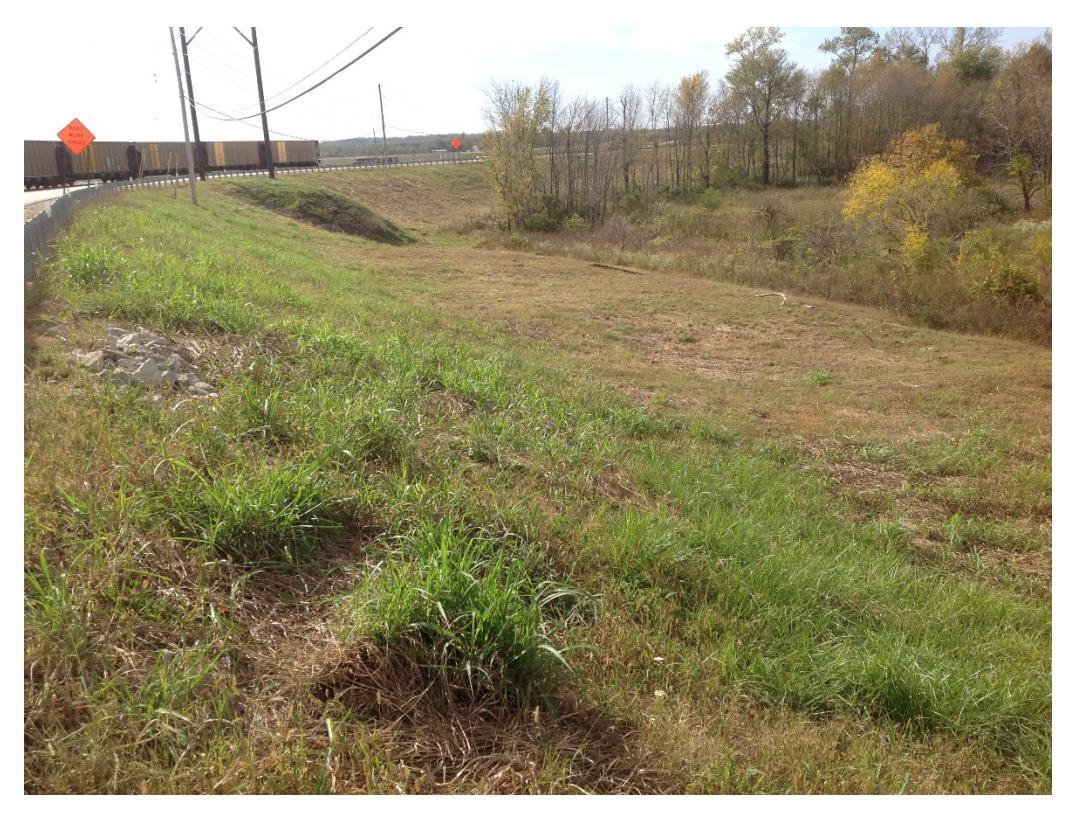
Figure 12 – Downstream slope on west side of pond.

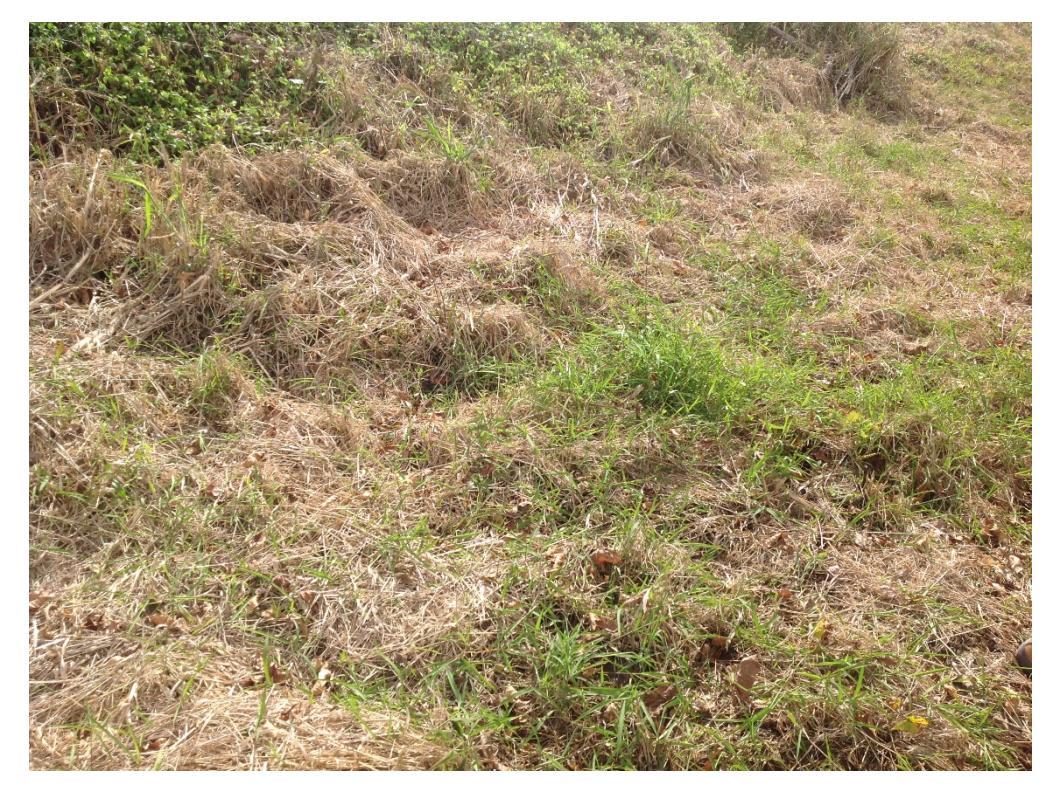
Figure 13 – Ponding and wetness at the downstream toe of the west embankment slope approximately 290 feet south of the outfall.

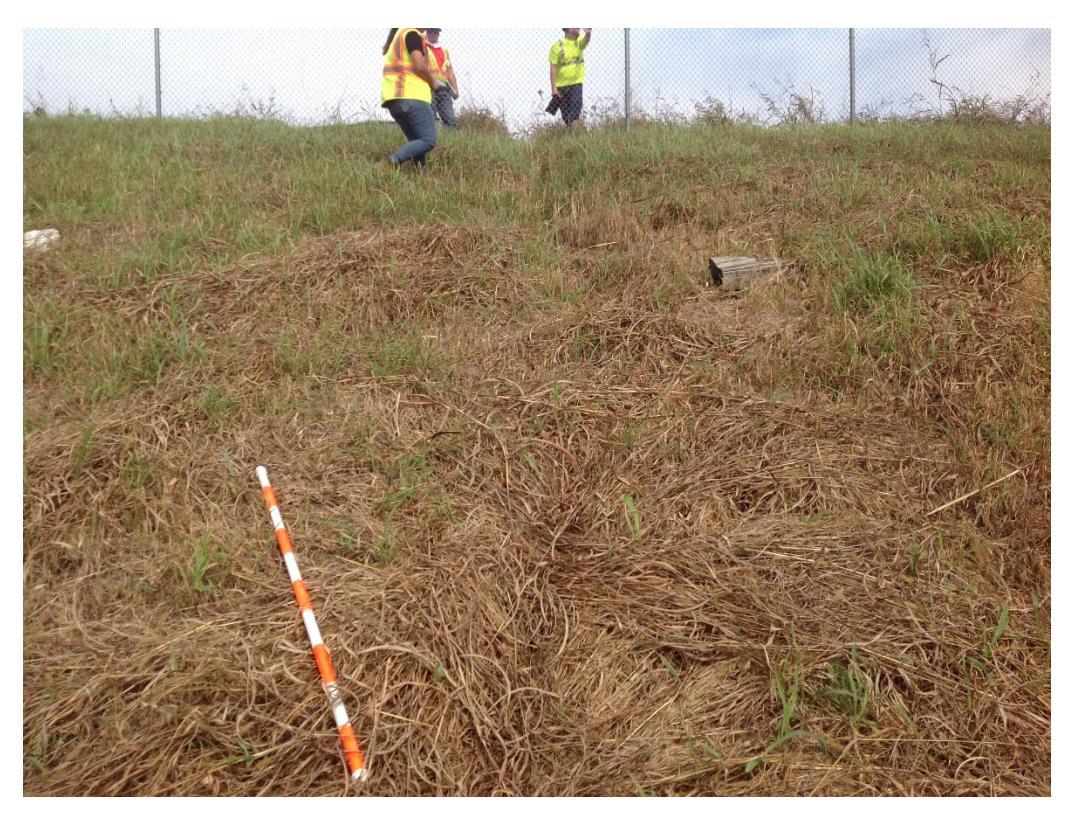
Figure 14 – Erosion feature on downstream slope of the south embankment, east of the access ramp.

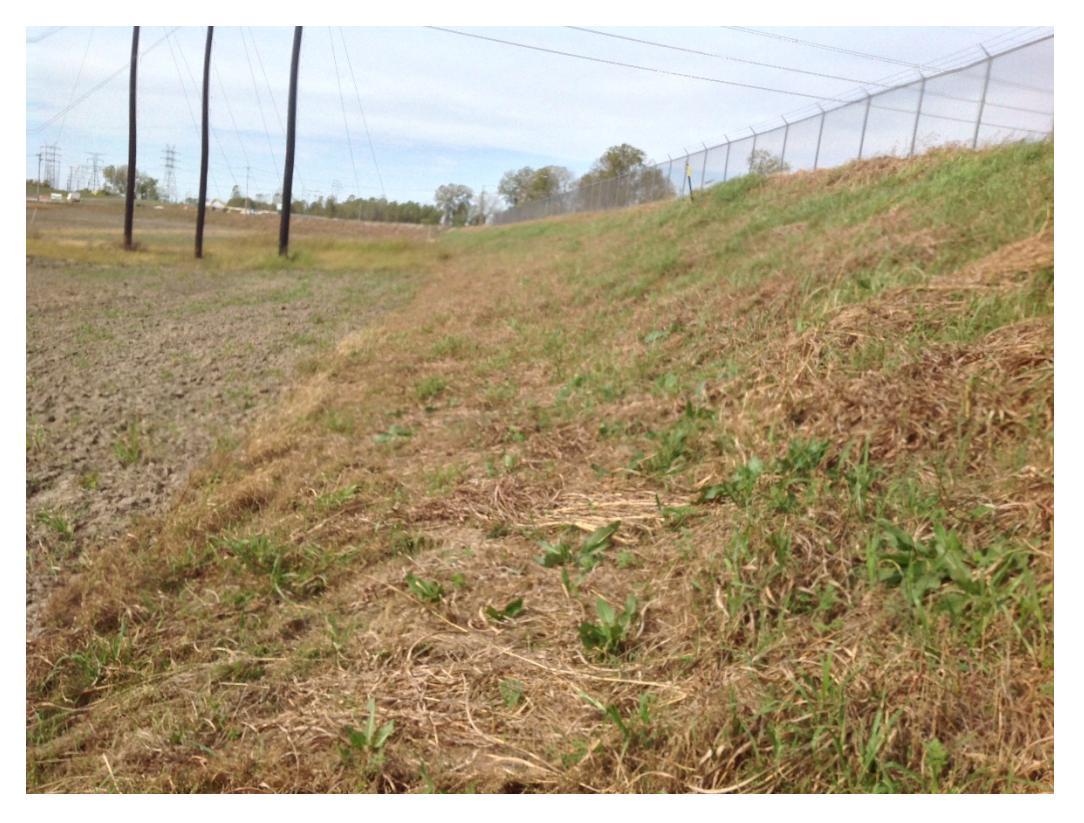
Figure 16 – Downstream embankment slope on the south side of the impoundment.

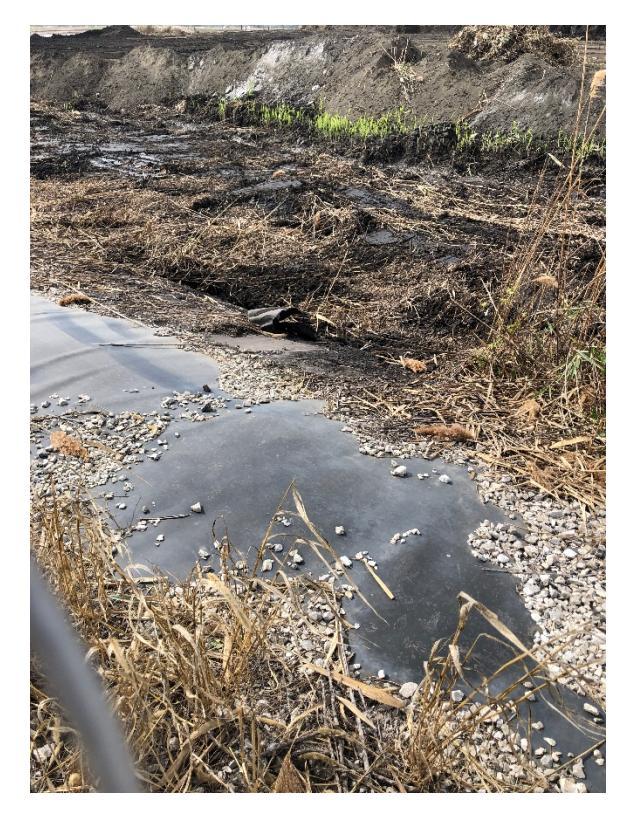
Figure 17 – Small tear in HDPE liner.

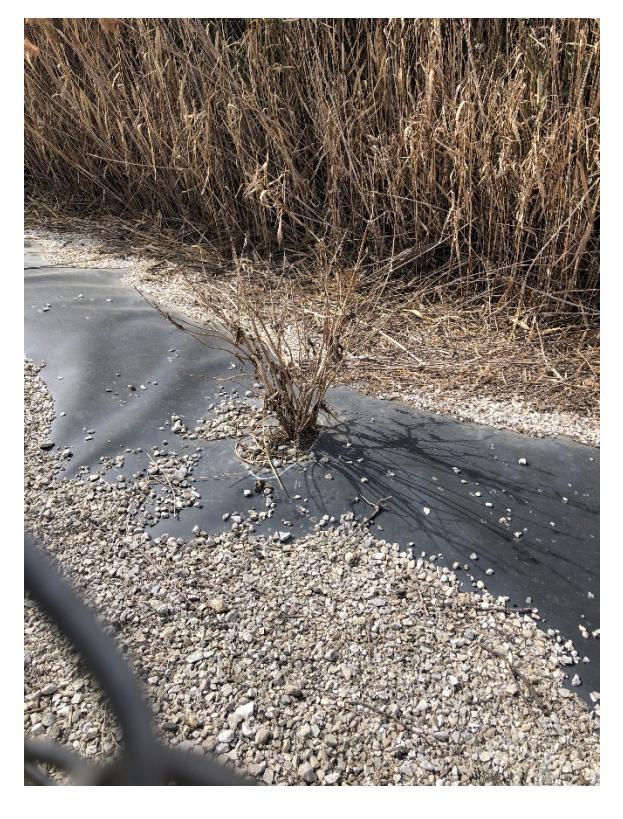
Figure 18 – Small tear in HDPE liner.

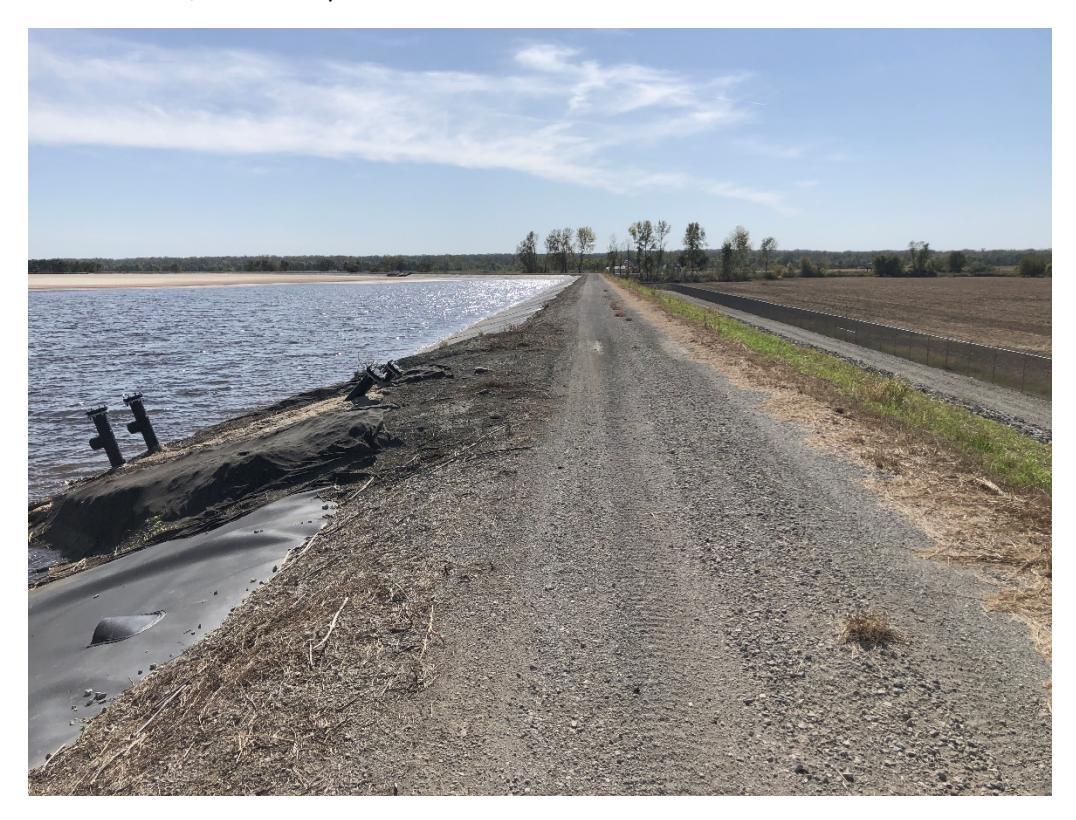
Figure 1 – Embankment crest on west side of impoundment.
