AMEREN MISSOURI SIOUX ENERGY CENTER EVALUATION OF CCR UNITS 40 CFR PART 257 ST. CHARLES COUNTY, MISSOURI

AMEREN MISSOURI SIOUX ENERGY CENTER EVALUATION OF CCR UNITS ST. CHARLES COUNTY, MISSOURI

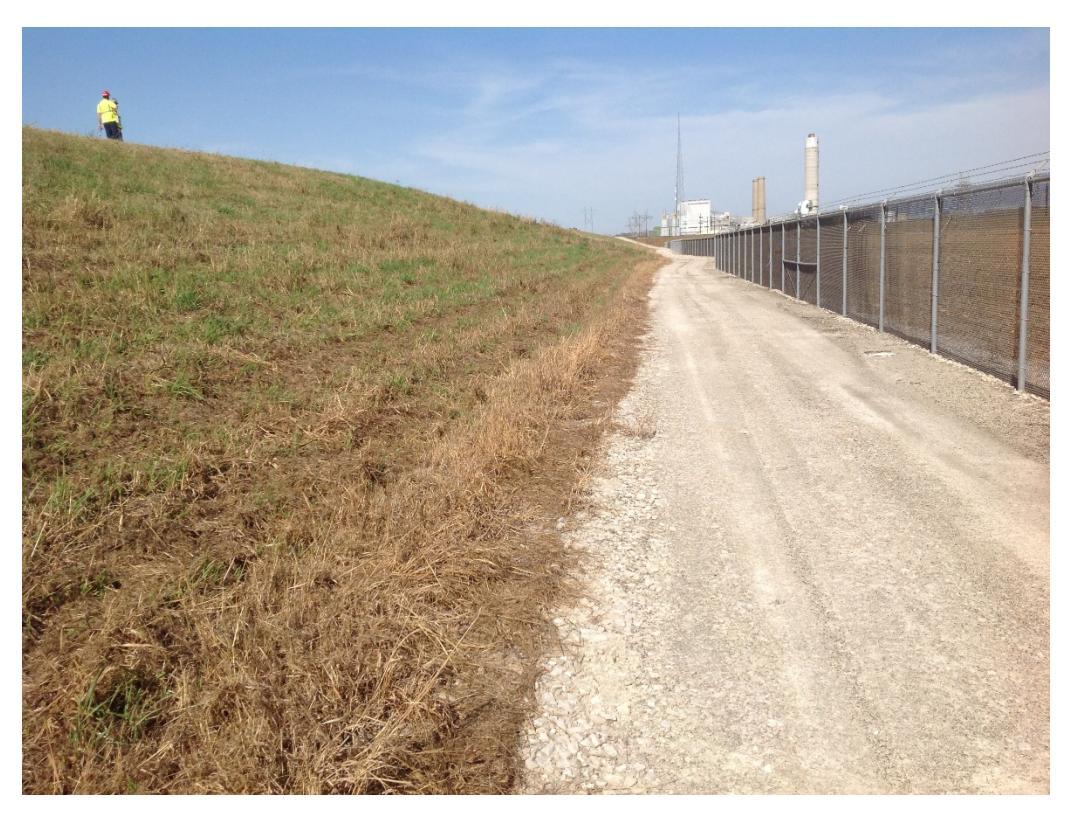
Figure 2 – Downstream slope on the east side of the impoundment.

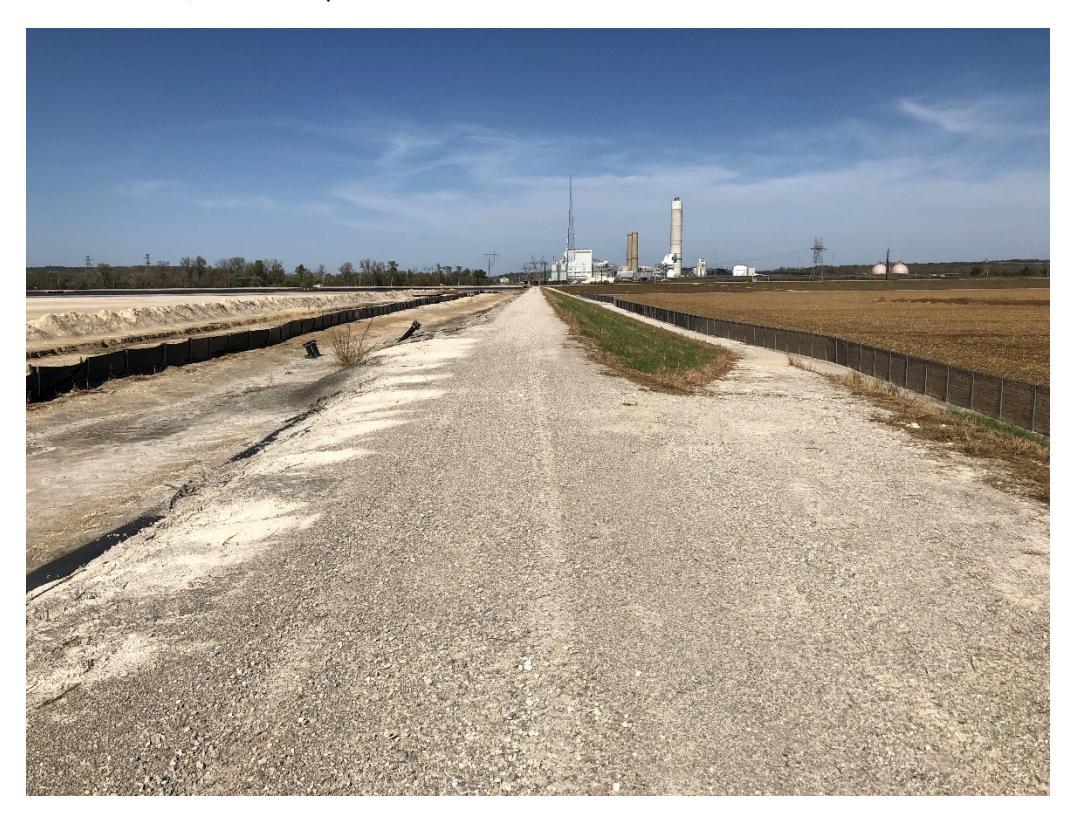
Figure 3 – Embankment crest on the east side of the impoundment.

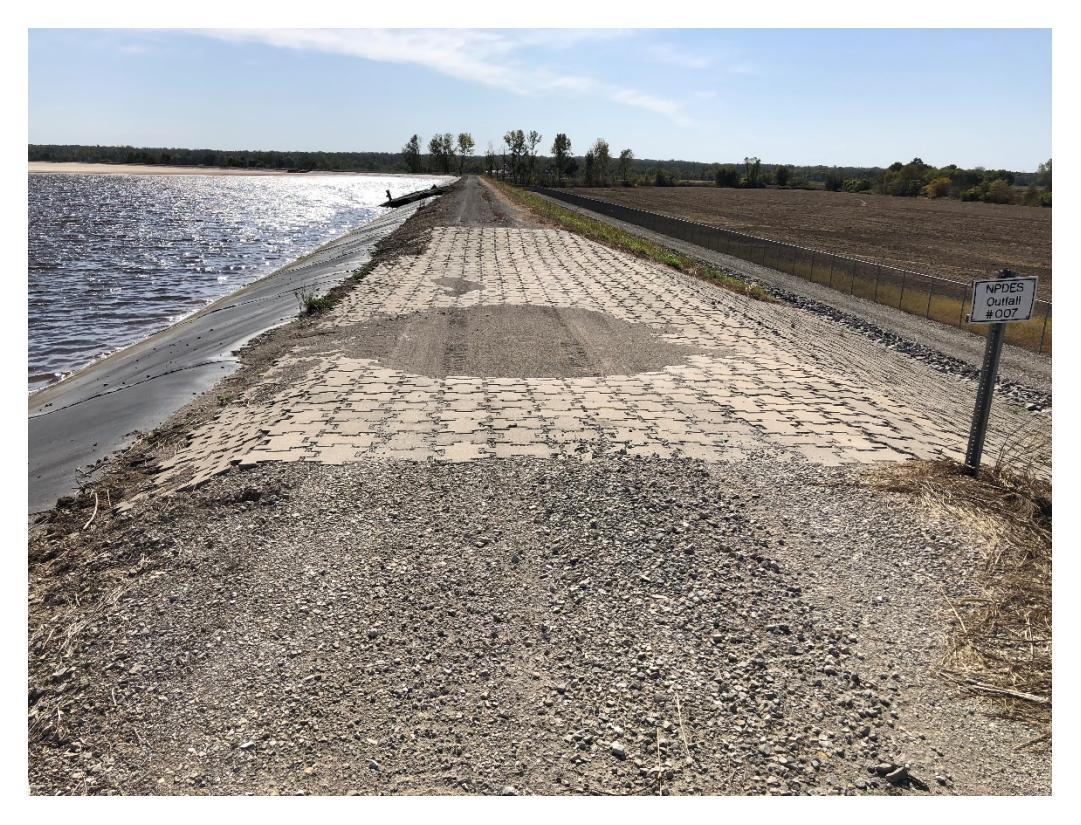
Figure 4 – Cell 1 emergency spillway.

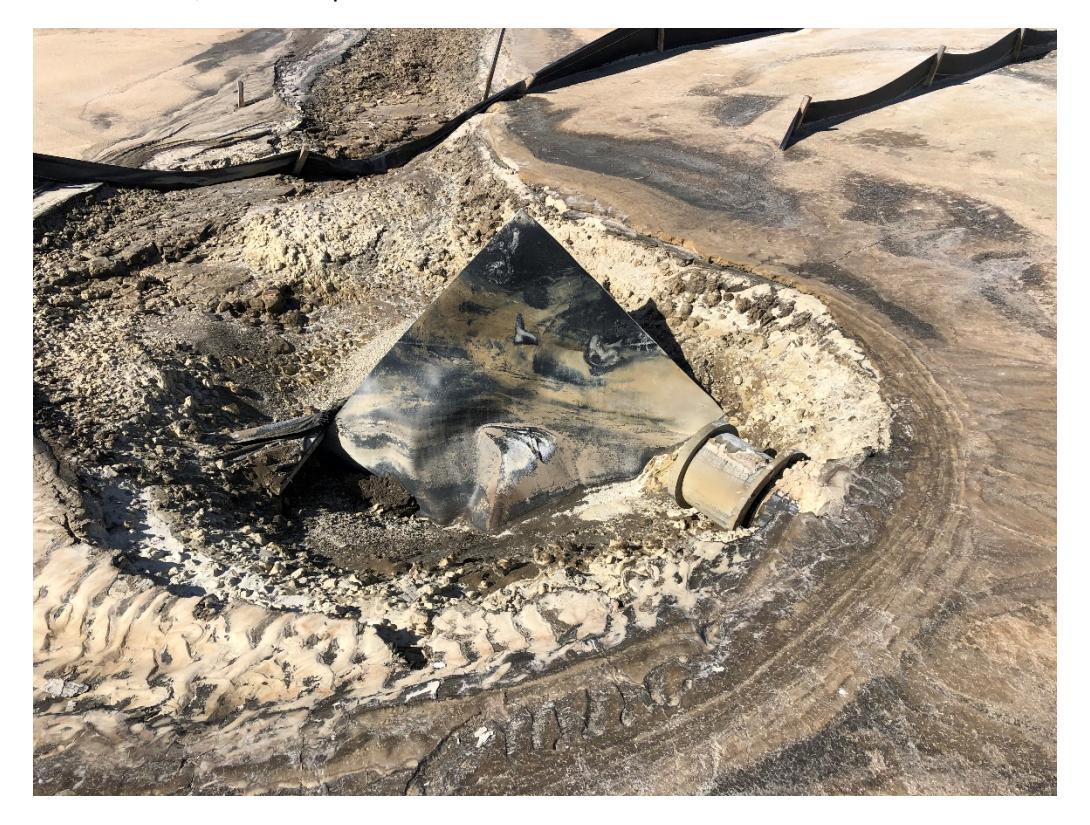
Figure 5 – Point of discharge for gypsum slurry.

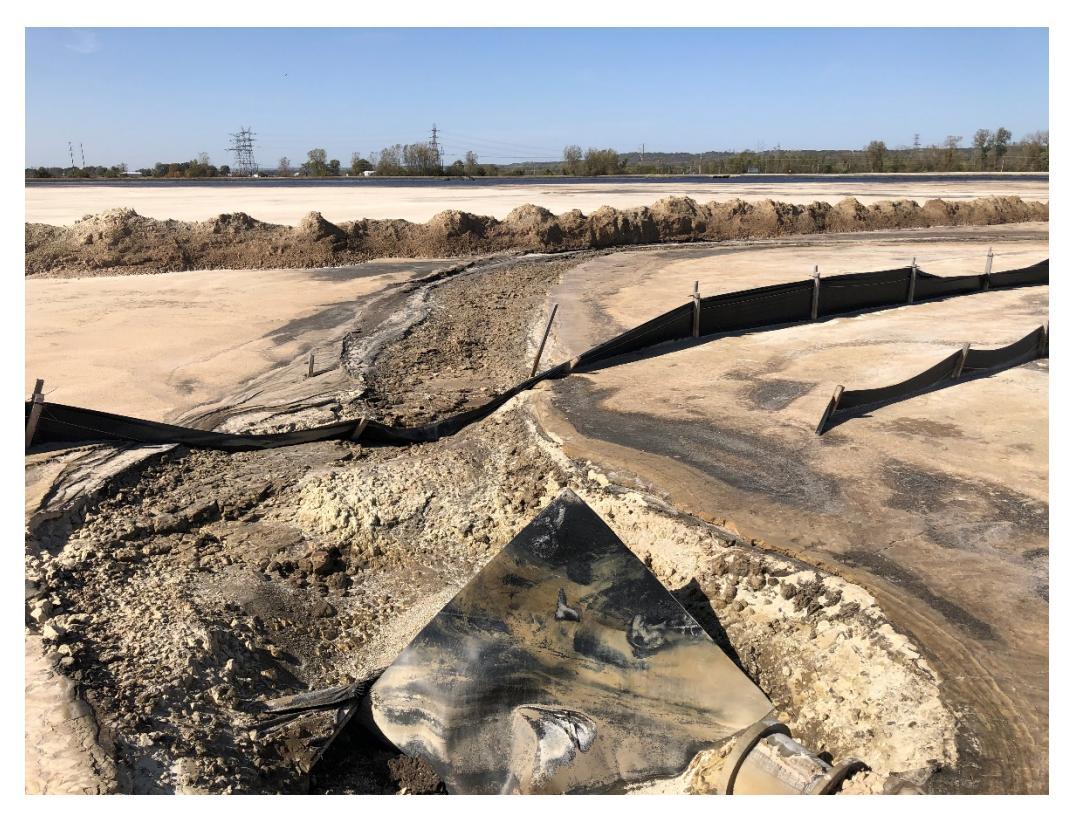
Figure 6 – Point of discharge for gypsum slurry.

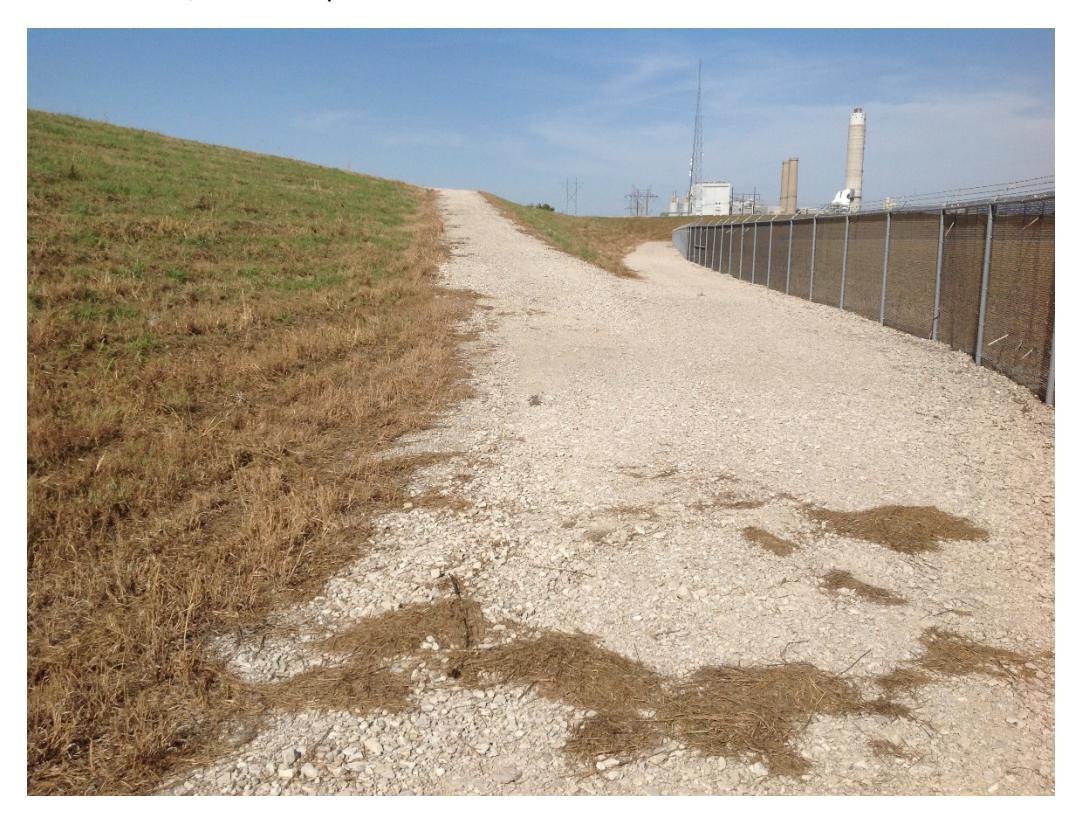
Figure 7 – Access ramp on downstream slope on east side of the impoundment.

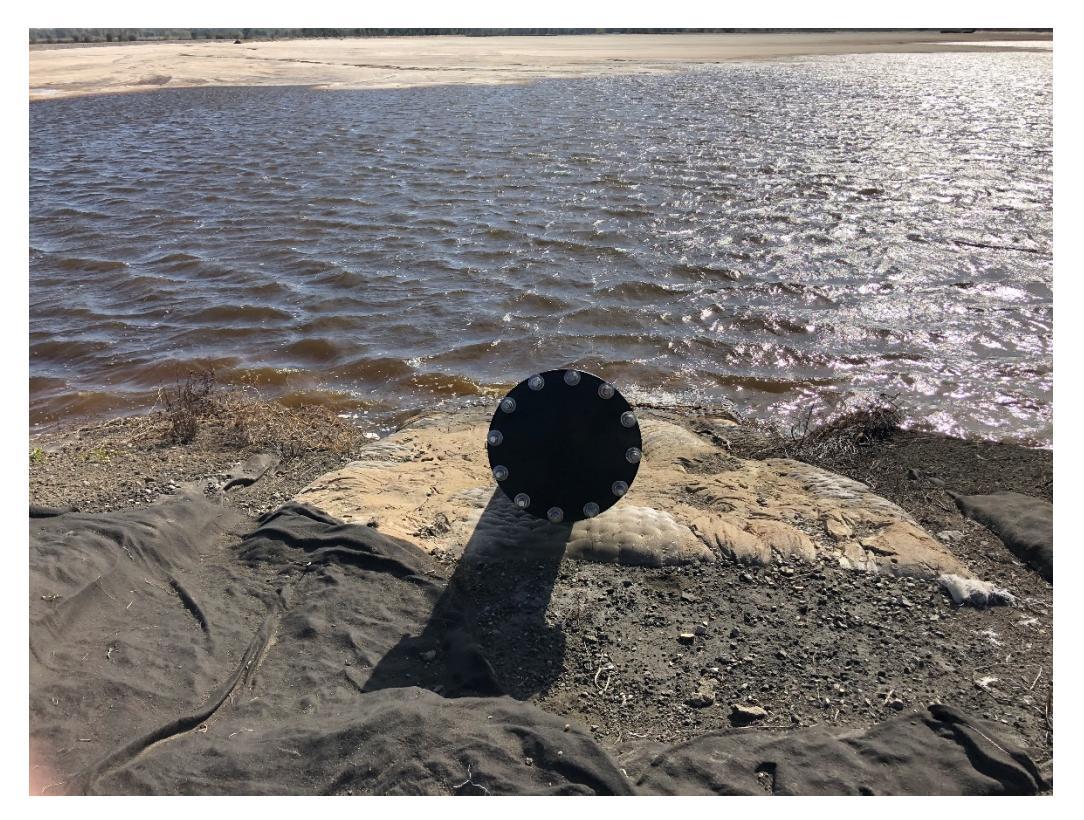
Figure 8 – Cell 1 sump.

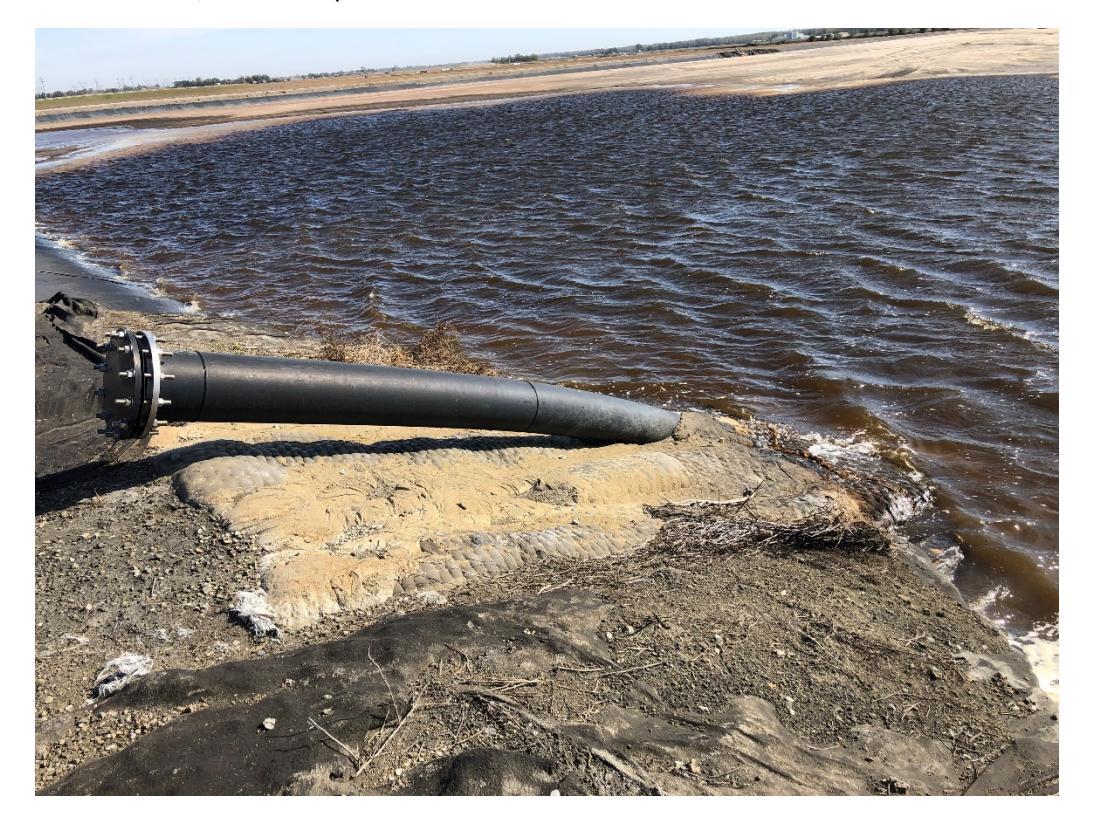
Figure 9 – Cell 1 sump.

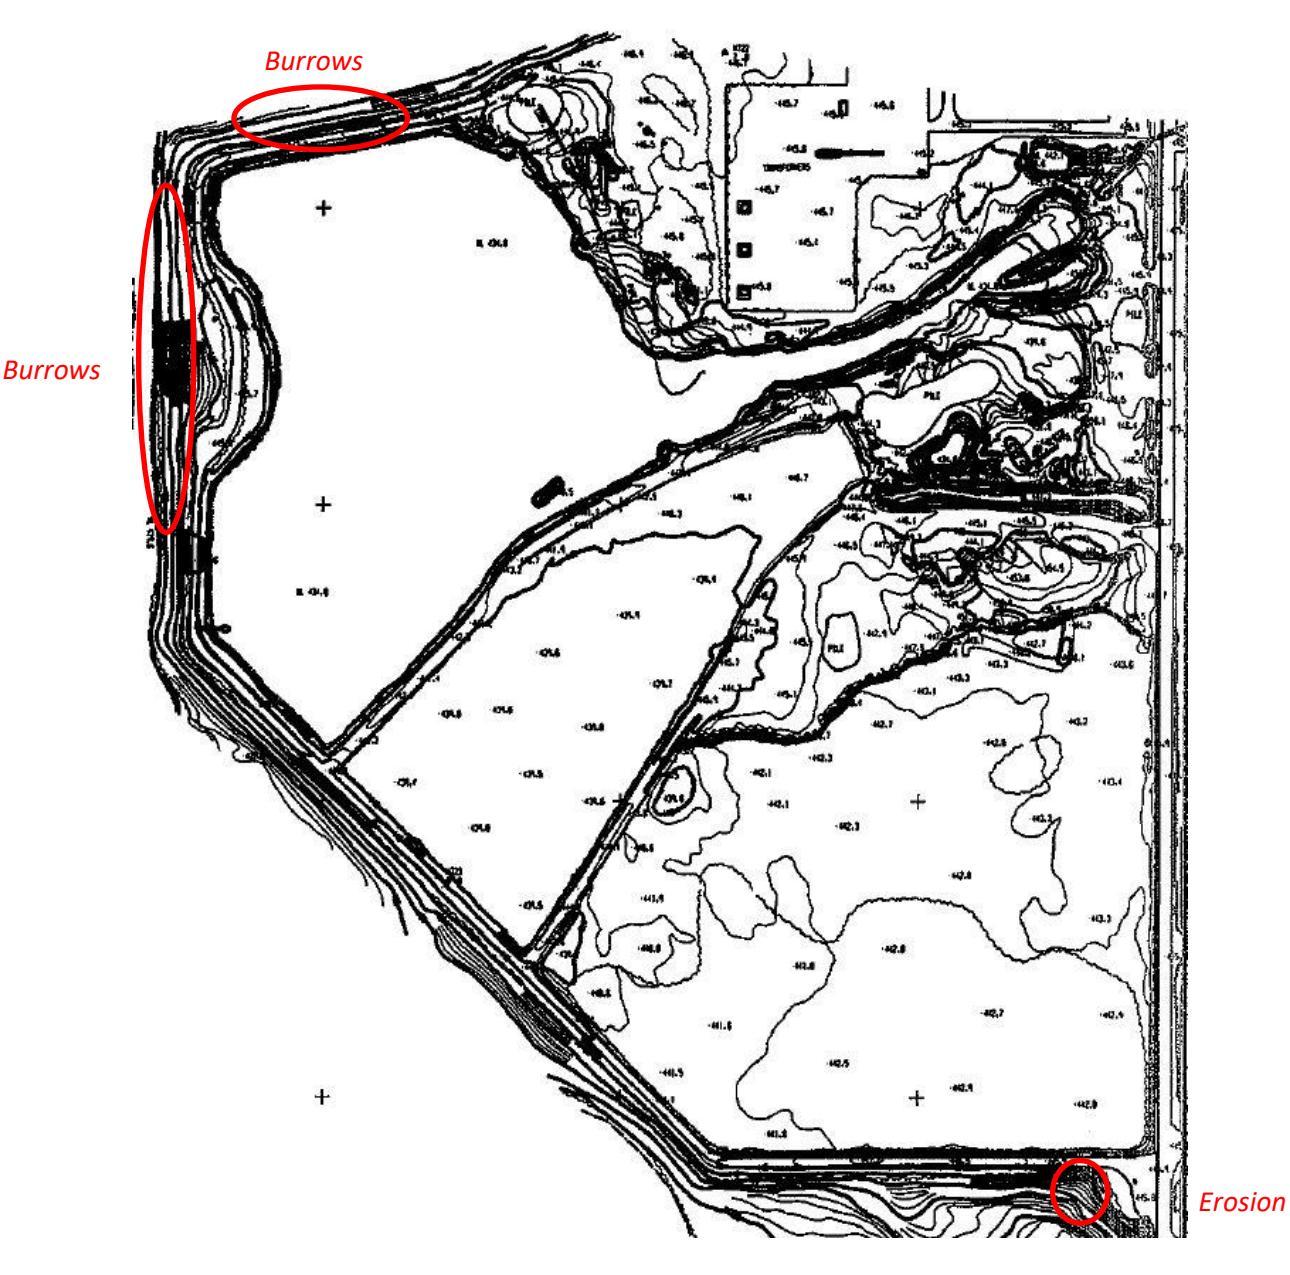
SIOUX ENERGY CENTER Bottom Ash Pond (SCPA) Annual Inspection Check Sheet

Description of Emergency (EC) or Immediate Maintenance (IM) conditions observed since the last annual inspection: None

Inlet and Outlet Works				
ltem	Condition Code	Comments		
Outlet Condition	GC			
Gate Condition/ Operability	GC			
Outfall Condition	GC			
Outlet Channel	GC			
Discharge (color and/or sediment)	GC	Clear		
Obstructions	GC	None		
Instrumentation	GC			
Inlet Piping/Supports Condition	GC			
Leakage	GC	None observed.		
Other

Earth Embankment
ltem	Condition Code	Comments
Vertical & Horizontal Alignment of Crest	GC	
Seepage/Wetness/ Ponding Areas	GC	No wet or ponded water was identified in any locations.
Erosion/Rutting	OB	Some minor rutting on the south end of the pond outside the perimeter fence.
Fencing	GC	
Vegetation	GC	
Sloughs/Slides/ Cracks	GC	None.

Earth Embankment				
ltem	Condition Code	Comments		
HDPE Liner	GC			
Animal Control	GC	None witnessed.		
Other

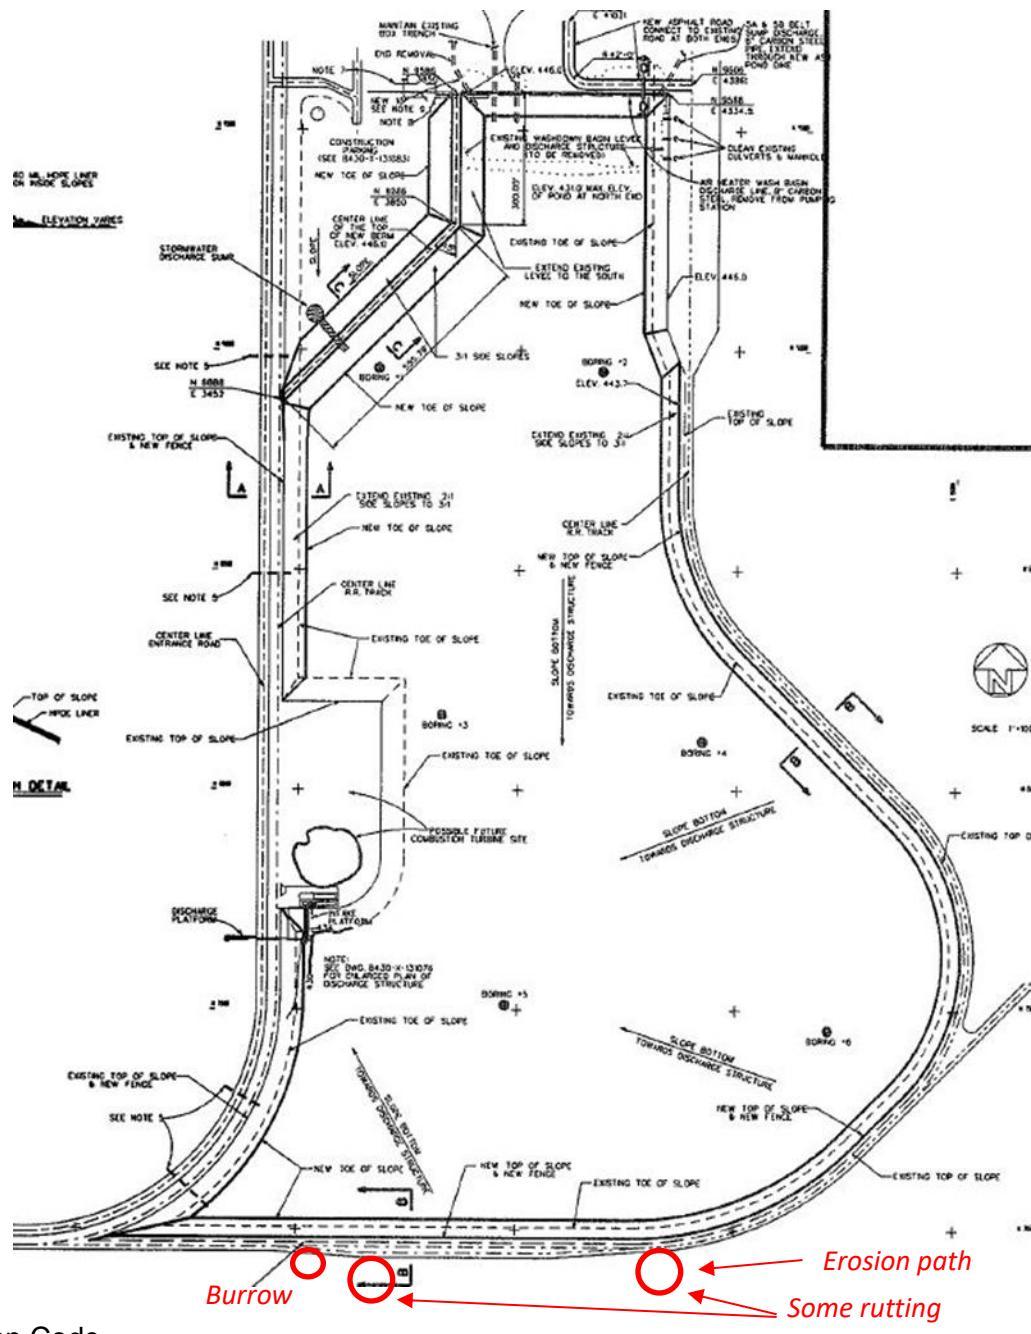
SIOUX ENERGY CENTER Fly Ash Pond (SCPB) Annual Inspection Check Sheet

Recycle Pond			
Item	Condition Code	Comments	
Erosion, sloughing, sliding, boils, seepage	OB	Sloughing of the clay liner under the HDPE liner noticed on the east interior embankment.	
Condition of grass cover, woody vegetation, burrows	GC		
Recycle Pond between el. 428 and 443	GC	Yes	
Settlement, depression or crack in embankment	GC	None	
Effluent Pump Intake Structures (when visible)	NO		
Gravel Ballast Covering Pump Intake Pipes (when visible)	NO		
Damage to transducer level controls or pipes	MM	Please add gravel ballast to the gravel trays on the transducer conduits. Slope could be off due to sloughing of clay liner.	
Unevenness, movement of triple box culverts	OB	Some slight gapping between 2 and 3 (reference going east to west). There does not seem to be any observable damage, if there was movement. It is possible that this has existed from construction and not noticed due to gravel obstructing the gap in previous inspections.

HDPE Recirculation Pipe	NO	Buried. Not observed.	
Erosion or rutting gravel top & perimeter roads and ramps	MM	Erosion on some ramps.	
HDPE Liner	OB	Some settlement at waterline.

Recycle Pond
Item	Condition Code	Comments
Precast Concrete Revetment below Box Culverts	GC	
Precast Concrete Revetment below Discharge Pipes	GC	
Emergency Spillway	OB	Minor but some rutting/depressions causing blocks to lift. This appears to be from traffic over the spillway.
Imminent discharge thru emergency spillway	GC	None occurred.

Cell 1				
Item	Condition Code	Comments		
Erosion, sloughing, sliding, boils, seepage	GC			
Condition of grass cover, woody vegetation, burrows	GC			
Settlement, depression or crack in embankment	GC			
Emergency Spillway	GC			
Imminent discharge thru emergency spillway	GC			
Gypsum slurry flowing unobstructed	GC			
Slurry spraying or running out of cleanouts	GC	None witnessed

Cell 1		
Item	Condition Code	Comments
Height from discharge pipe flow line to gypsum level	OB	Close. Currently below the pond level but flowing. Pipe is moved every 3 months to ensure no obstructions impact flow.
HDPE Liner	GC	
Erosion or rutting gravel top & perimeter roads and ramps	ММ	Erosion on some ramps.
Sump Outlet & Concrete Pad	NA	System is closed loop.
Drain Outlets & Concrete Pads	GC	
Movement of riprap	GC

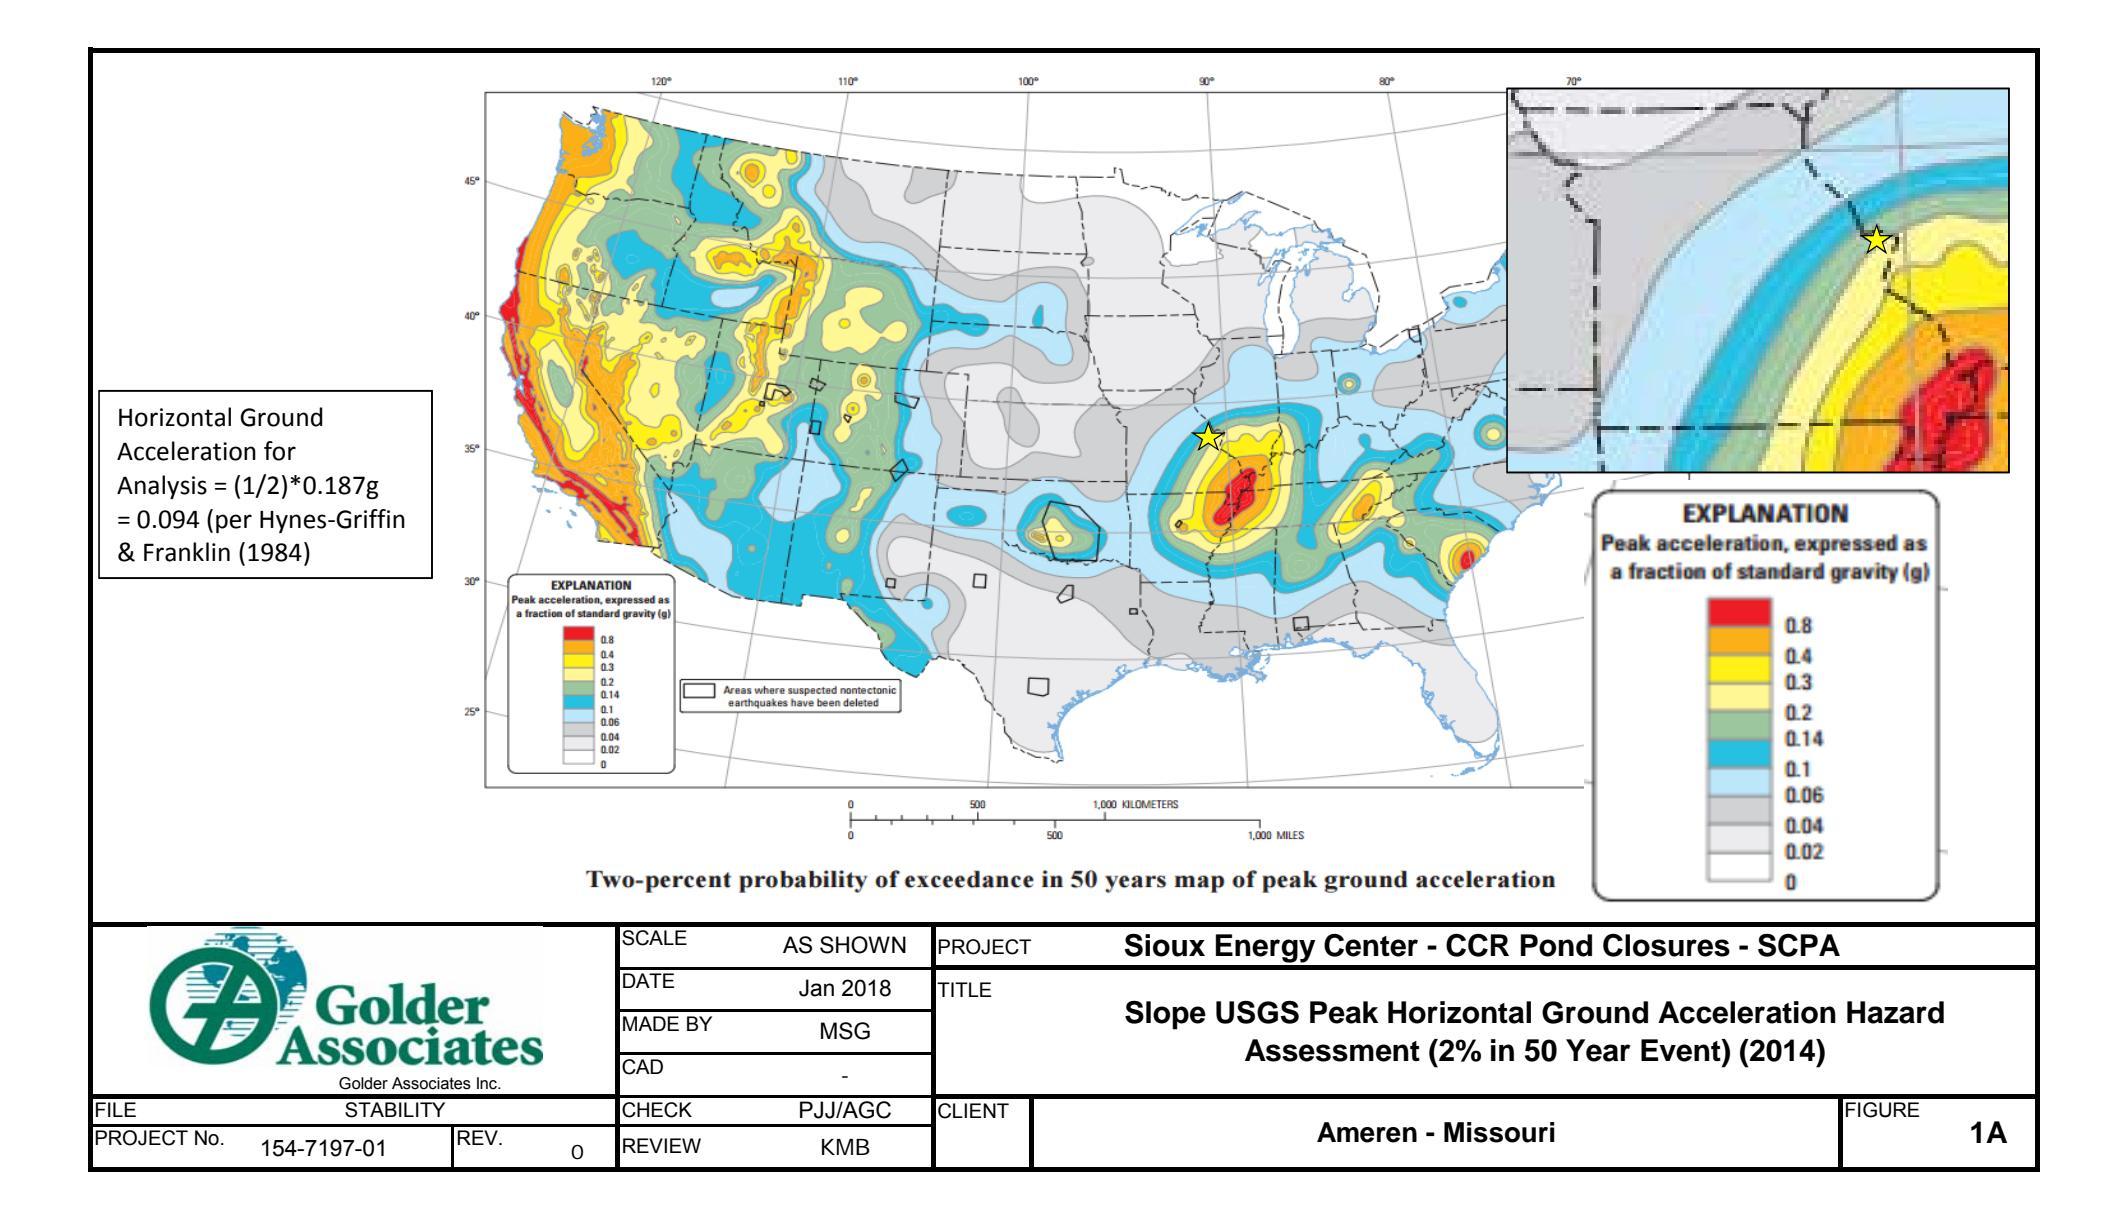
The results indicate that the slopes along SCPA and within the proposed closure plan do meet the minimum requirements set forth by MDNR and the EPA CCR Final Rule for Long-Term Steady State, Steady State with Surcharges, Pseudo-Static Seismic, and Post-Liquefaction. This conclusion includes cross-sections A-A', B-B', C-C', D-D', and E-E'.
