**CONSTRUCTION QUALITY ASSURANCE REPORT
CLOSURE OF THE BOTTOM ASH POND
AND FLY ASH POND
MEREDOSIA POWER STATION
800 SOUTH WASHINGTON STREET
MEREDOSIA, MORGAN COUNTY, ILLINOIS**

**AMEREN ENERGY RESOURCES
ST. LOUIS, MISSOURI**

**GEOTECHNOLOGY, INC.
ST. LOUIS, MISSOURI**

JANUARY 18, 2019

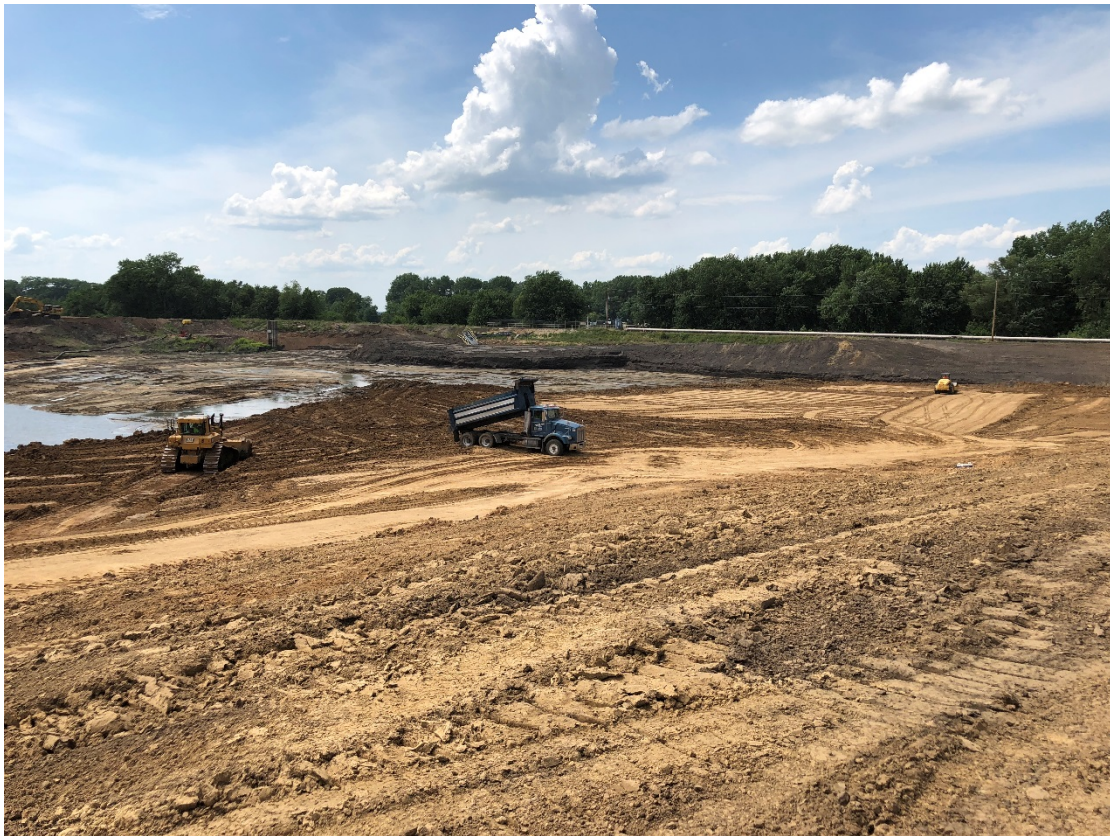
Photograph 1 ▲ - View of borrow soil placement at the Bottom Ash Pond, looking west.

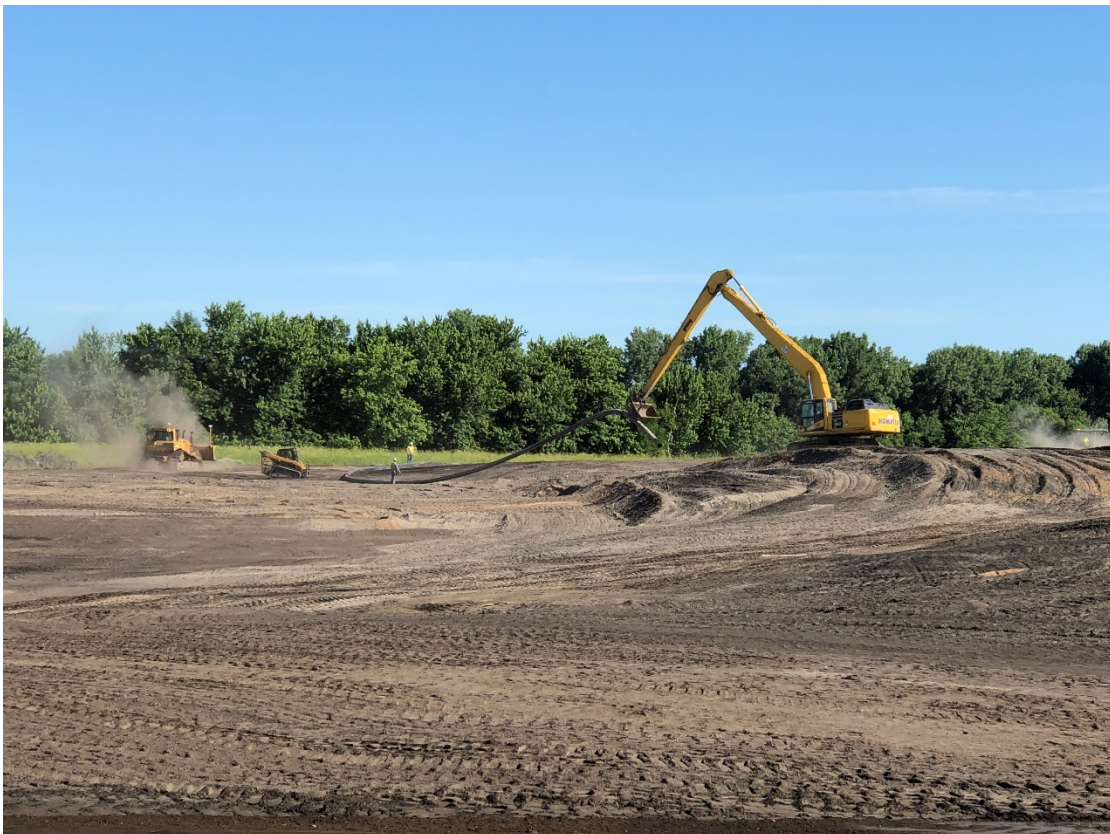
Photograph 2 ▲ - View of a long-reach excavator moving the Bottom Ash Pond discharge pipe, looking northwest.

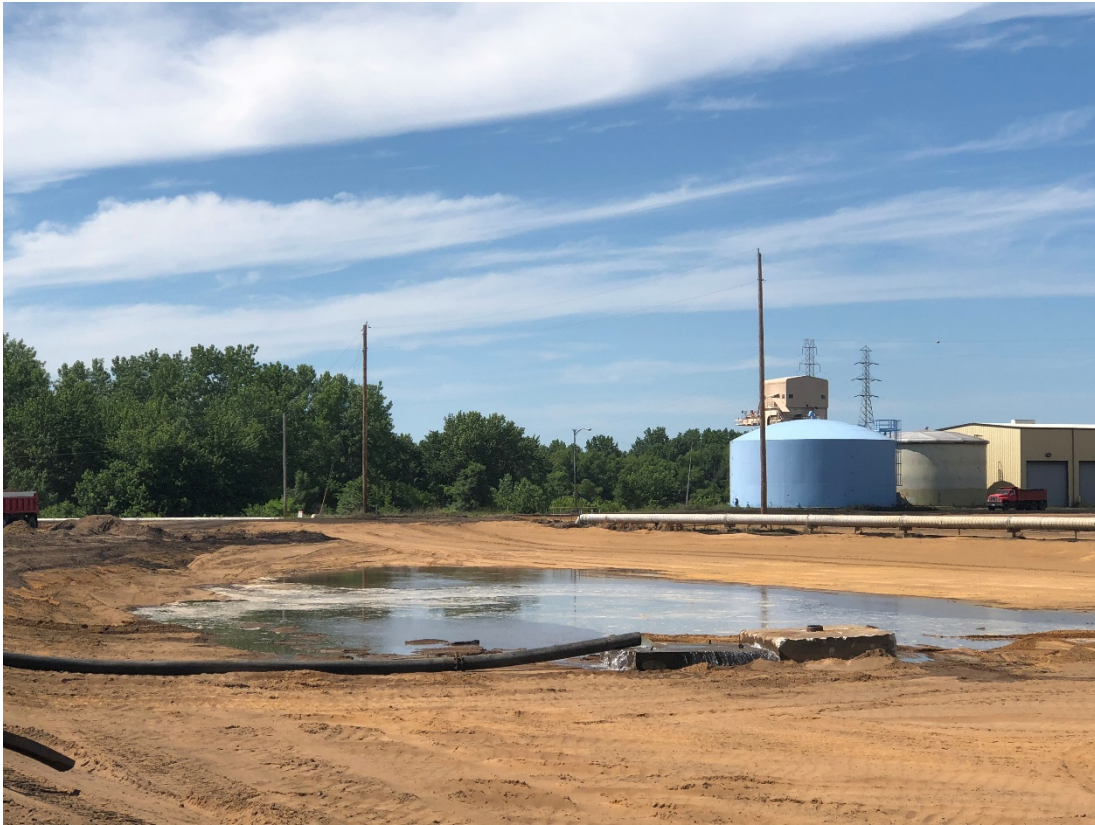
Photograph 3 ▲ - View of the new Bottom Ash Pond discharge location in the Coal Yard runoff area, looking northwest.

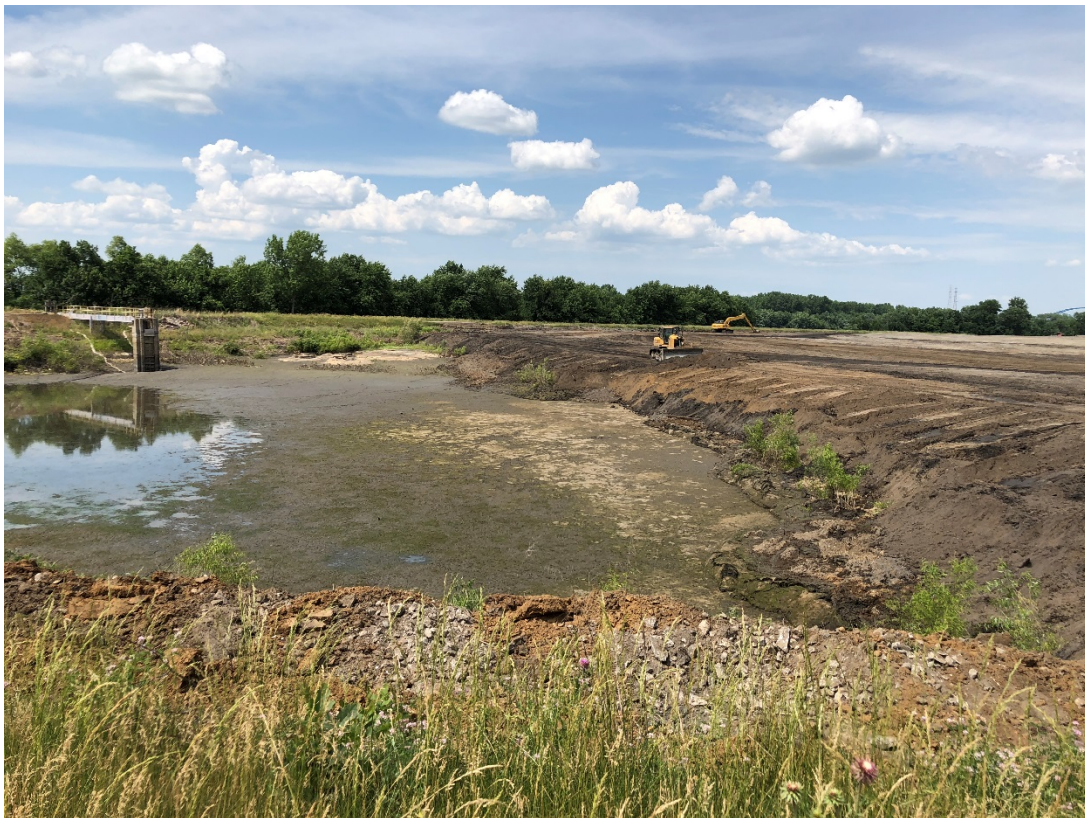
Photograph 4 ▲ - View of grading activities at the Fly Ash Pond, looking northwest.

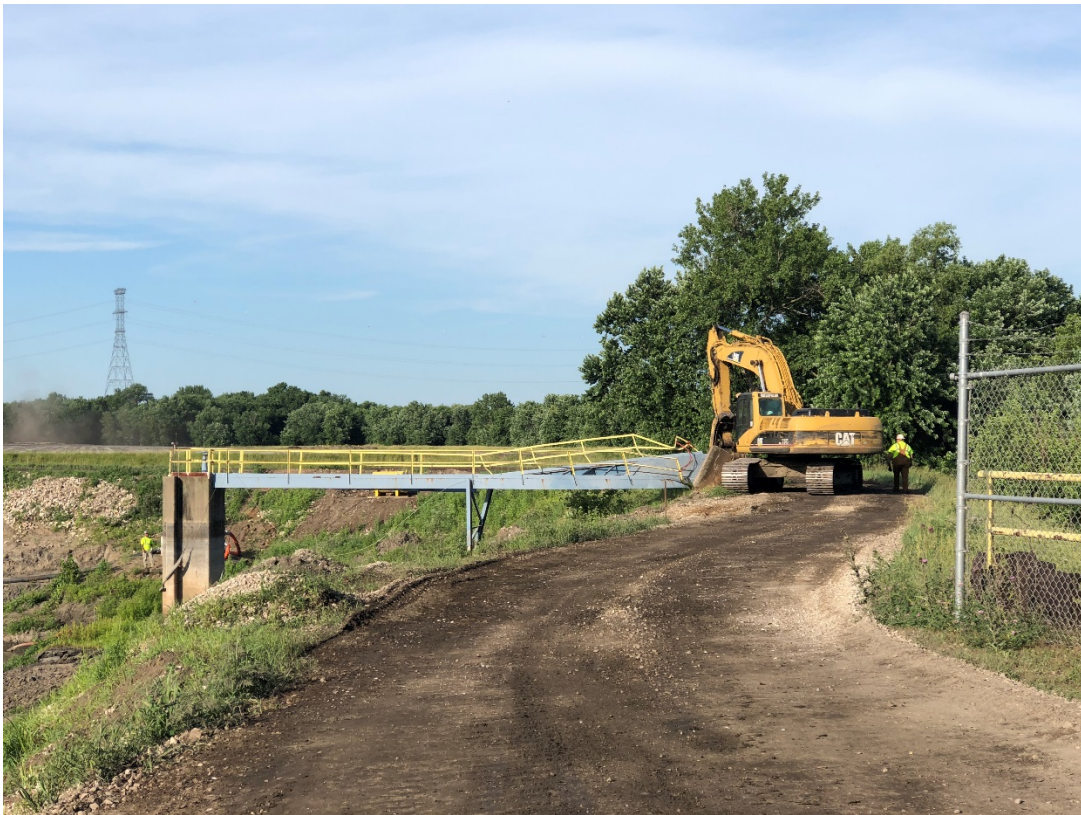
Photograph 5 ▲ - View of demolition of the Outfall 003 structure at the Bottom Ash Pond, looking southwest.

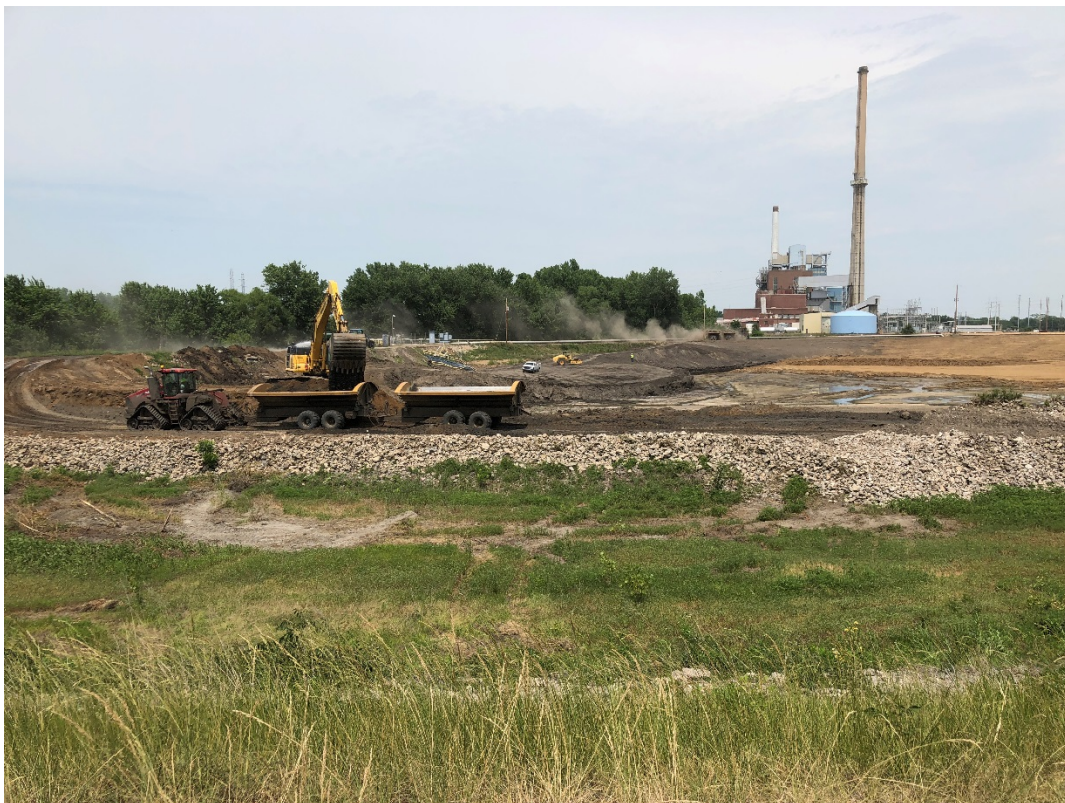
Photograph 6 ▲ - View of removal of the southwest berm of the Bottom Ash Pond, looking northeast.

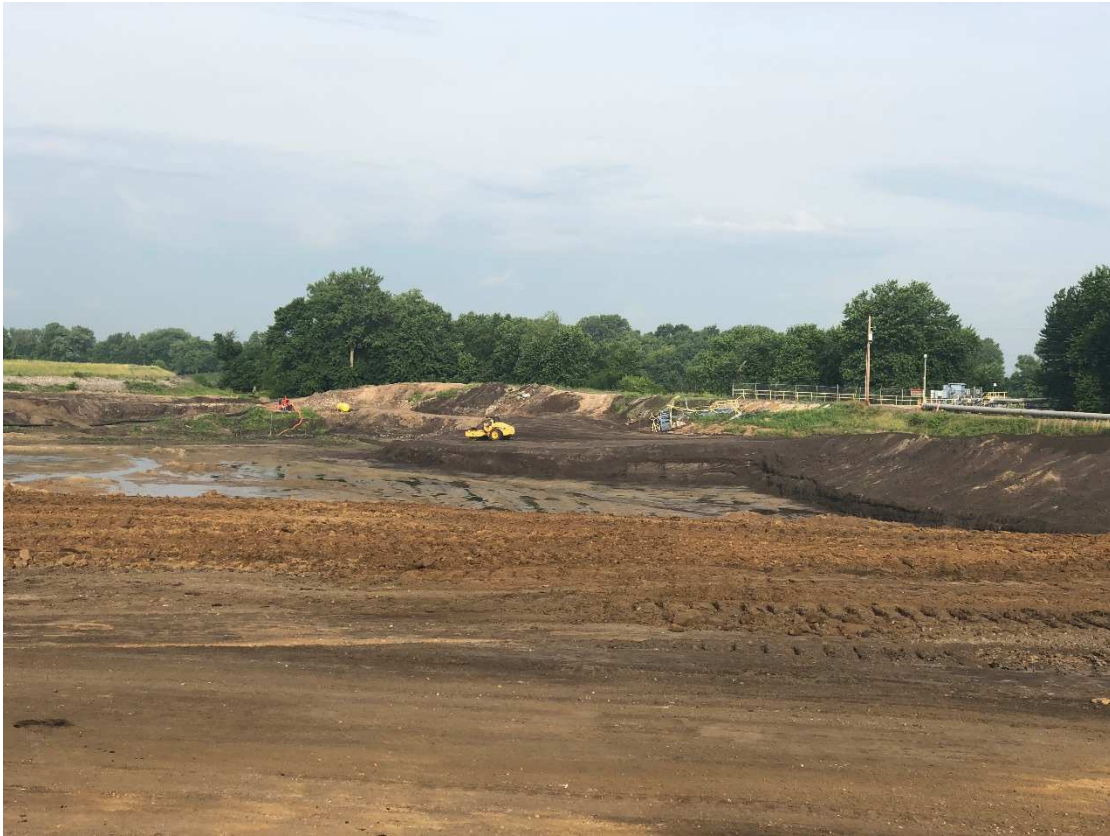
Photograph 1 ▲ - View of borrow soil placement at the Bottom Ash Pond, looking west.

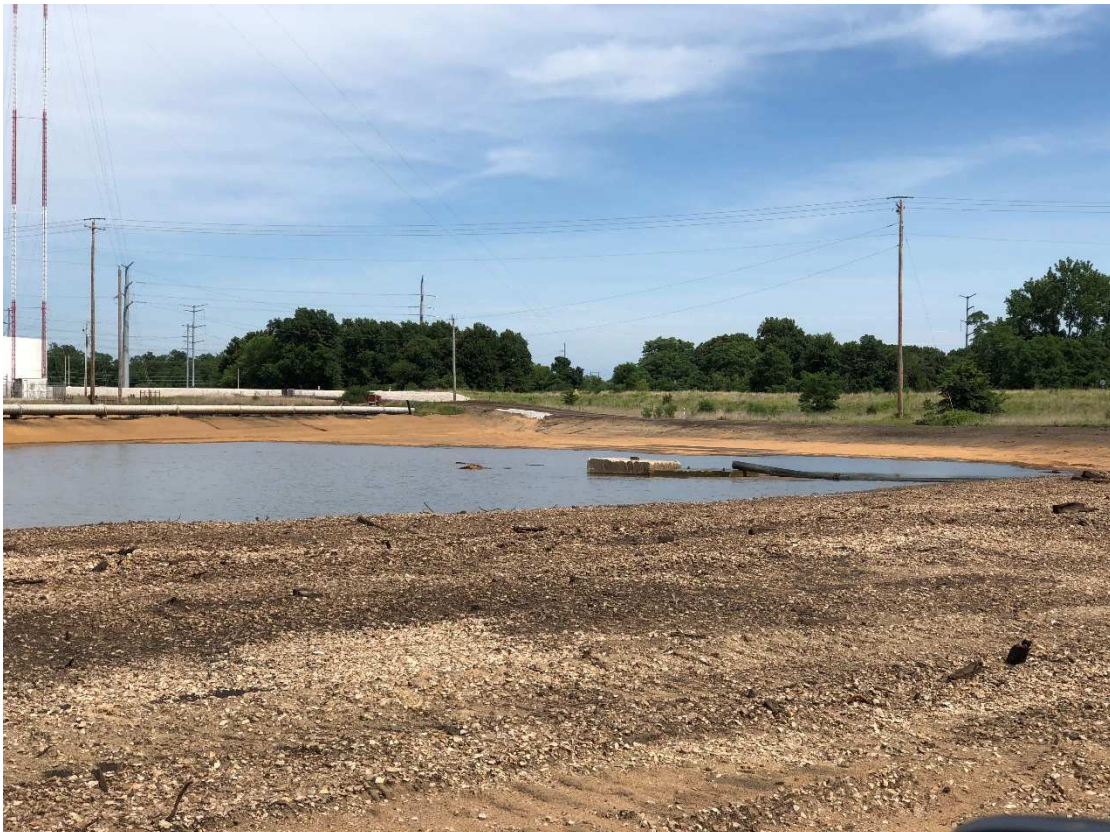
Photograph 2 ▲ - View of the Bottom Ash Pond discharge location in the Coal Yard runoff area, looking southwest.

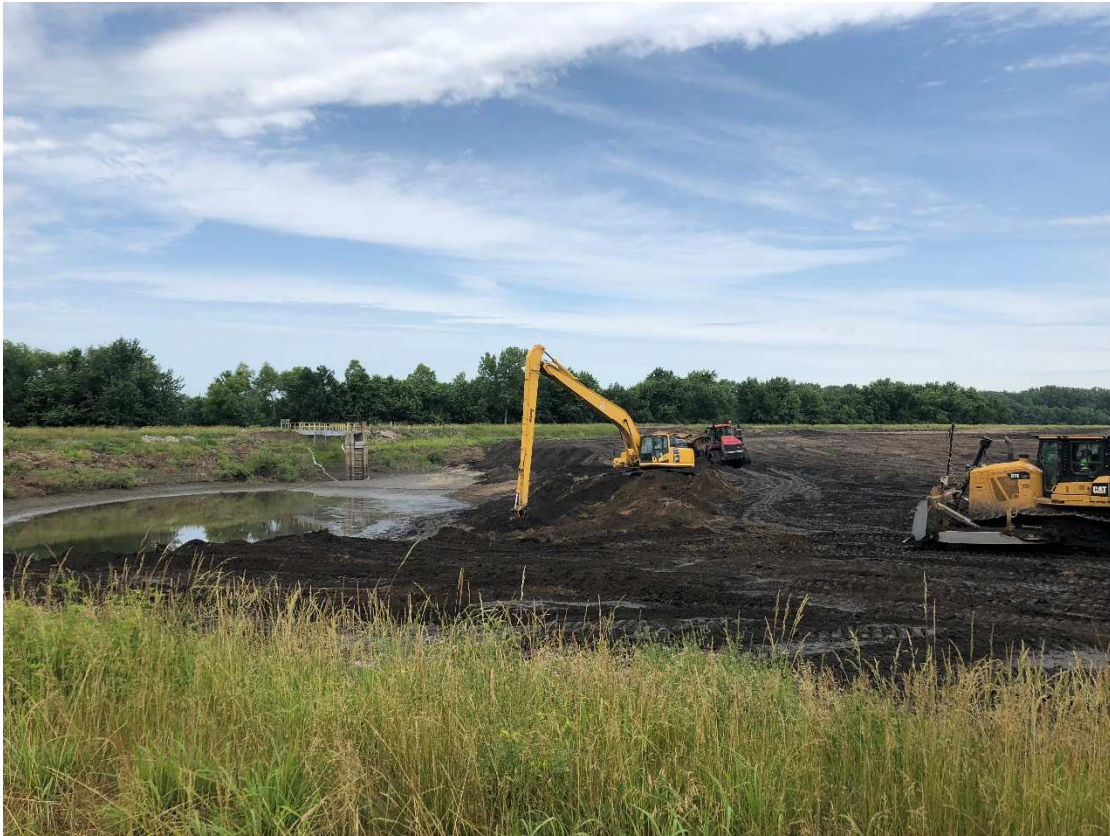
Photograph 3 ▲ - View of grading activities at the Fly Ash Pond, looking northeast.

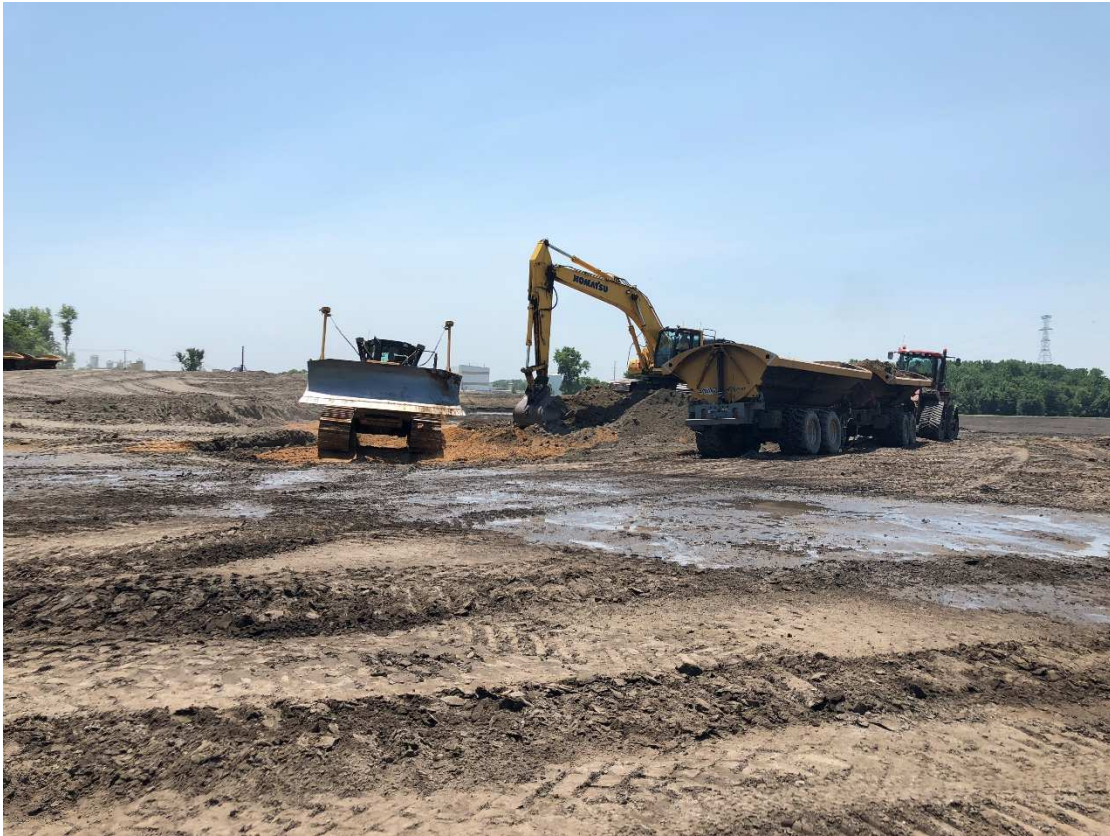
Photograph 5 ▲ - View of removal of the southwest berm of the Bottom Ash Pond, looking north.

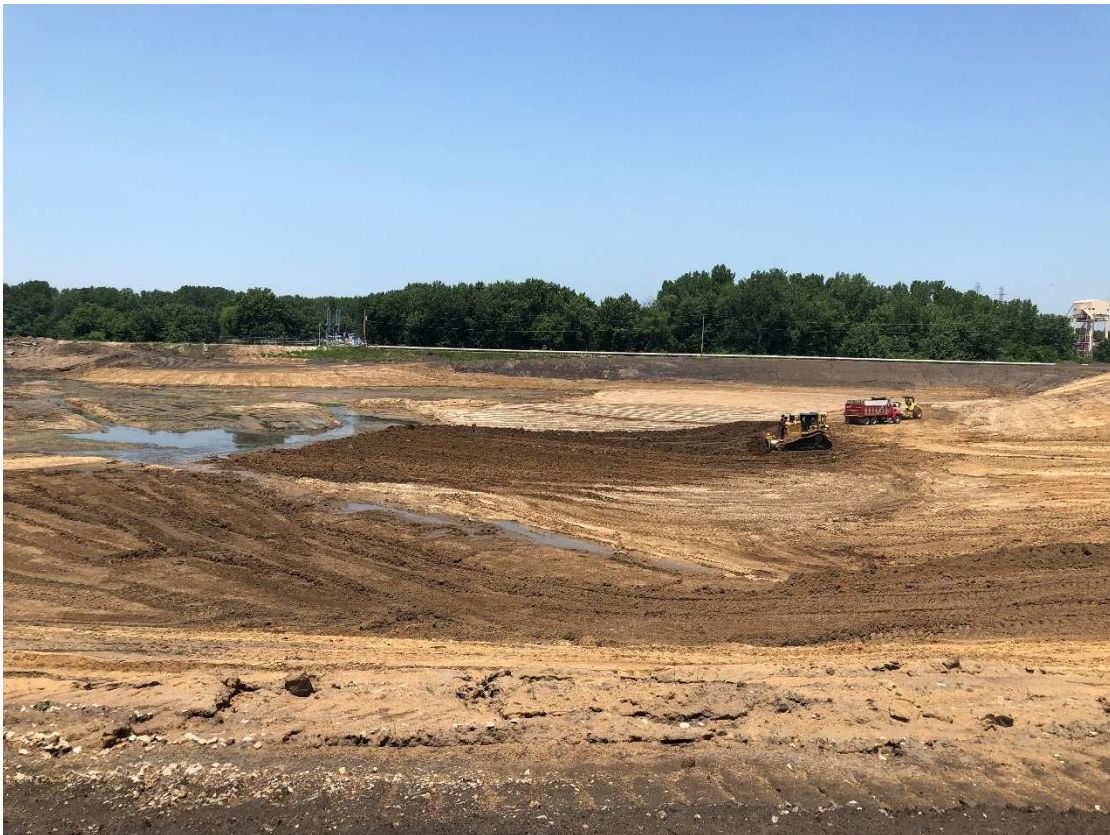
Photograph 6 ▲ - View of Bottom Ash Pond floor fill activities, looking north.

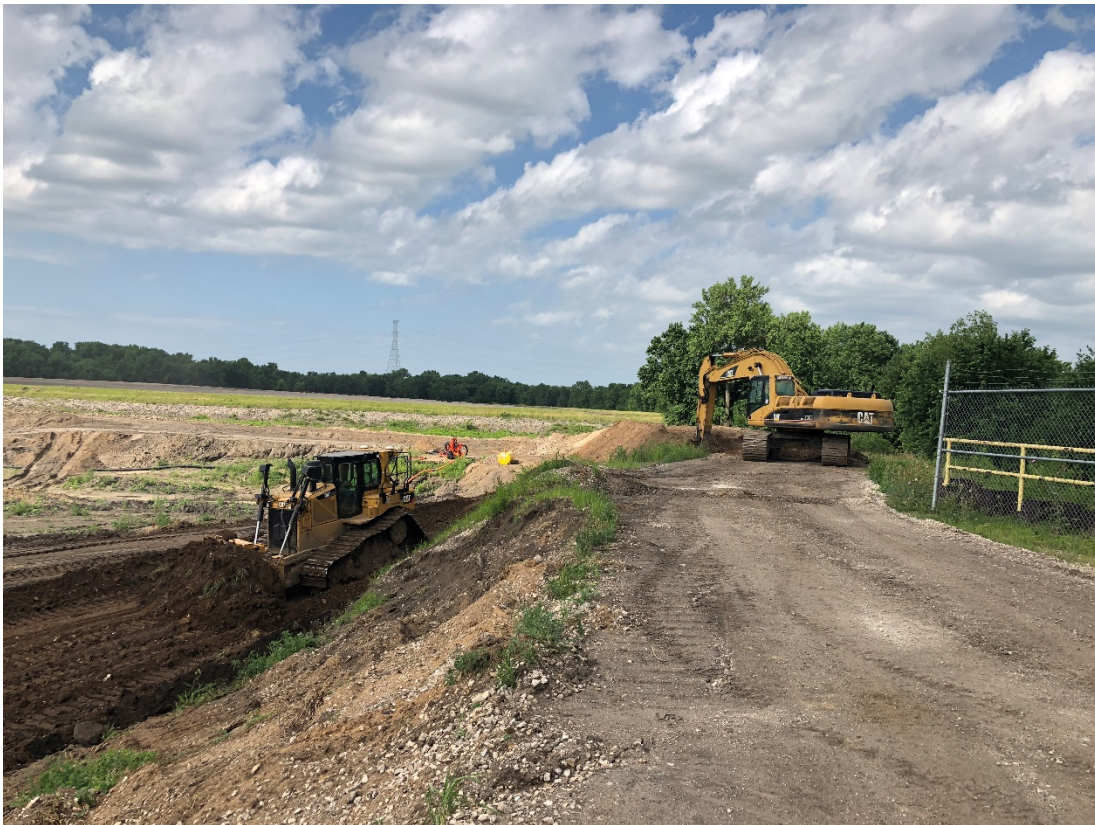
Photograph 1 ▲ - View of Bottom Ash Pond berm backfill and grading activities, looking southwest.

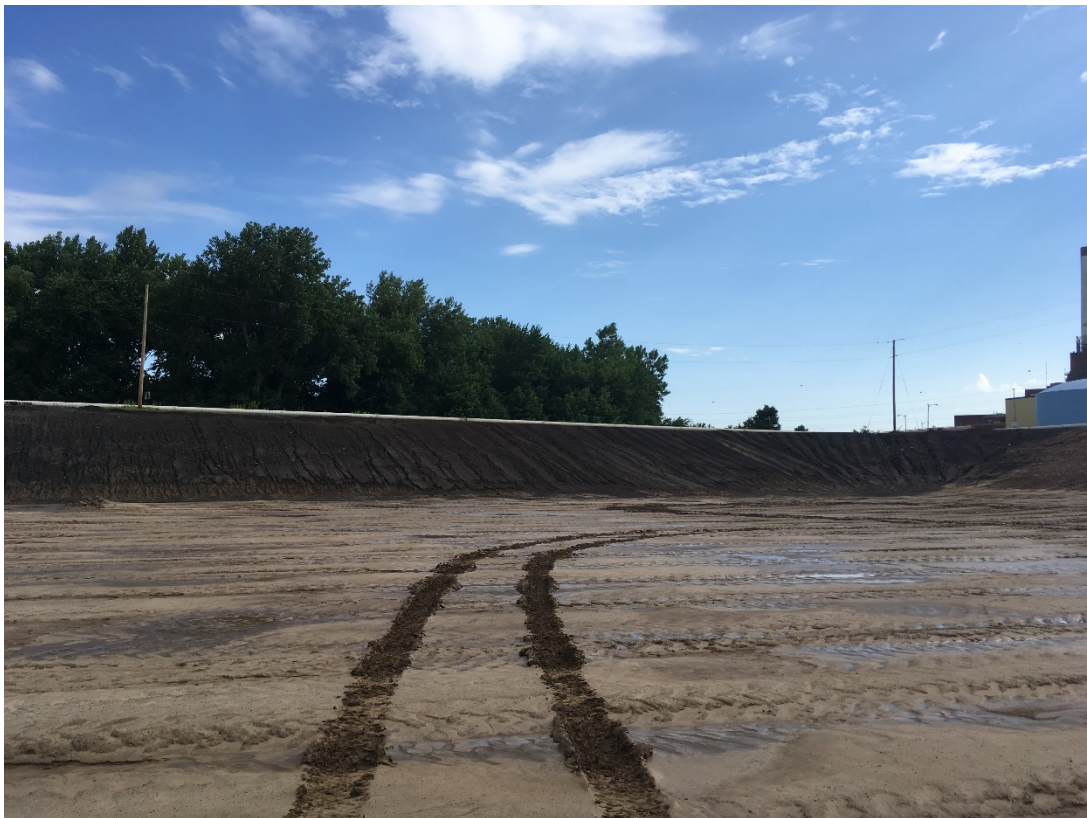
Photograph 2 ▲ - View of Bottom Ash Pond floor fill, looking northwest.

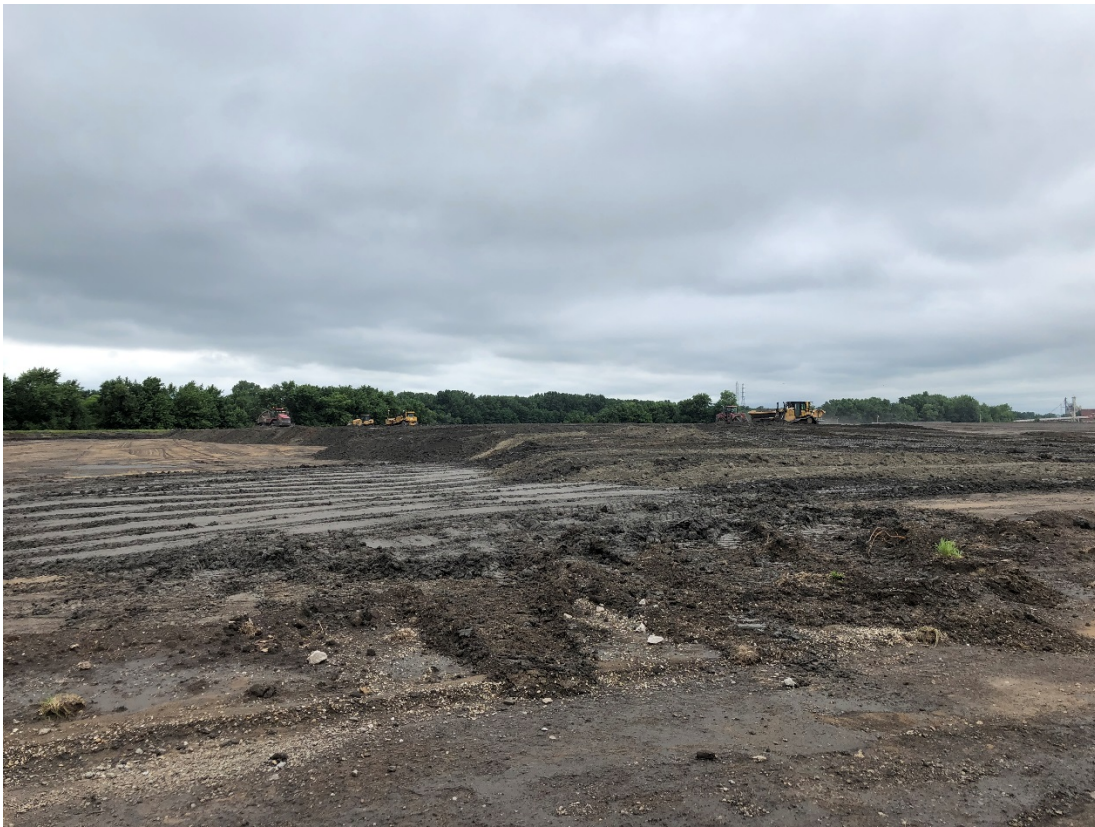
Photograph 3 ▲ - View of grading activities at the Fly Ash Pond, looking northeast.

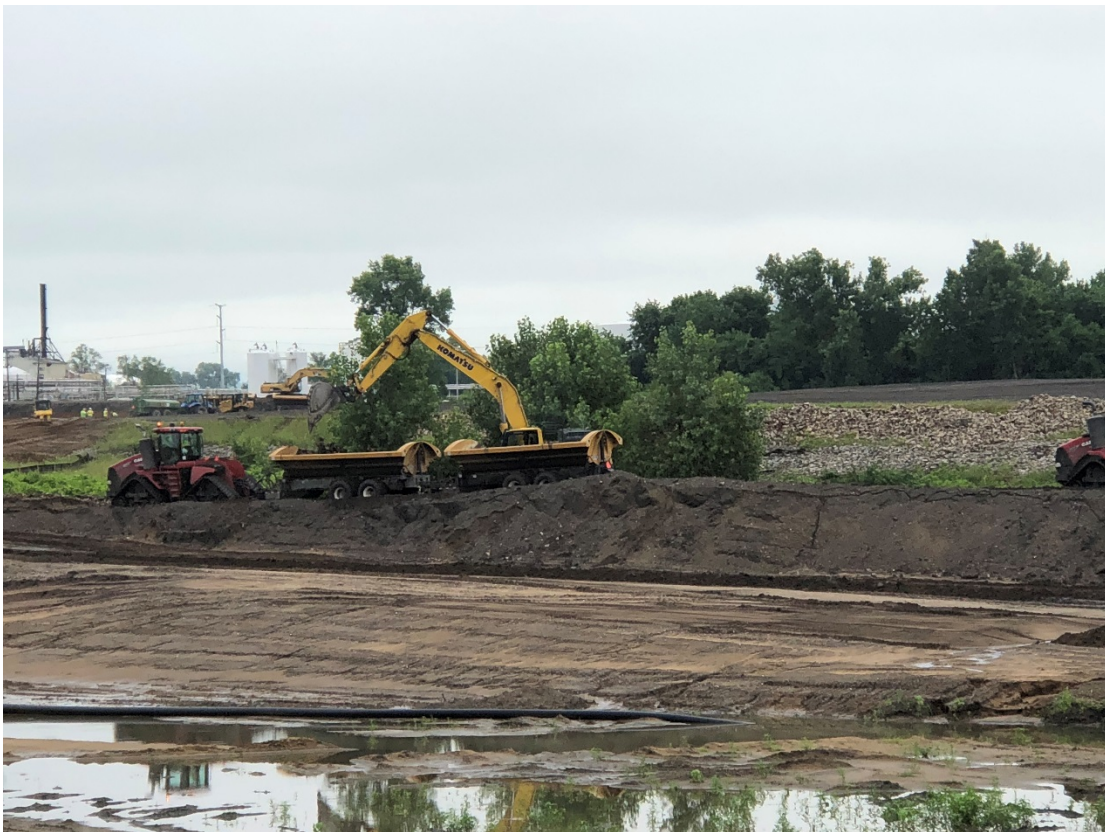
Photograph 4 ▲ - View of southwest Bottom Ash Pond berm removal activities, looking southwest.

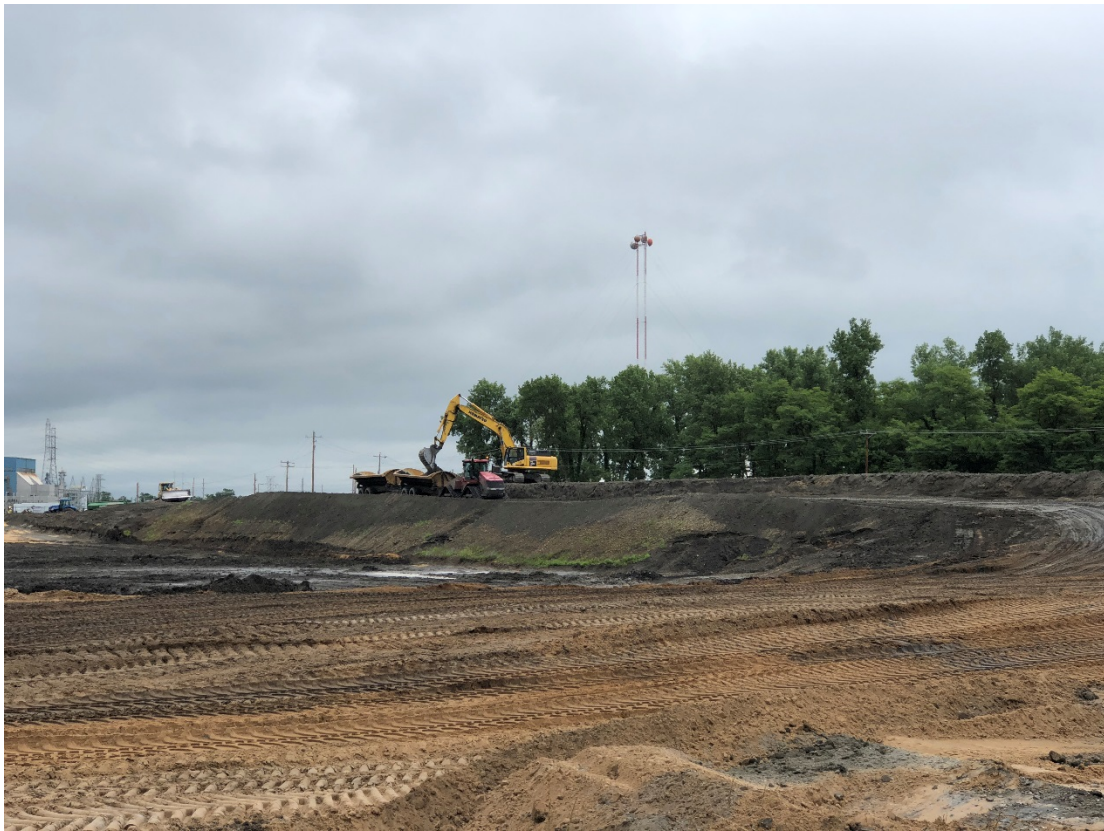
Photograph 5 ▲ - View of removal of the fly ash stockpile material, looking northeast.

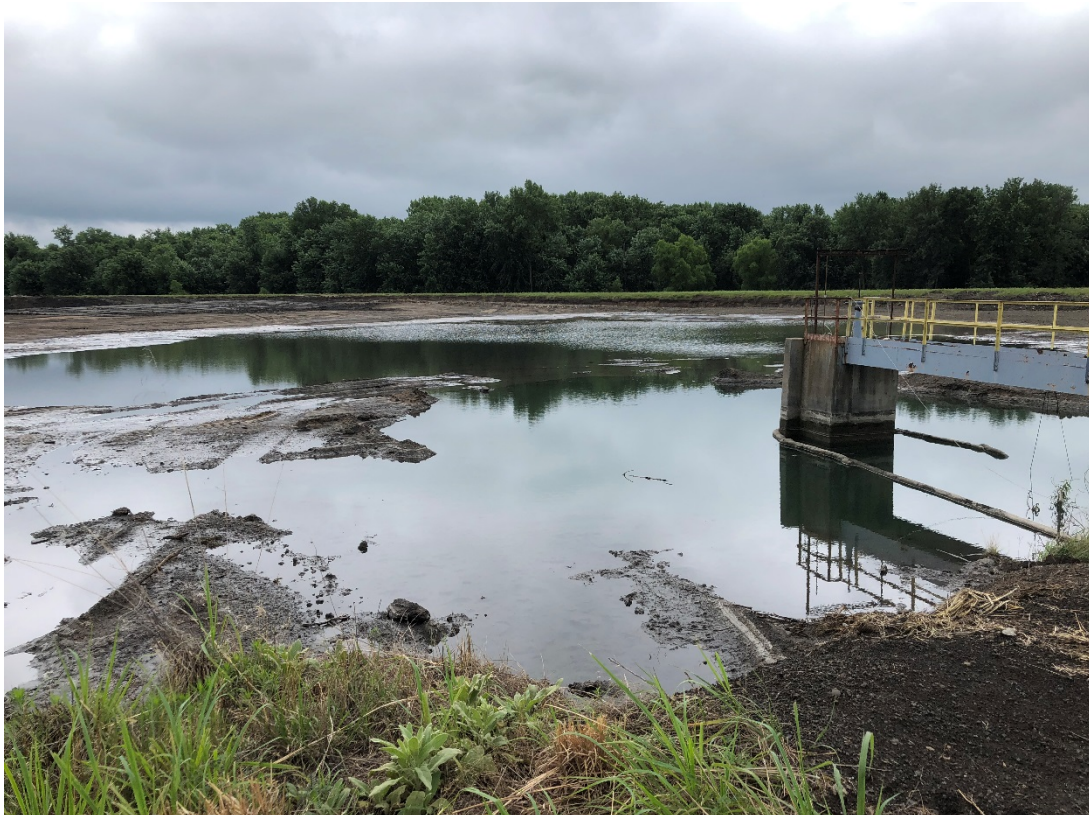
Photograph 6 ▲ - View of Fly Ash Pond at Outfall 004 showing the water level on June 22, 2018 after overnight rains, looking south.

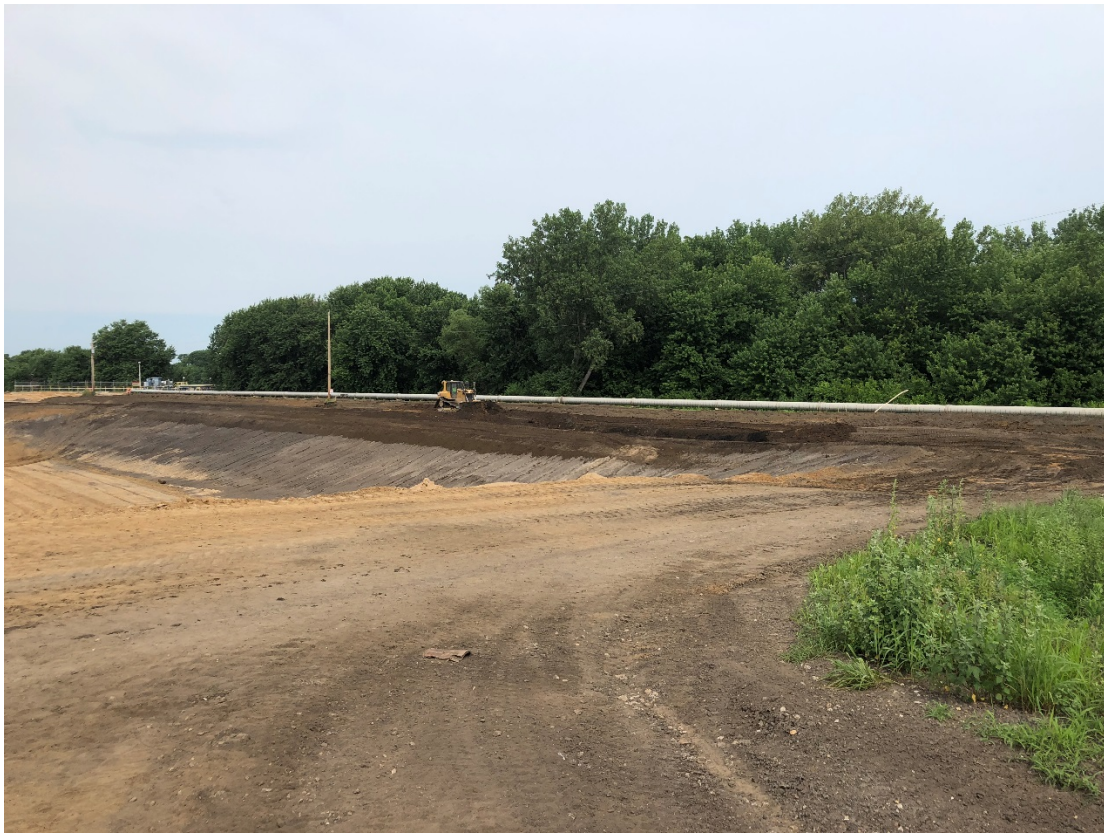
Photograph 1 ▲ - View of Bottom Ash Pond berm backfill and grading activities, looking west.

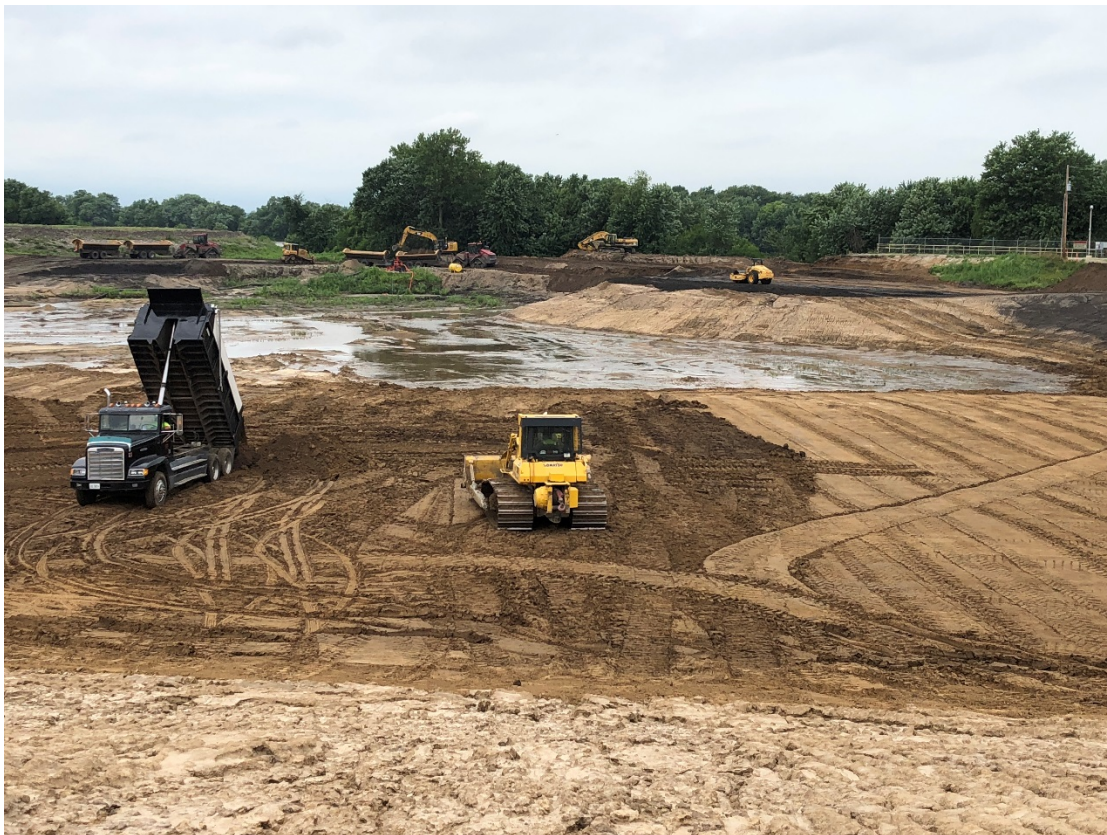
Photograph 2 ▲ - View of Bottom Ash Pond floor fill activities, looking west.

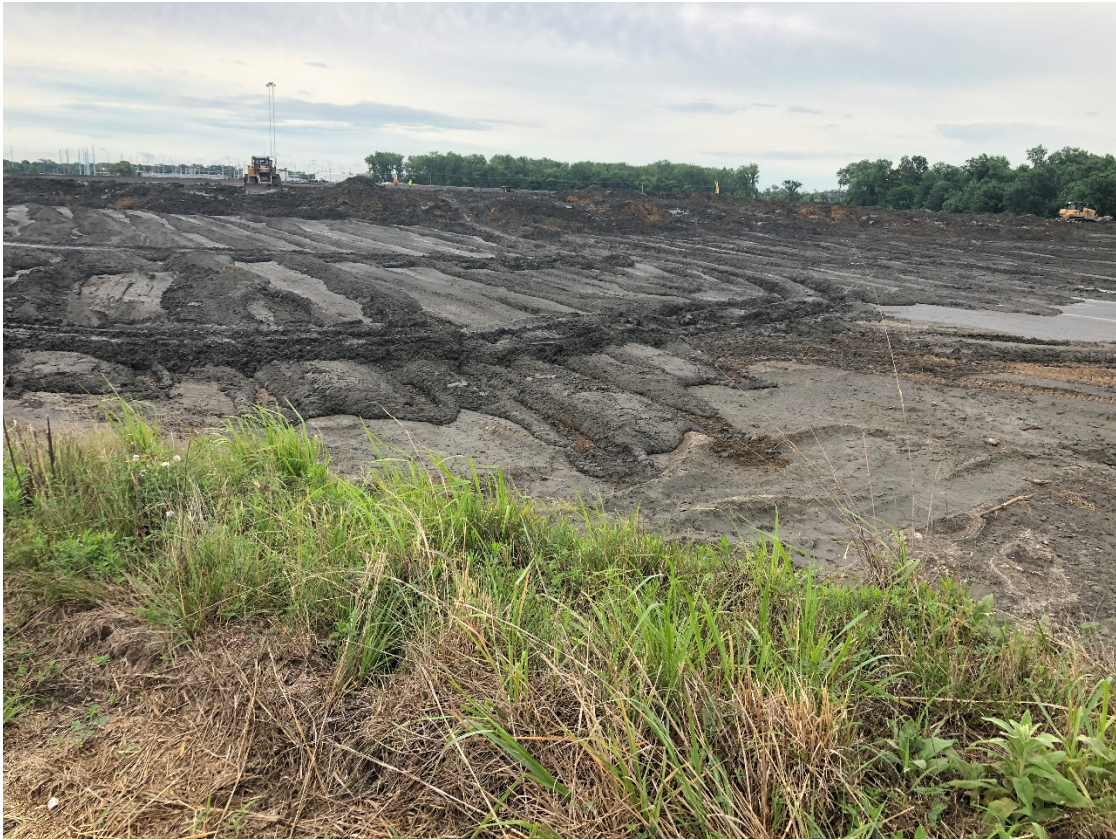
Photograph 3 ▲ - View of grading activities at the Fly Ash Pond, looking south.

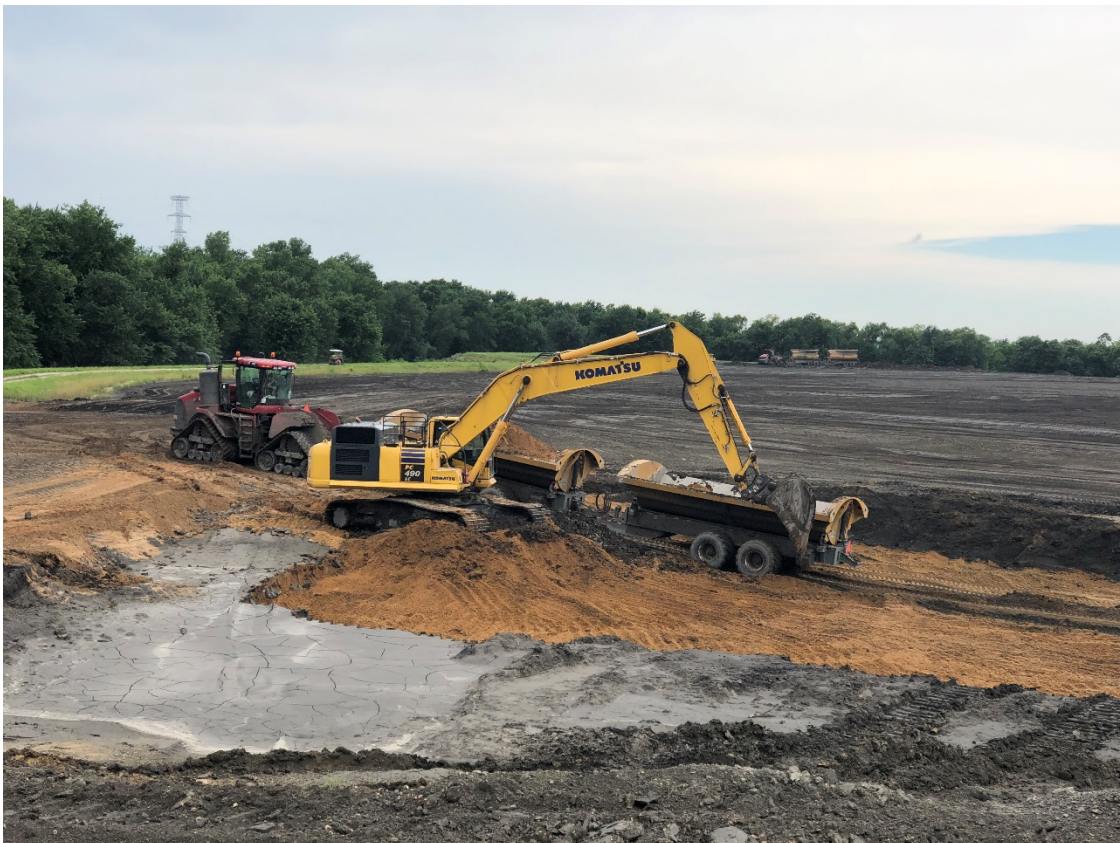
Photograph 4 ▲ - View of removal of the fly ash stockpile material, looking northeast.

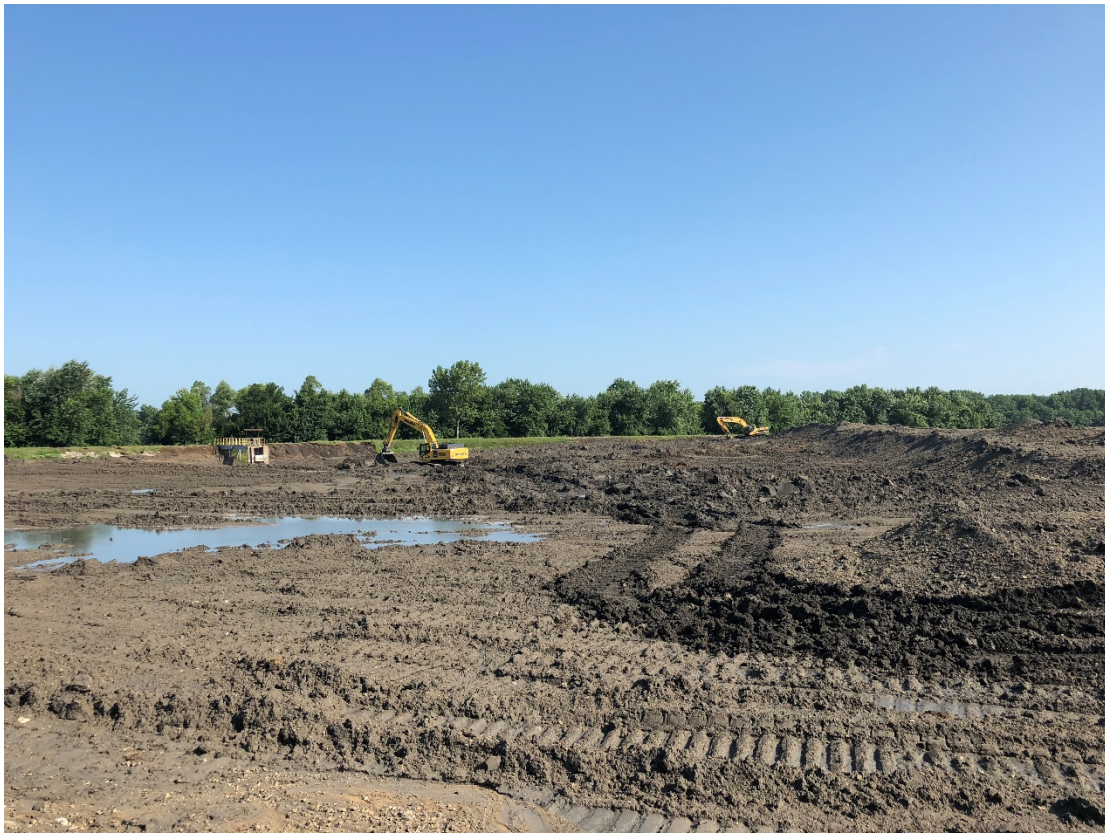
Photograph 5 ▲ - View of fly ash spreading activities at the Fly Ash Pond to facilitate drying, looking northwest.

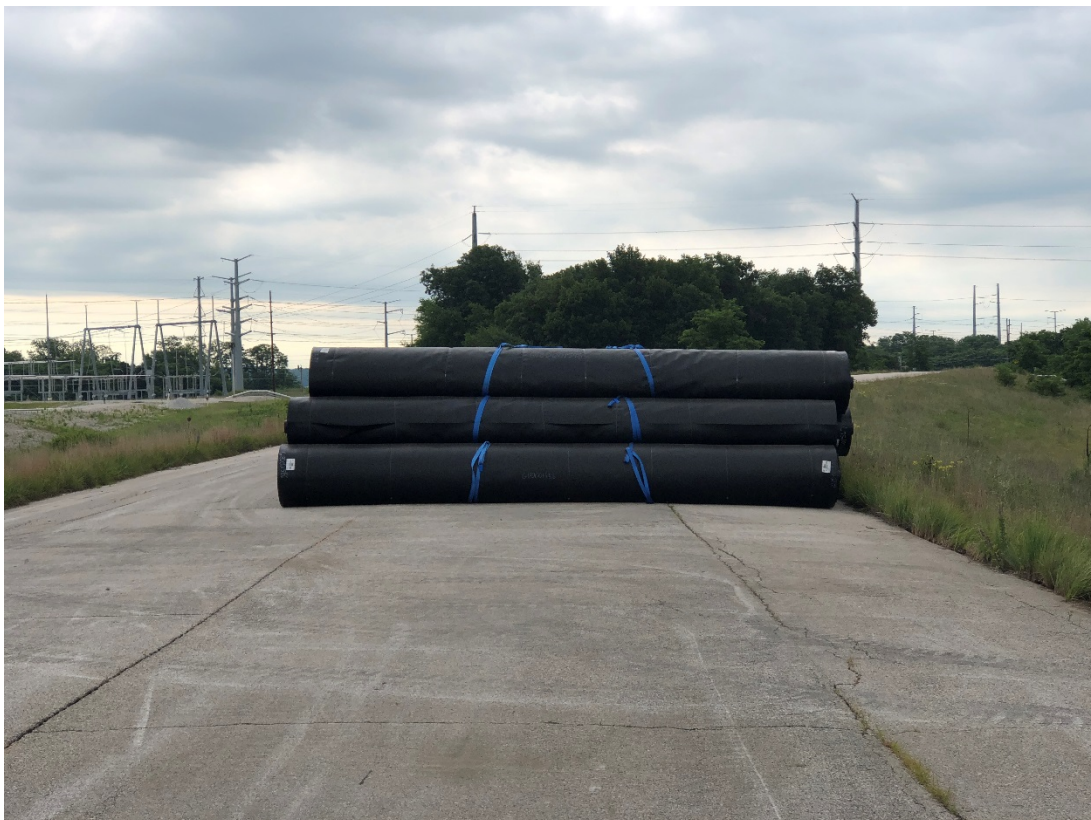
Photograph 6 ▲ - View of geomembrane (40-mil HDPE MicroSpike) storage on site, looking southeast.

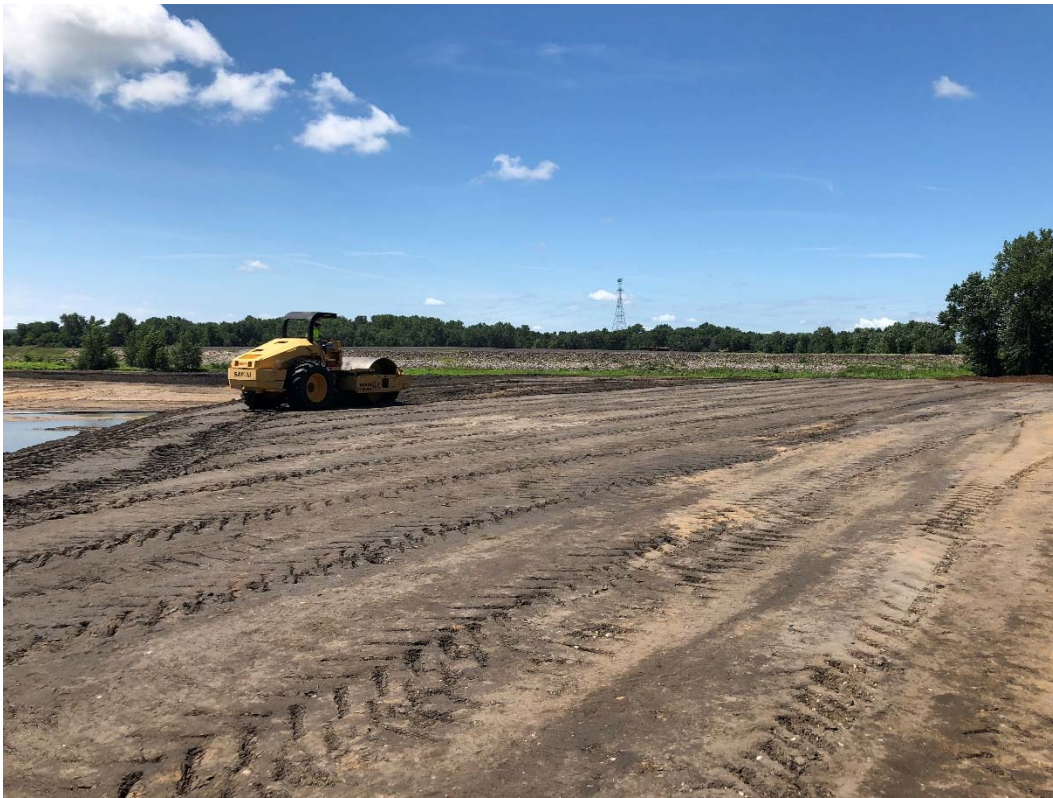
Photograph 1 ▲ - View of Bottom Ash Pond berm compaction activities, looking south.

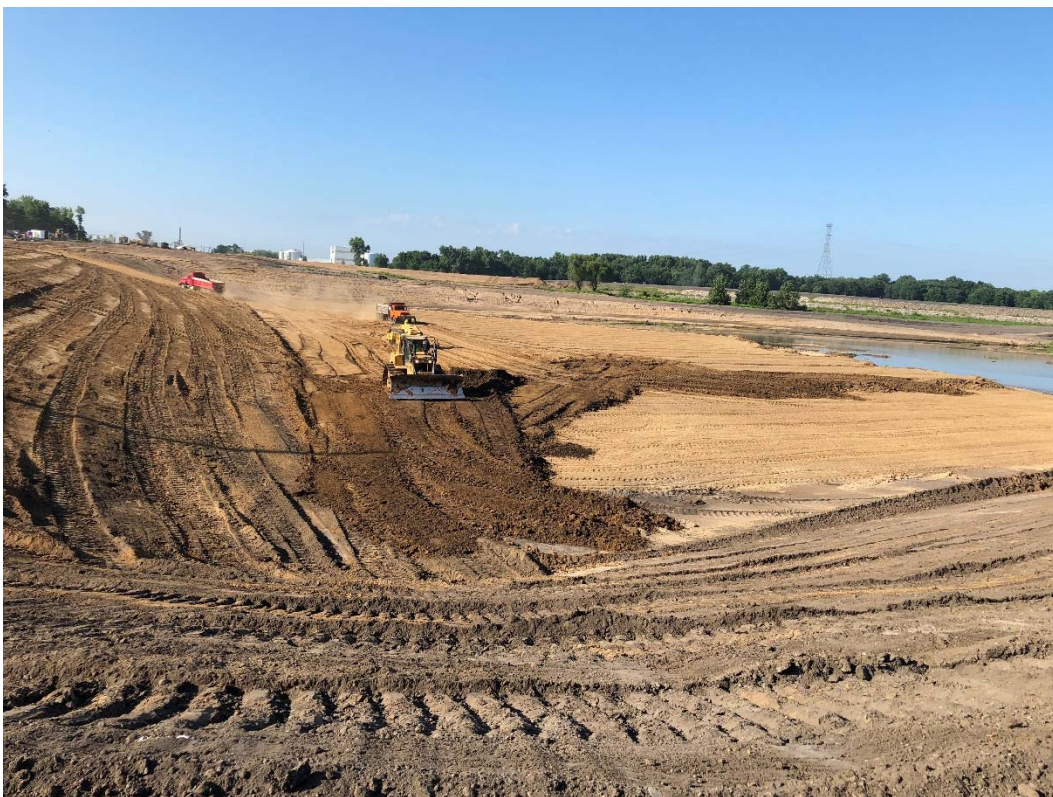
Photograph 2 ▲ - View of Bottom Ash Pond floor fill activities, looking south.
