**CONSTRUCTION QUALITY ASSURANCE REPORT
CLOSURE OF THE BOTTOM ASH POND
AND FLY ASH POND
MEREDOSIA POWER STATION
800 SOUTH WASHINGTON STREET
MEREDOSIA, MORGAN COUNTY, ILLINOIS**

**AMEREN ENERGY RESOURCES
ST. LOUIS, MISSOURI**

**GEOTECHNOLOGY, INC.
ST. LOUIS, MISSOURI**

JANUARY 18, 2019

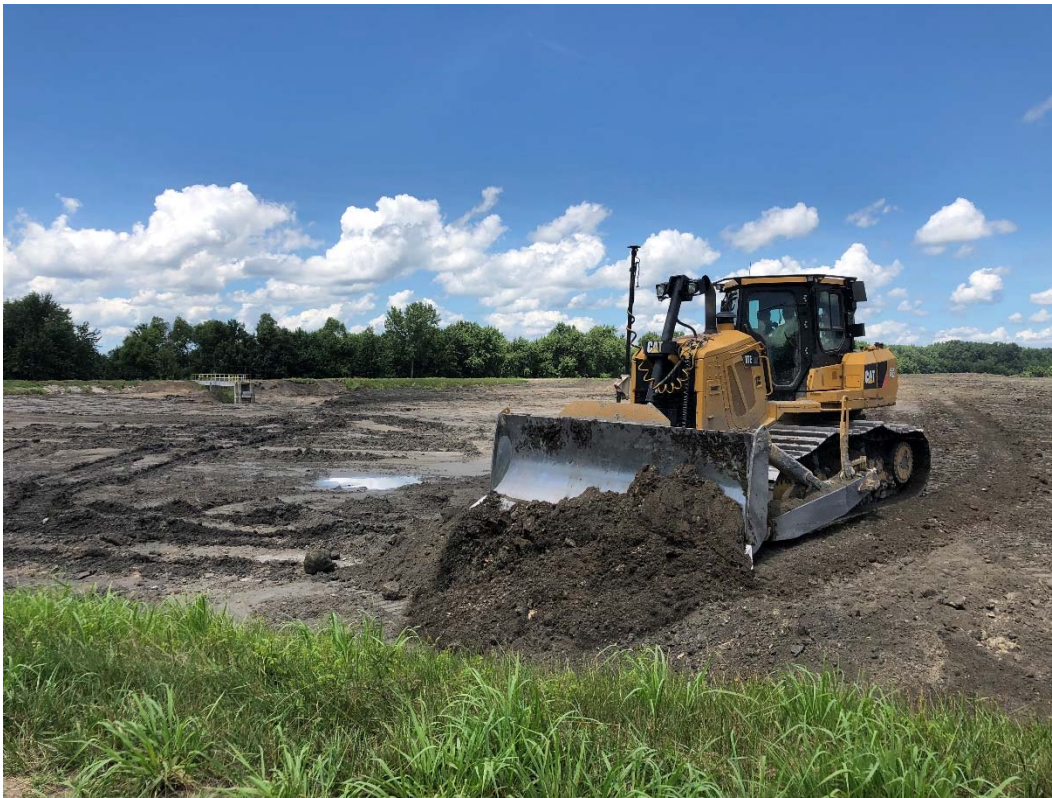
Photograph 3 ▲ - View of grading activities at the Fly Ash Pond, looking northwest.

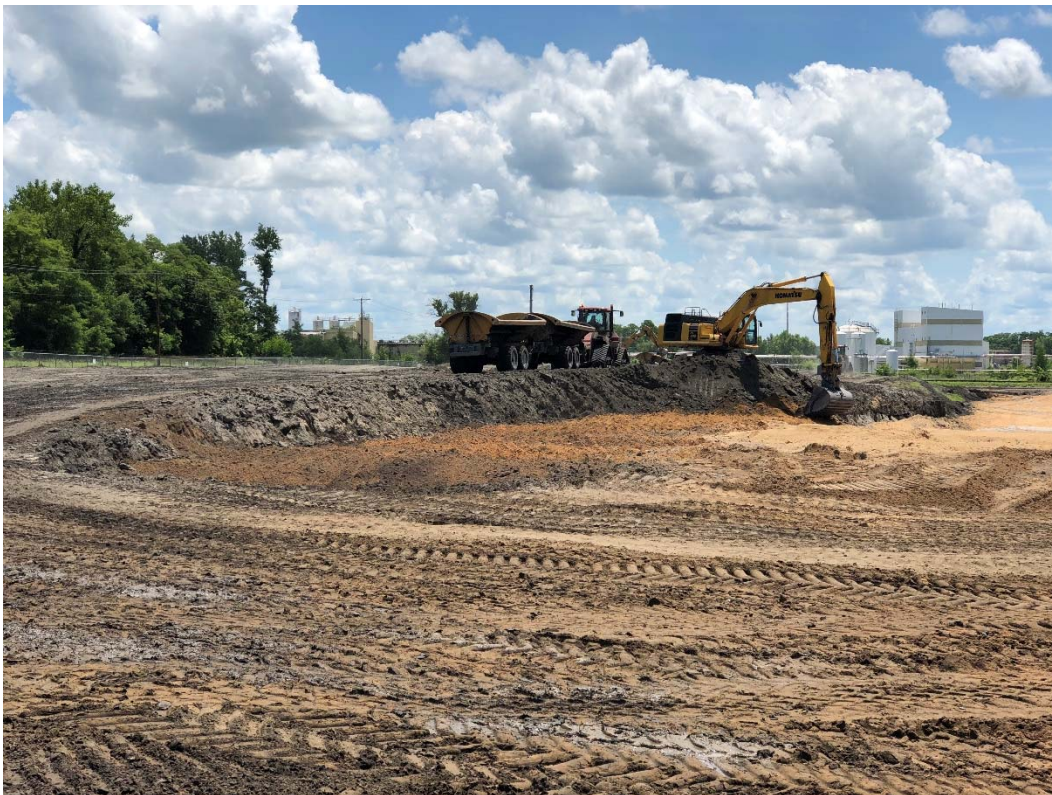
Photograph 4 ▲ - View of removal of the fly ash stockpile material, looking south.

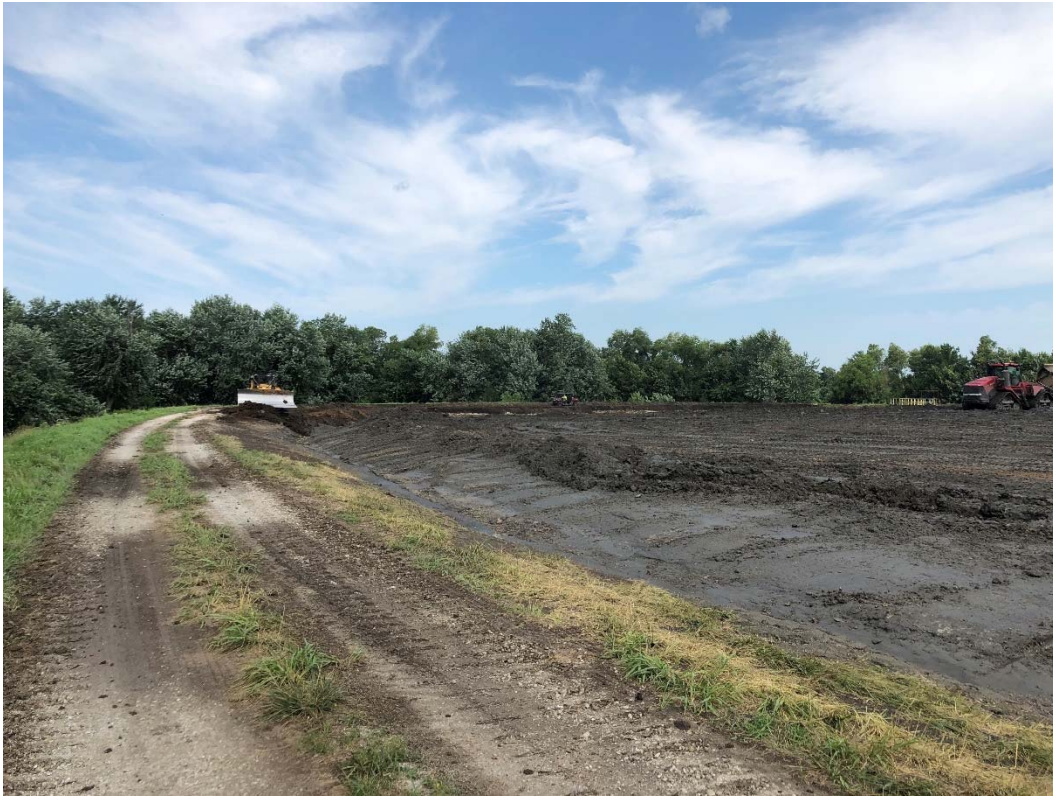
Photograph 5 ▲ - View of ditch construction at the Fly Ash Pond, looking west.

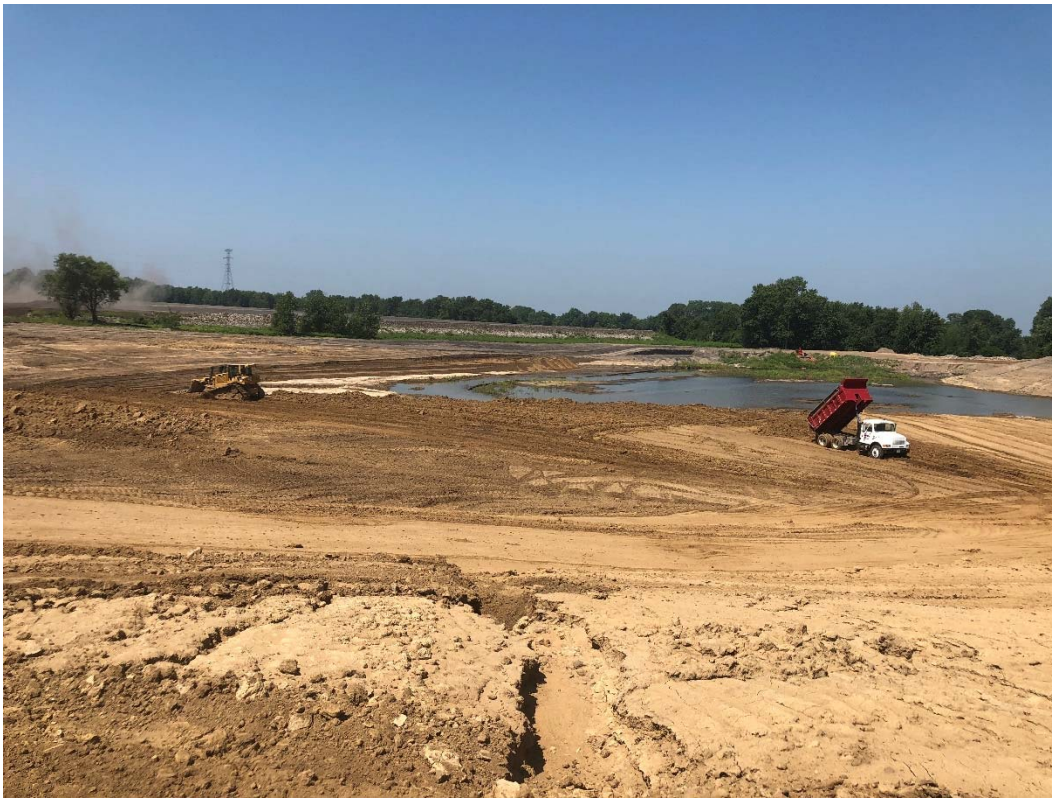
Photograph 1 ▲ - View of Bottom Ash Pond floor fill activities, looking south.

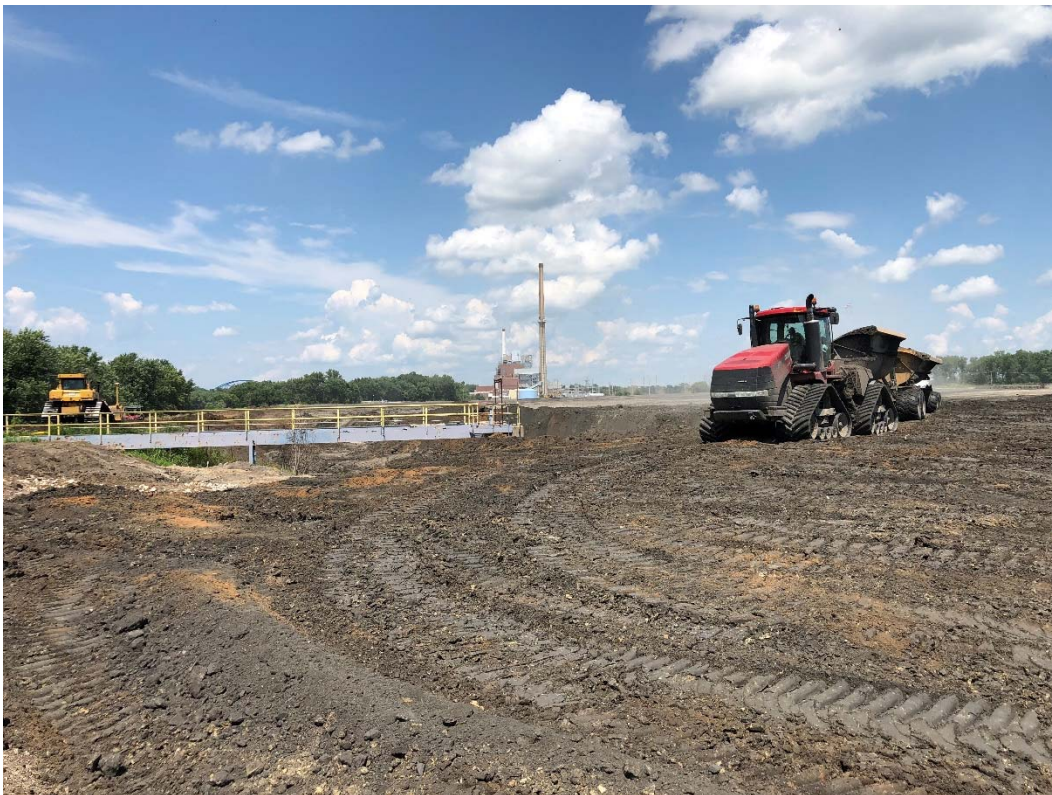
Photograph 2 ▲ - View of grading activities at the Fly Ash Pond, looking northwest.

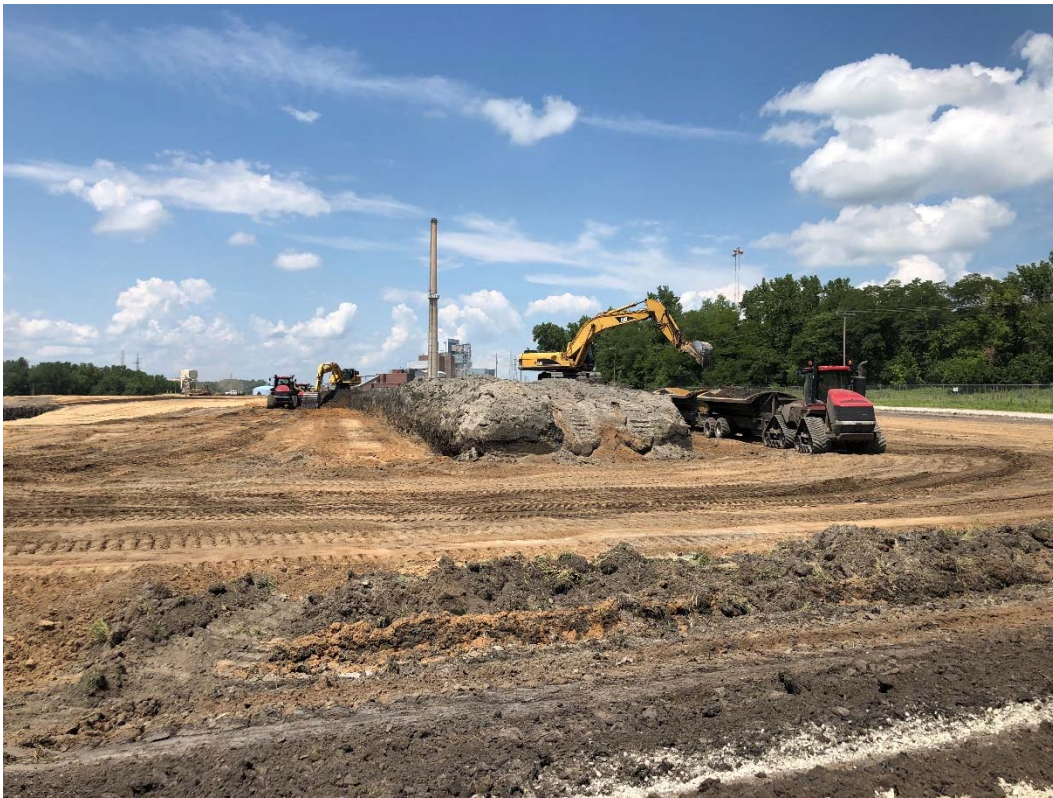
Photograph 3 ▲ - View of removal of the fly ash stockpile material, looking north.

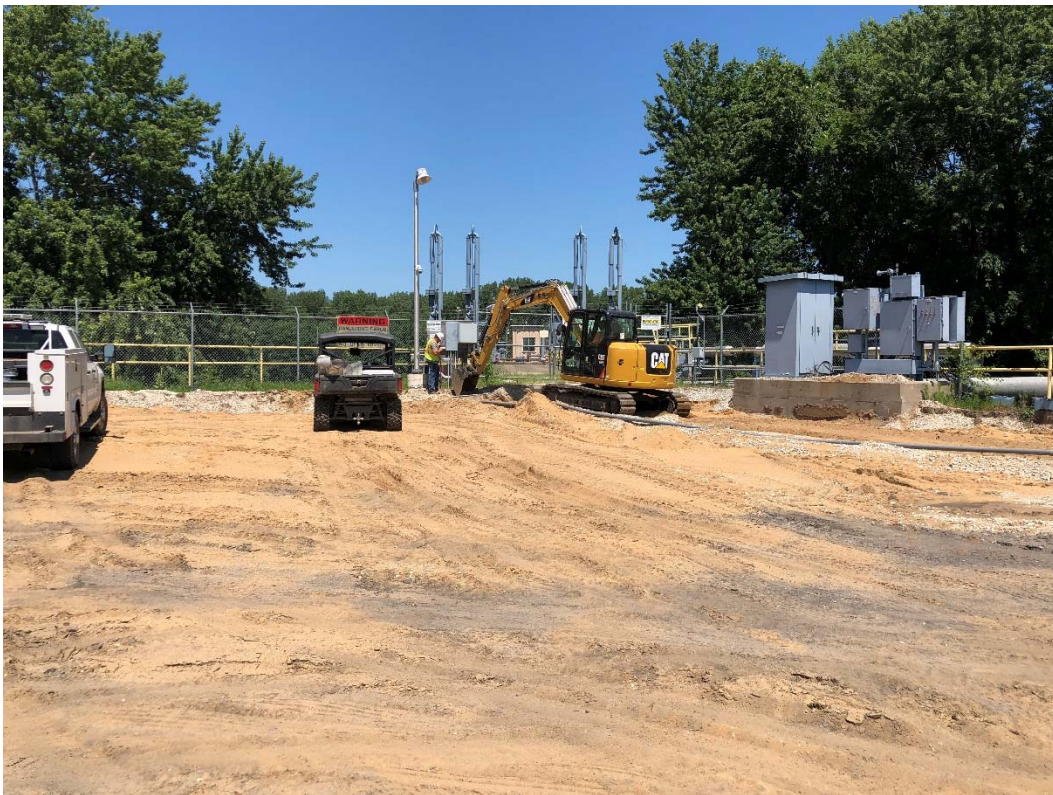
Photograph 4 ▲ - View of utility trench excavation at the Bottom Ash Pond berm, looking northwest.

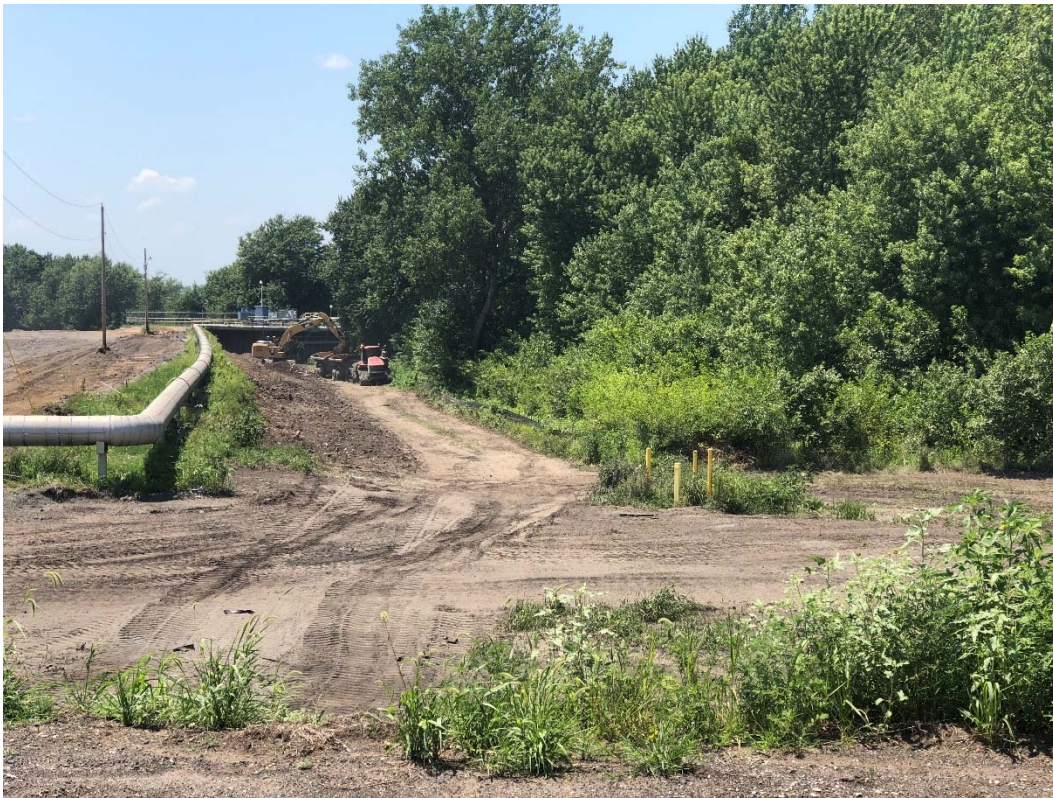
Photograph 5 ▲ - View of rock blanket removal at the Bottom Ash Pond berm, looking west.

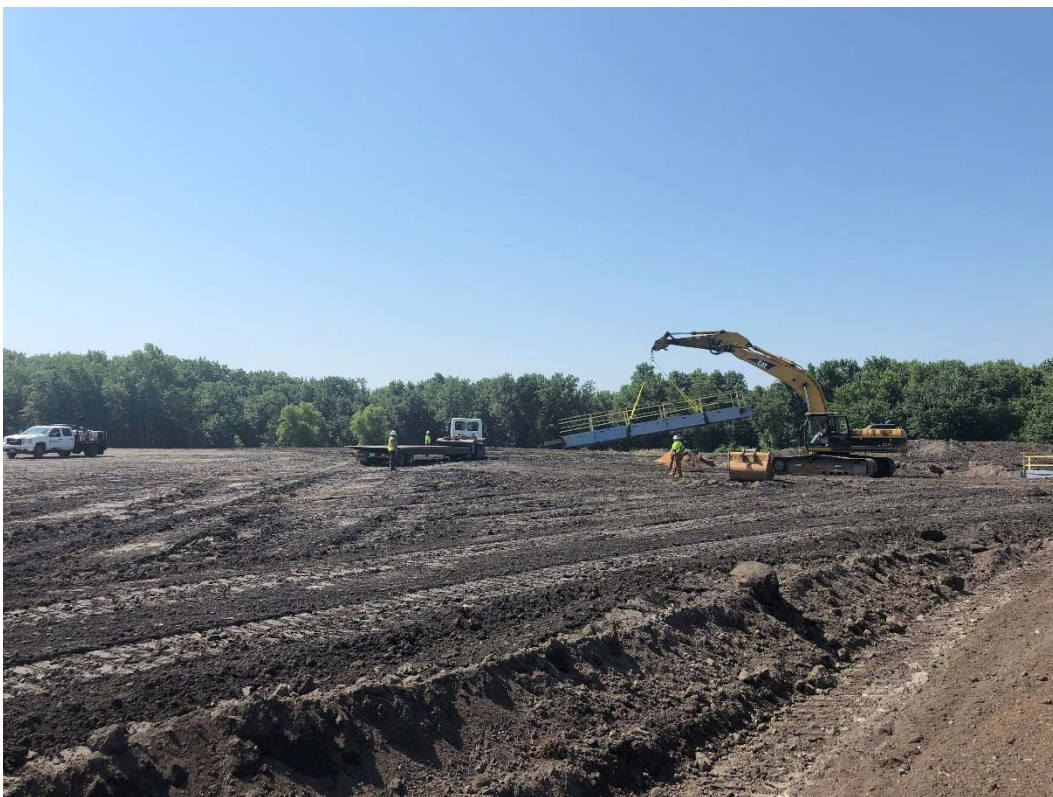
Photograph 6 ▲ - View of Outfall 004 removal at the Fly Ash Pond, looking southwest.

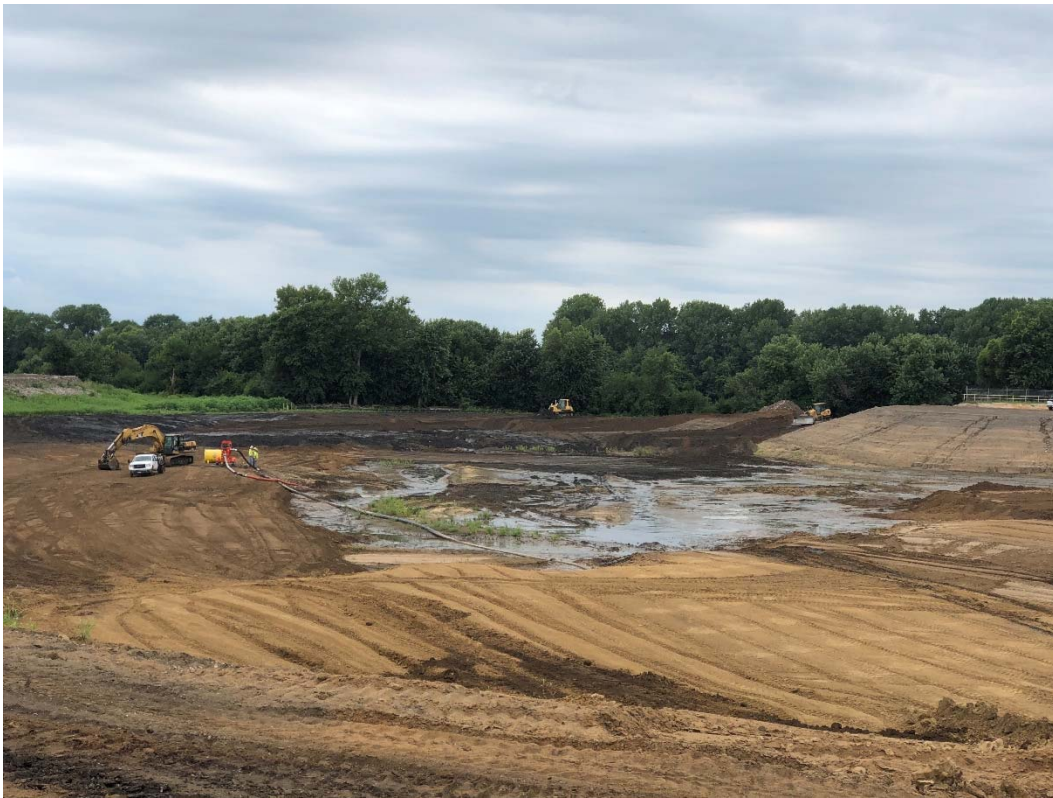
Photograph 1 ▲ - View of Bottom Ash Pond floor fill activity status, looking northeast.

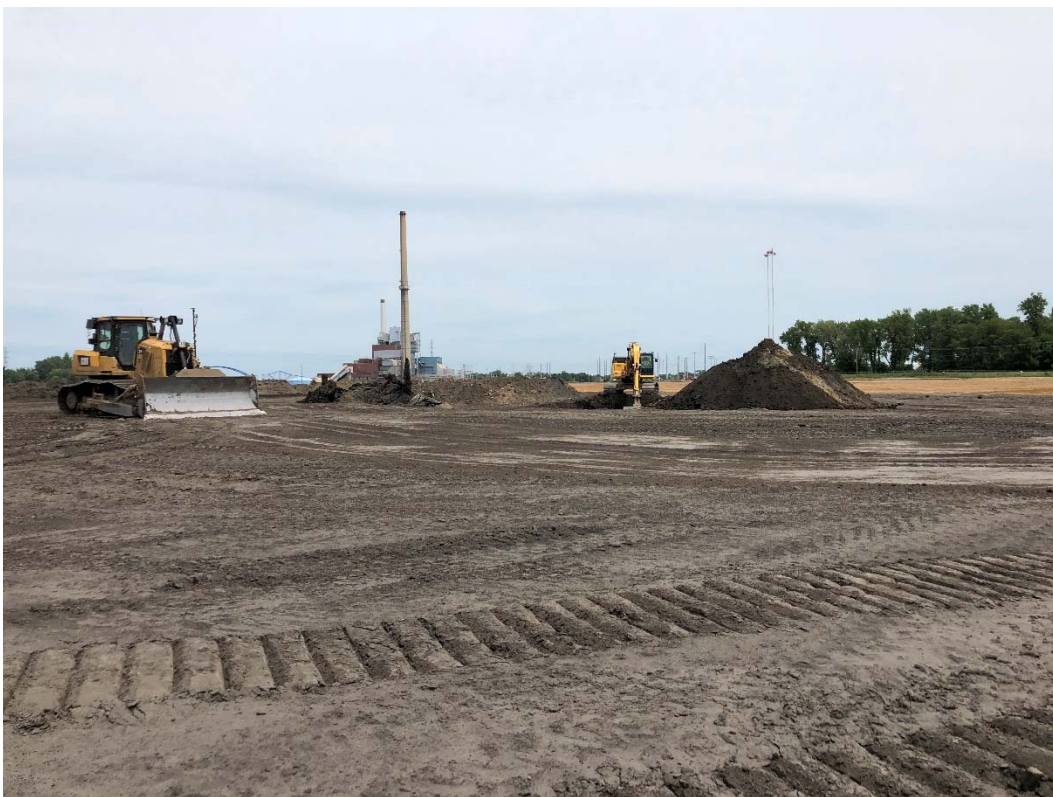
Photograph 2 ▲ - View of grading activities at the Fly Ash Pond, looking northeast.

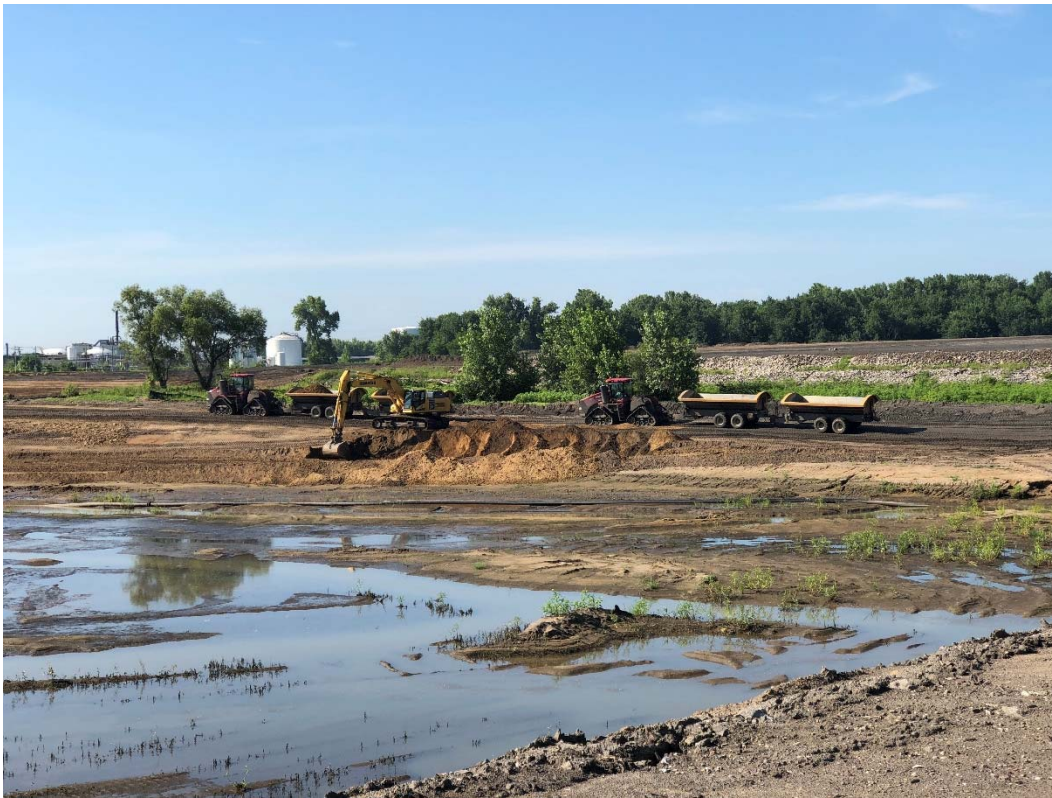
Photograph 3 ▲ - View of Bottom Ash Pond southwest berm removal activities, looking south.

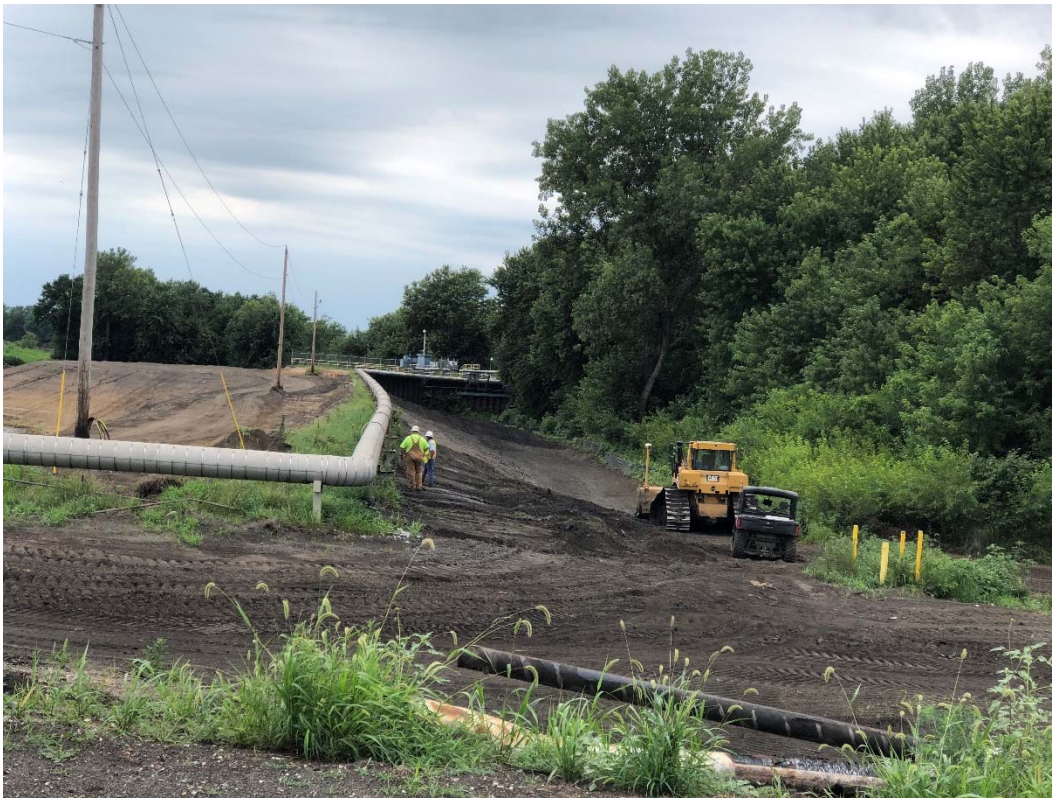
Photograph 5 ▲ - View of Bottom Ash Pond north berm grading activities, looking west.

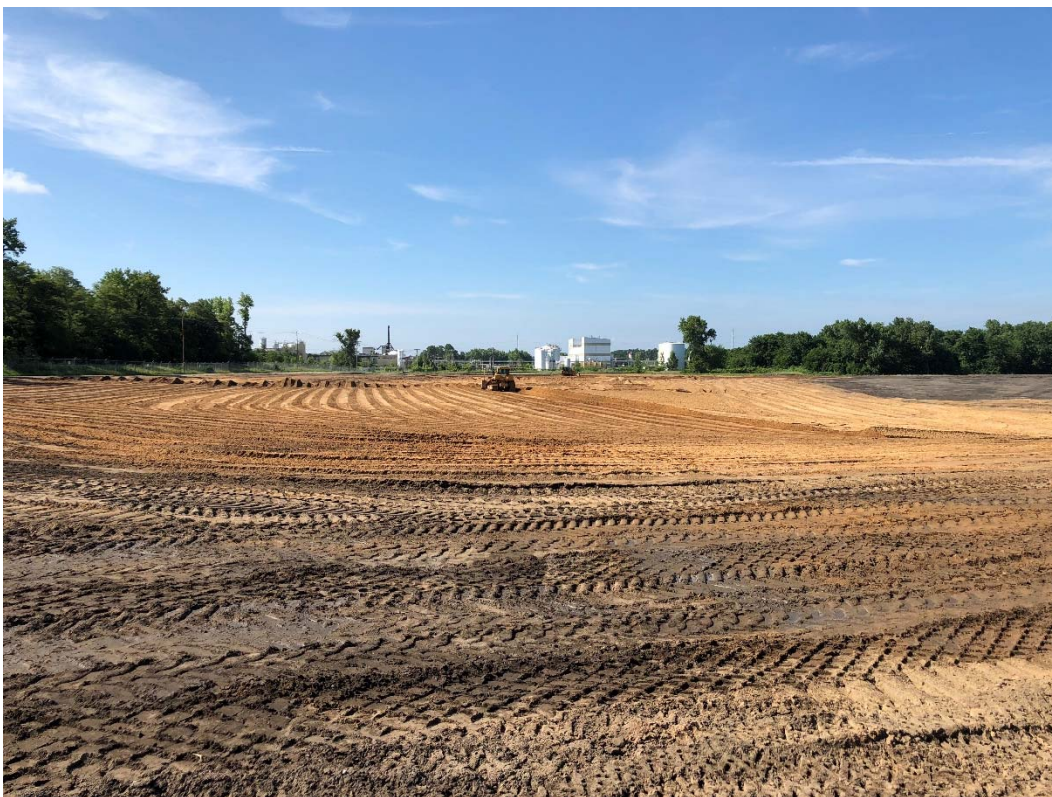
Photograph 6 ▲ - View of grading activities at the former east fly ash stockpile.

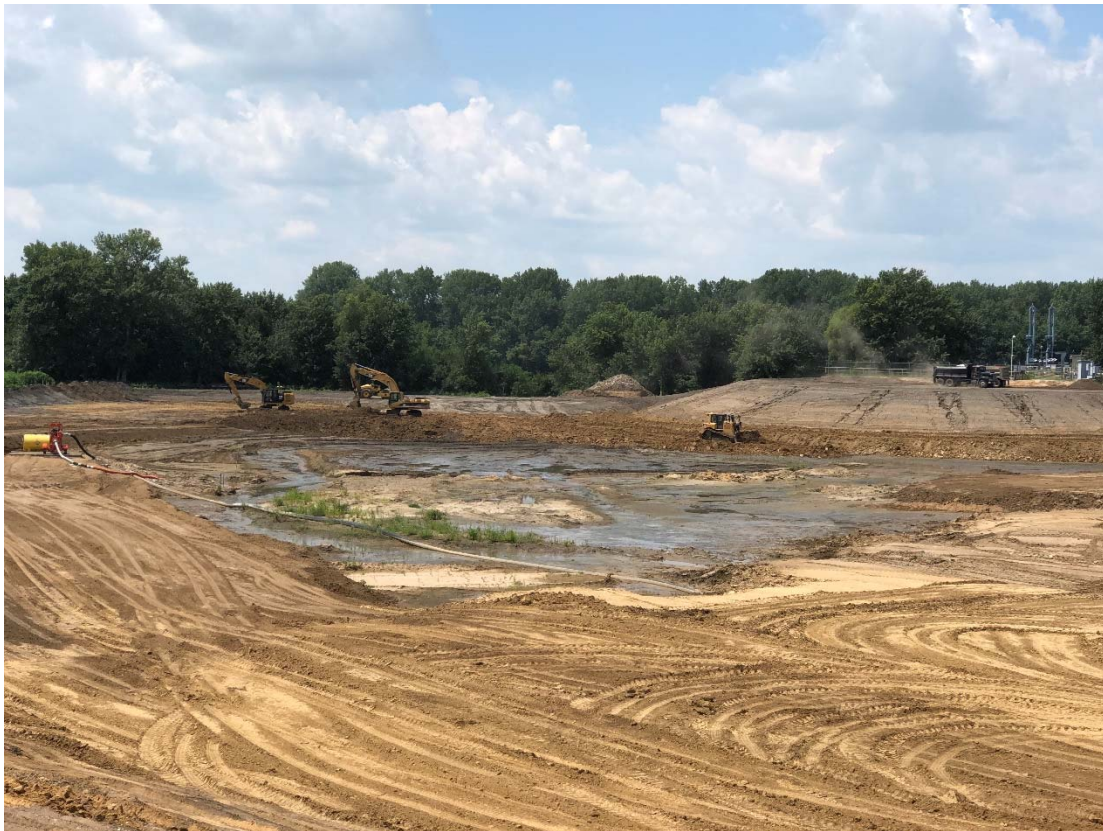
Photograph 1 ▲ - View of Bottom Ash Pond floor fill activities, looking northwest.

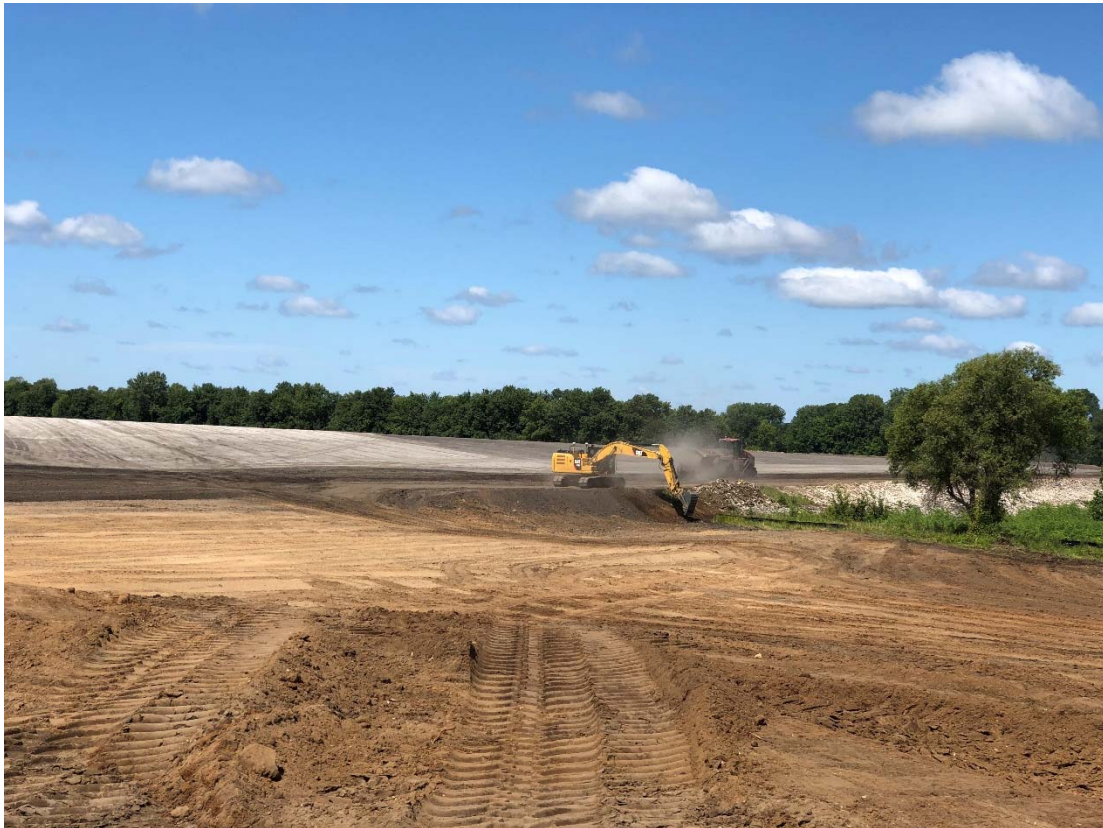
Photograph 2 ▲ - View of rip rap loading activities at the Fly Ash Pond, looking southwest.

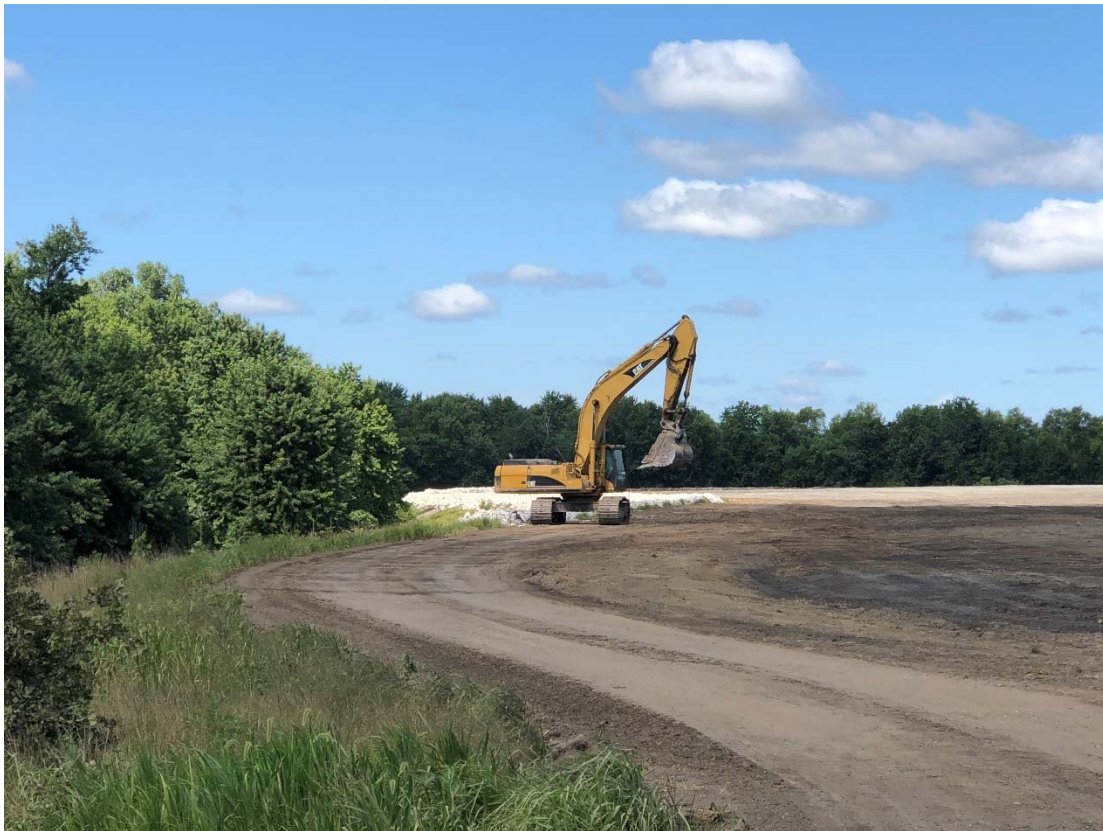
Photograph 3 ▲ - View of rip rap placement activities at the Fly Ash Pond, looking southwest.

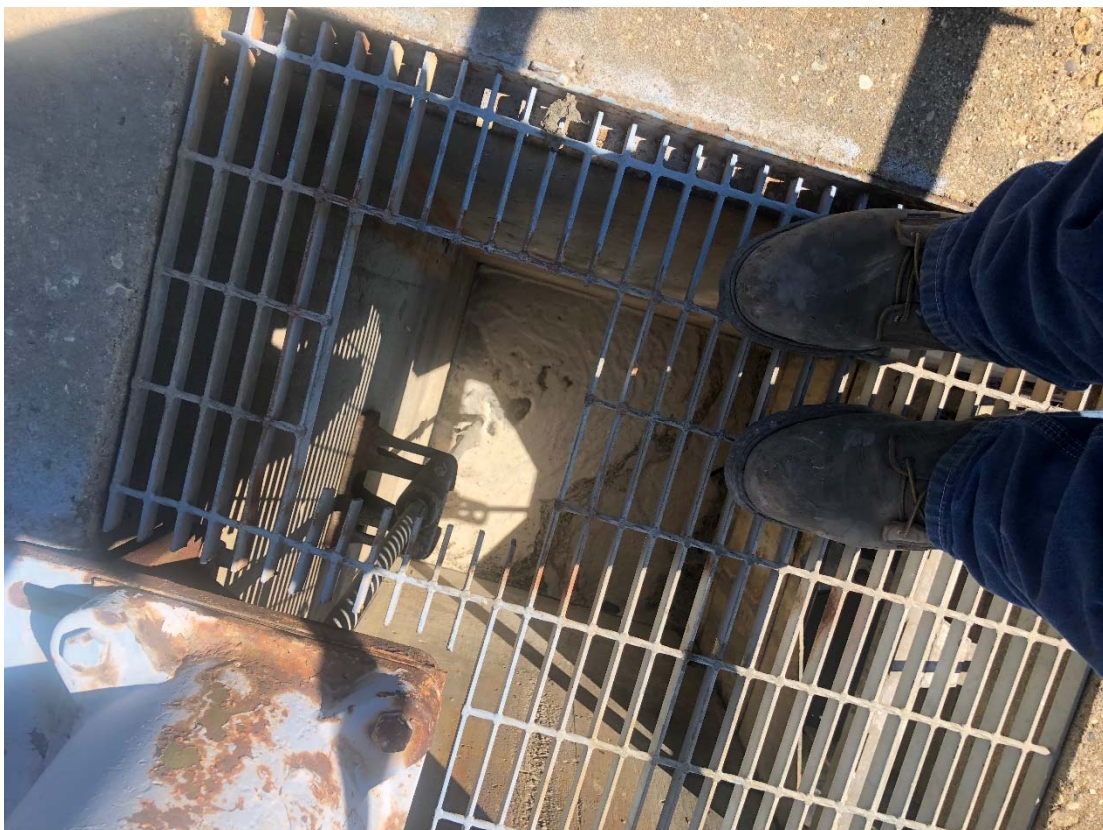
Photograph 4 ▲ - View of grouted Outfall 004 at the Fly Ash Pond.

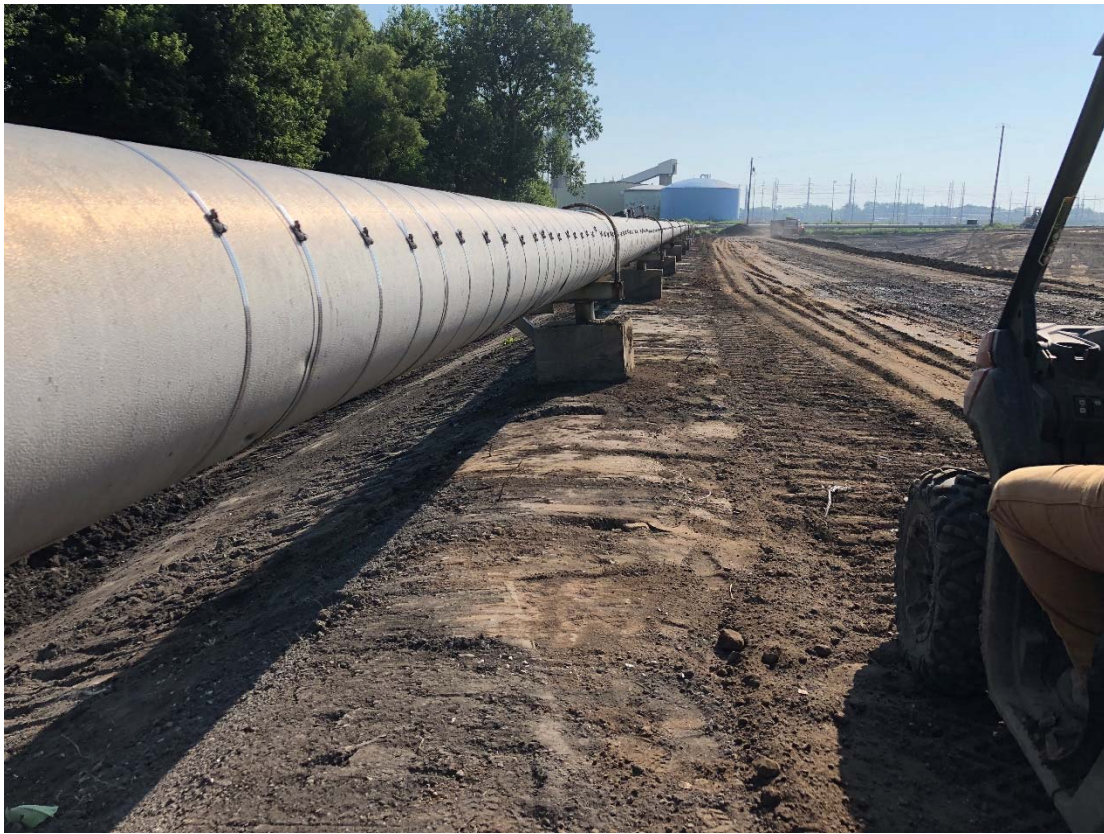
Photograph 5 ▲ - View of Bottom Ash Pond north berm after pipeline clearing activities, looking east.

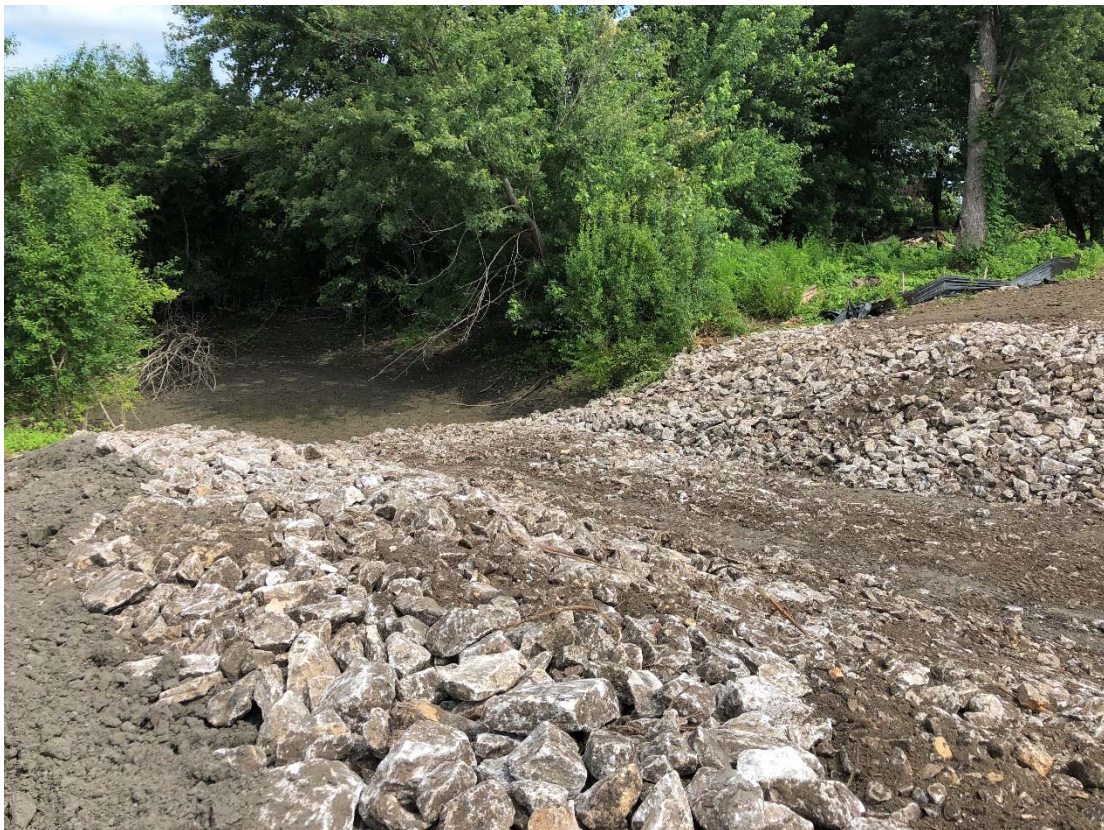
Photograph 6 ▲ - View of Bottom Ash Pond western swale, looking north.

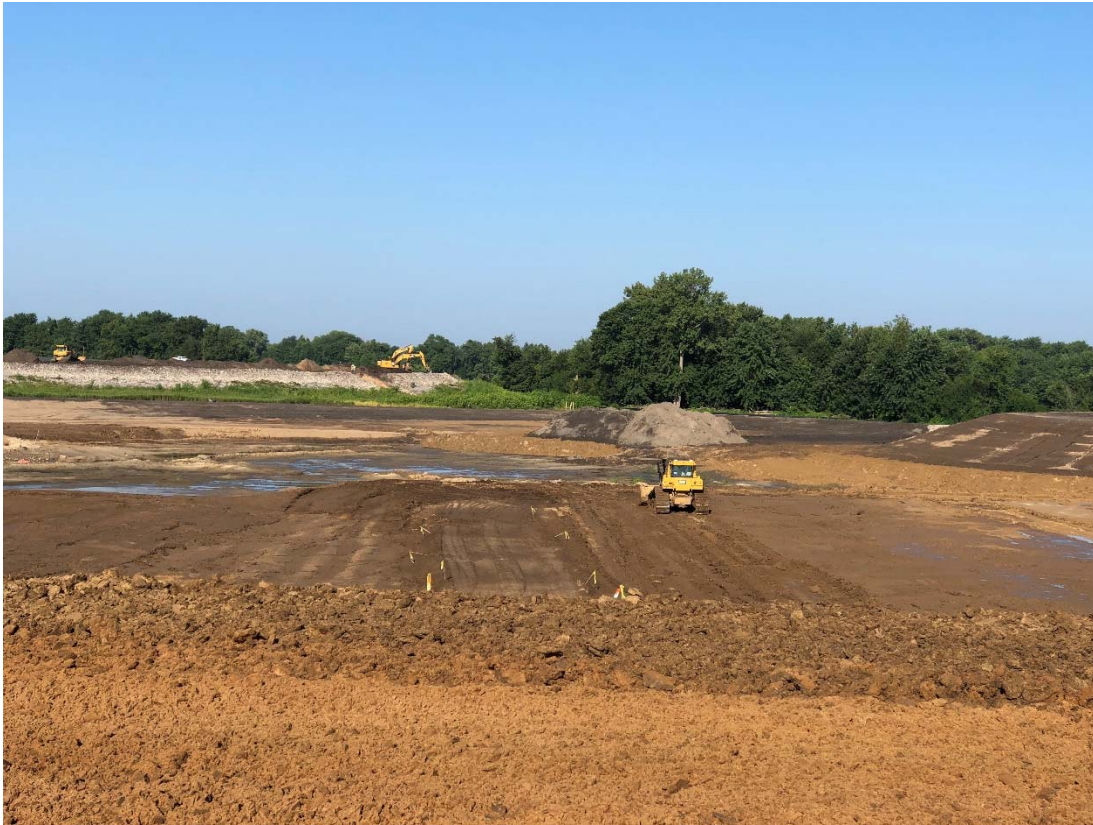
Photograph 1 ▲ - View of Bottom Ash Pond floor fill activities, looking northwest.

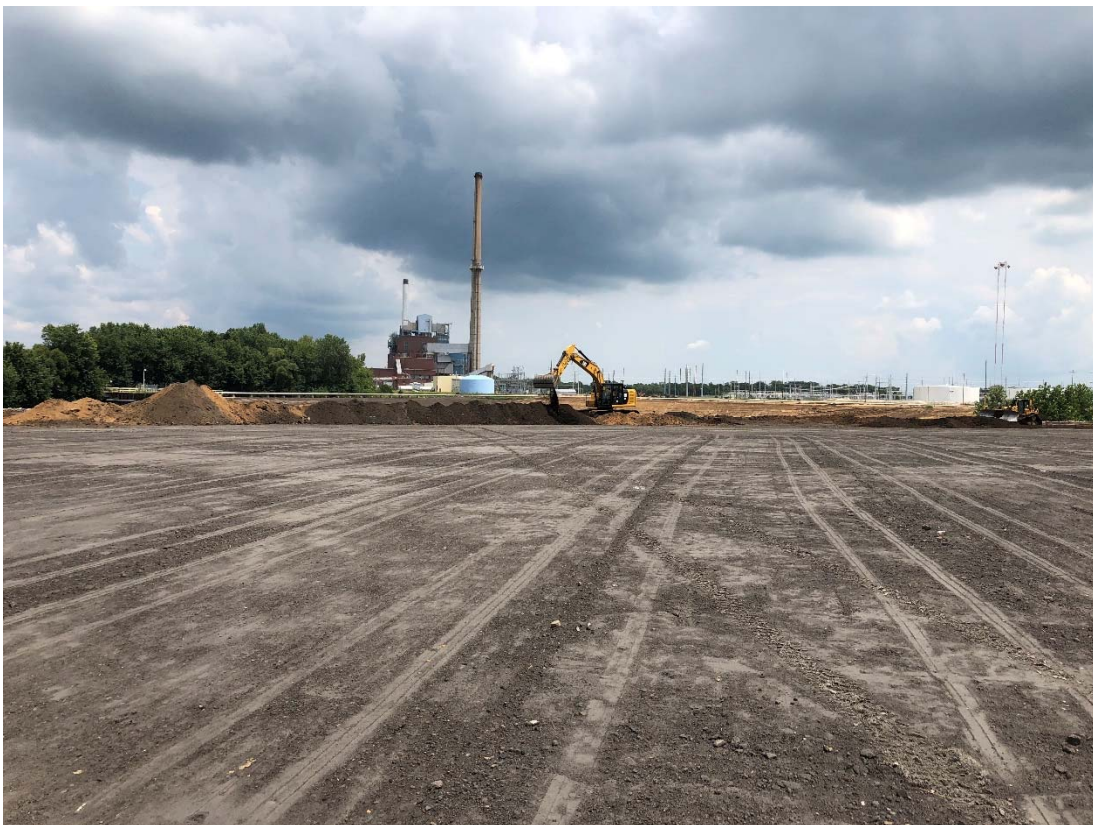
Photograph 2 ▲ - View of drainage excavation activities at the Fly Ash Pond, looking northeast.

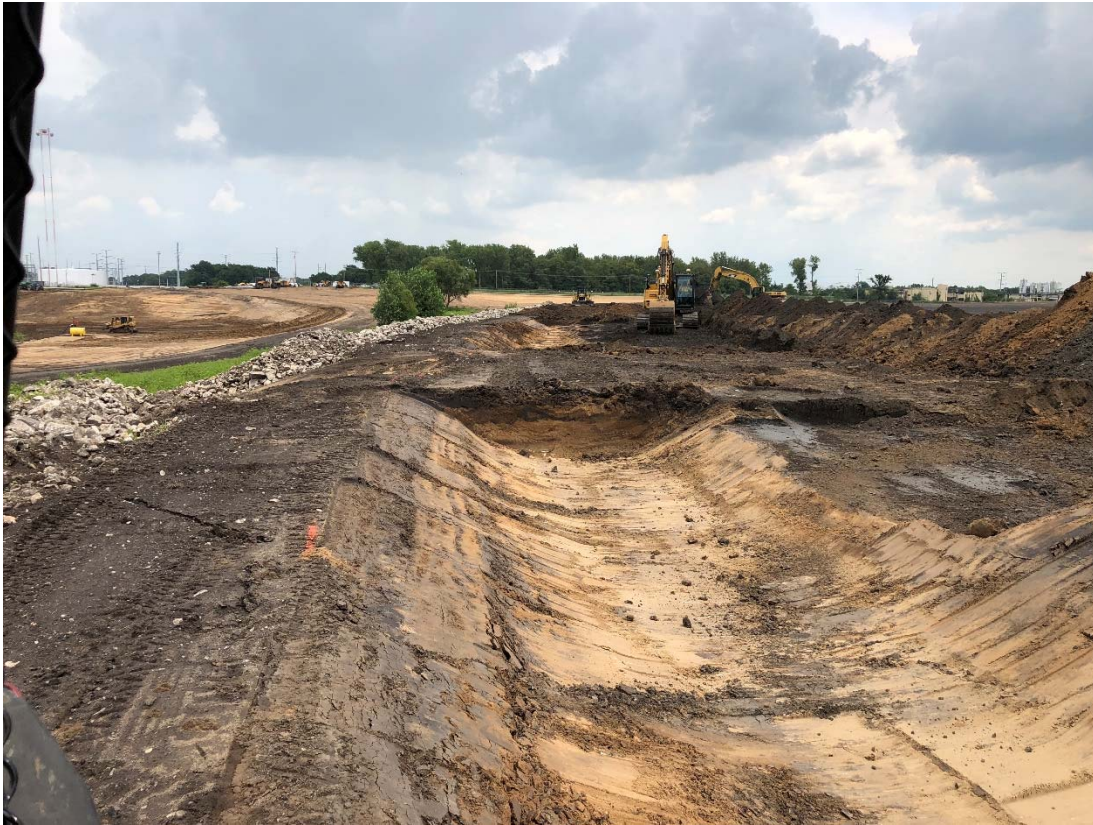
Photograph 3 ▲ - View of drainage excavation activities at the Fly Ash Pond, looking east.

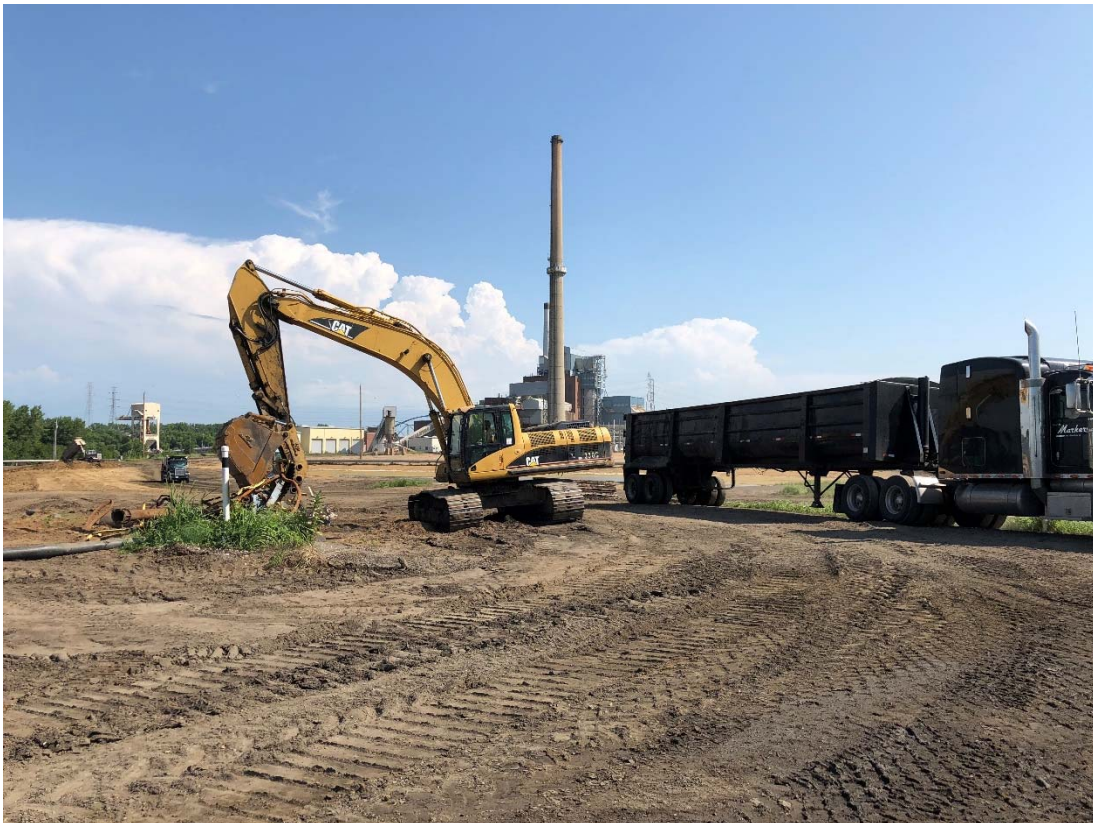
Photograph 4 ▲ - View of scrap removal activities, looking northeast.

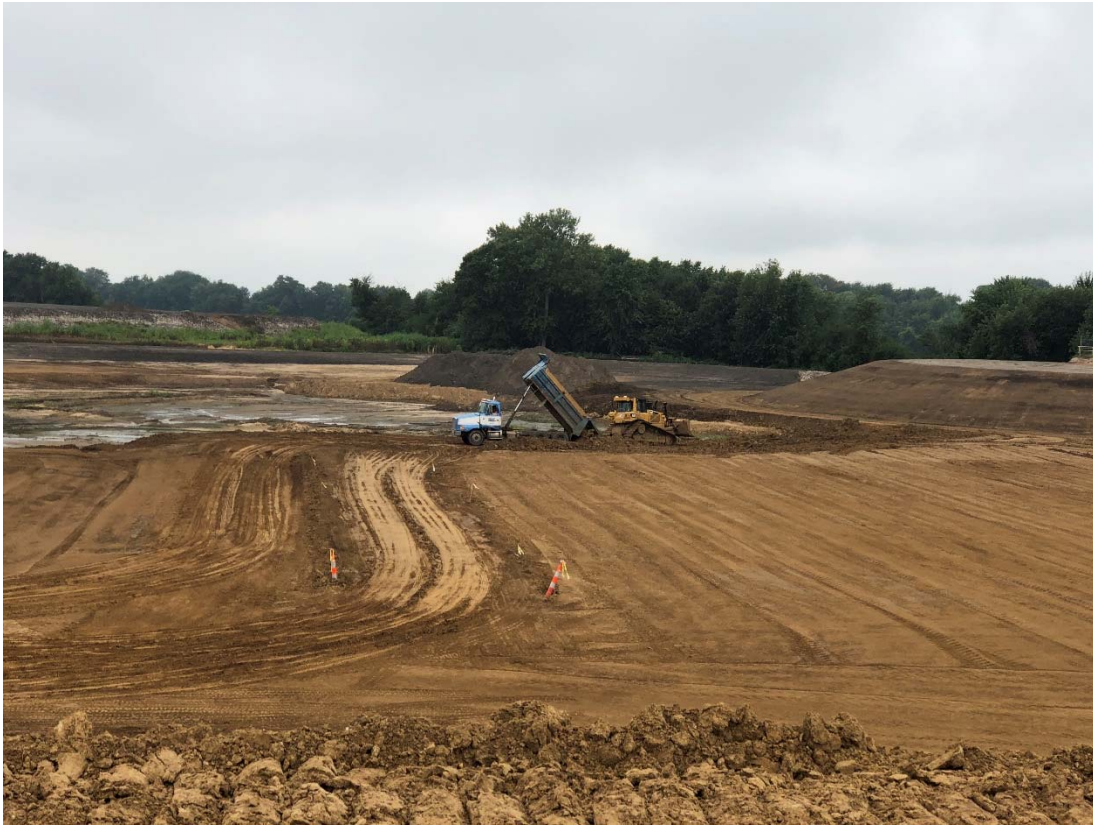
Photograph 1 ▲ - View of Bottom Ash Pond floor fill activities, looking northwest.

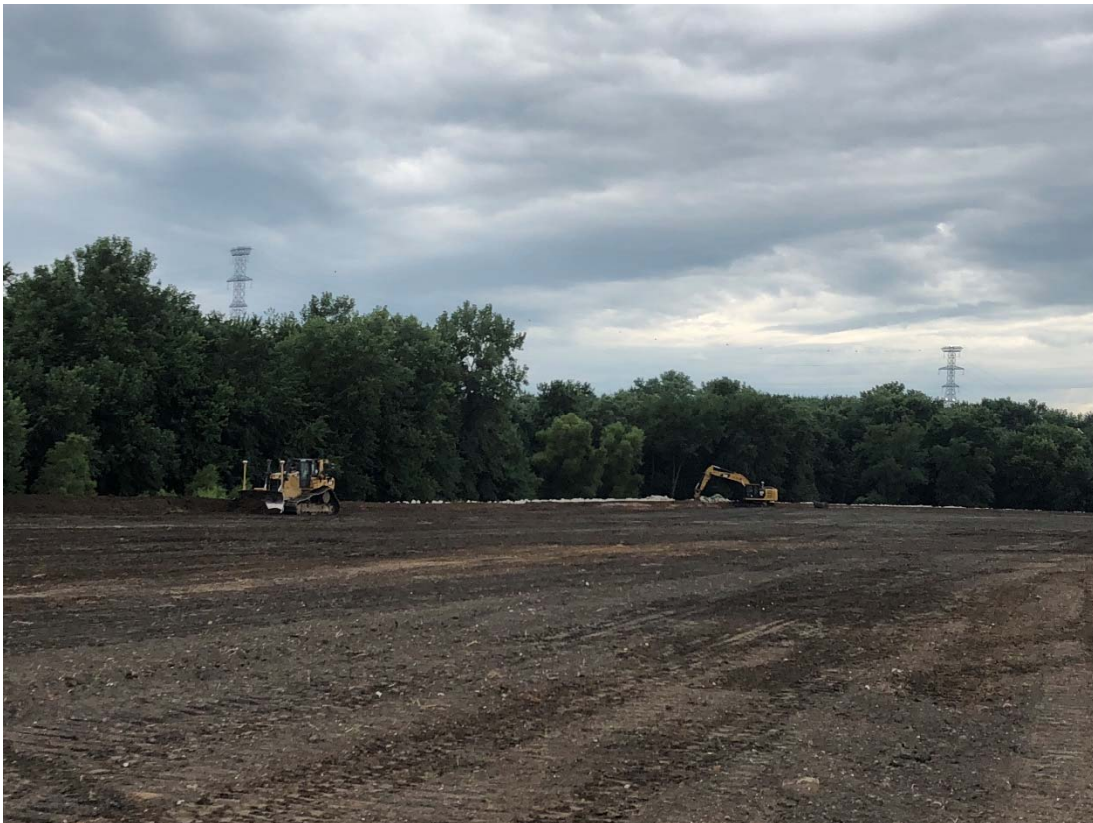
Photograph 2 ▲ - View of drainage excavation activities at the Fly Ash Pond, looking southwest.
