**CONSTRUCTION QUALITY ASSURANCE REPORT
CLOSURE OF THE BOTTOM ASH POND
AND FLY ASH POND
MEREDOSIA POWER STATION
800 SOUTH WASHINGTON STREET
MEREDOSIA, MORGAN COUNTY, ILLINOIS**

**AMEREN ENERGY RESOURCES
ST. LOUIS, MISSOURI**

**GEOTECHNOLOGY, INC.
ST. LOUIS, MISSOURI**

JANUARY 18, 2019

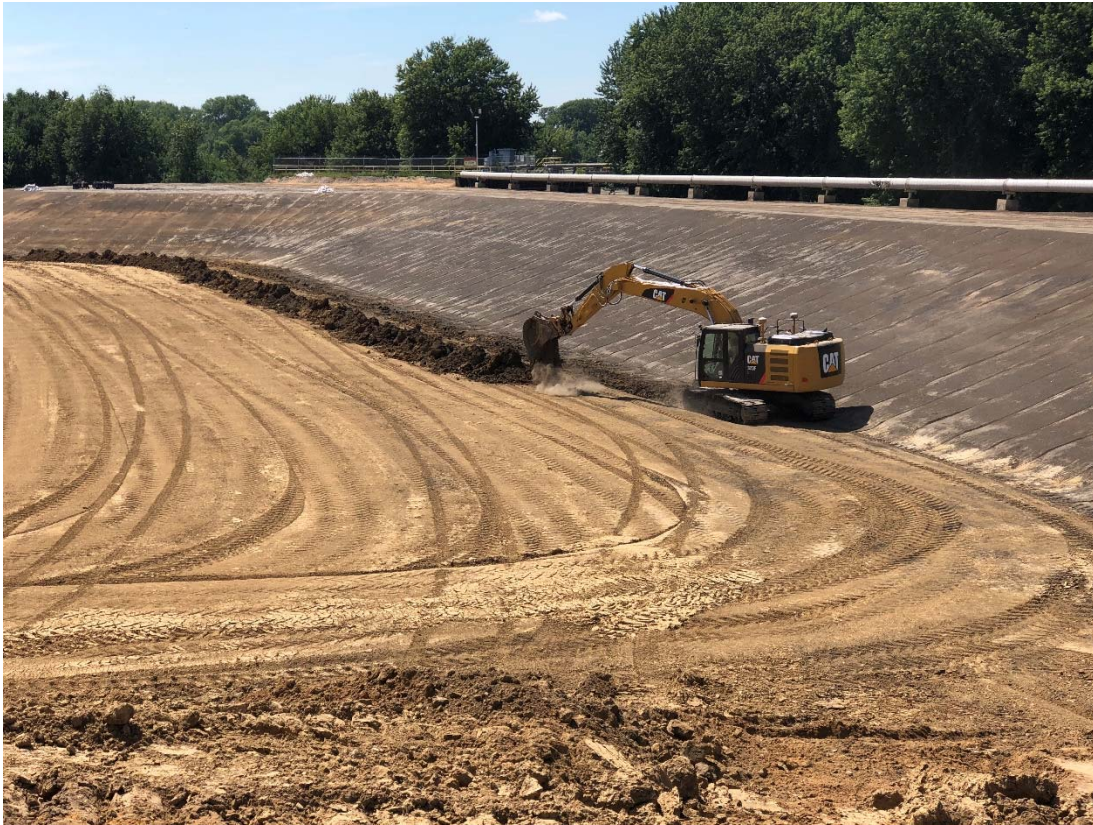
Photograph 3 ▲ - View of anchor trench excavation activities at the Bottom Ash Berm, looking west.

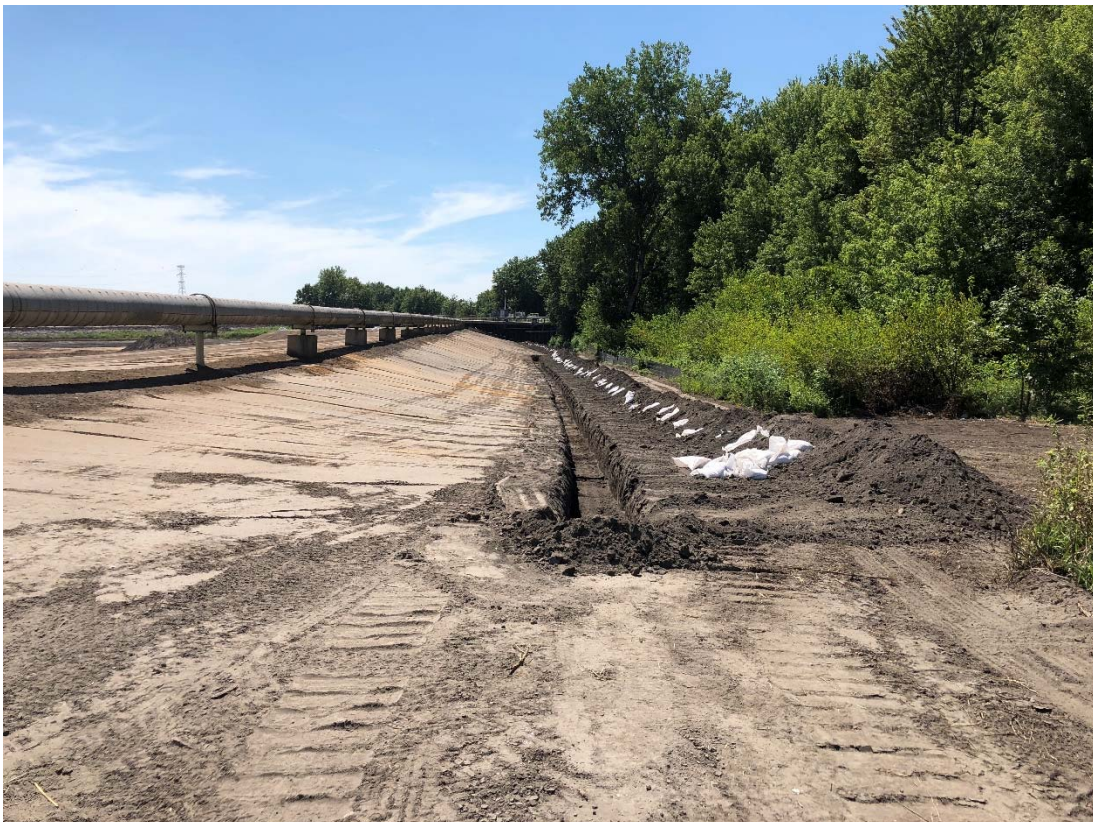
Photograph 4 ▲ - View of anchor trench at the Bottom Ash Berm, looking west.

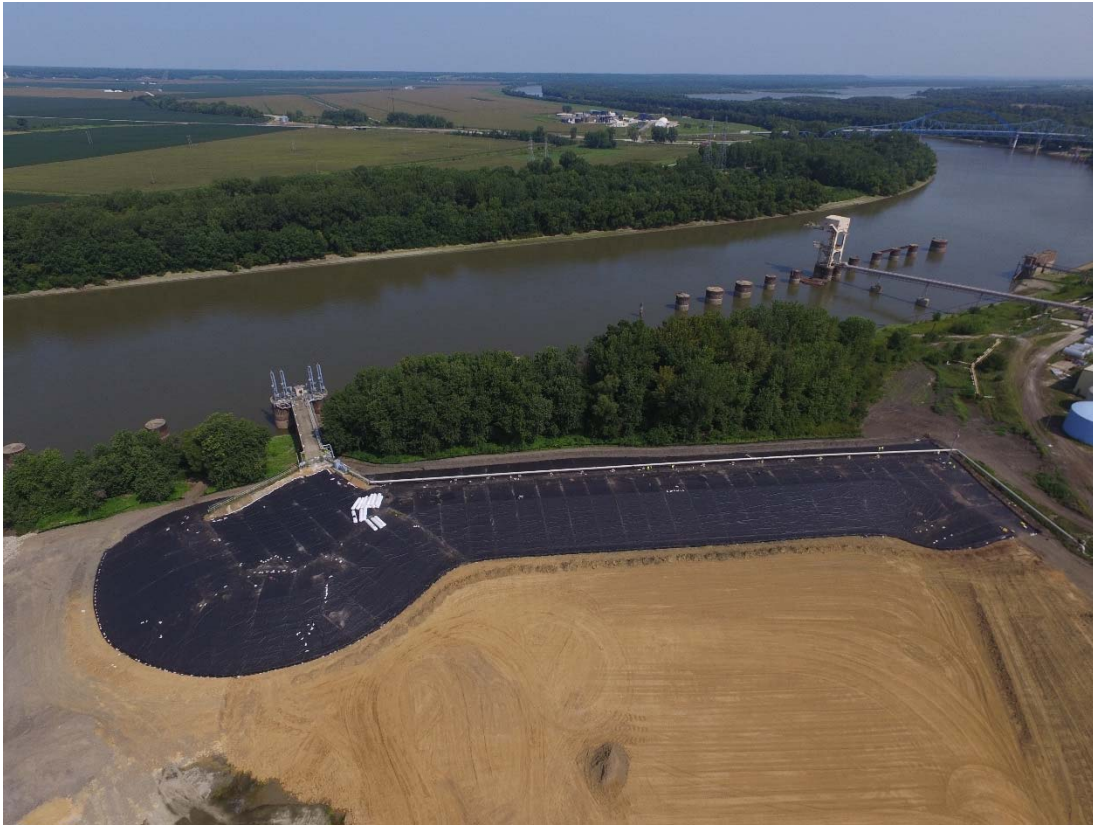
Photograph 5 ▲ - Aerial view of geomembrane at the Bottom Ash Berm, looking northwest. Photograph provided by GSI.

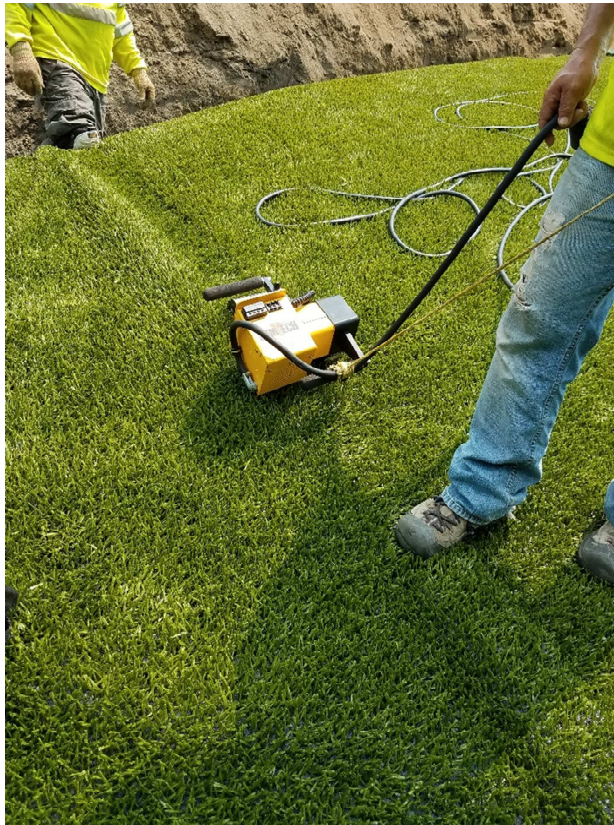
Photograph 1

- View of turf seaming at Bottom Ash Berm.

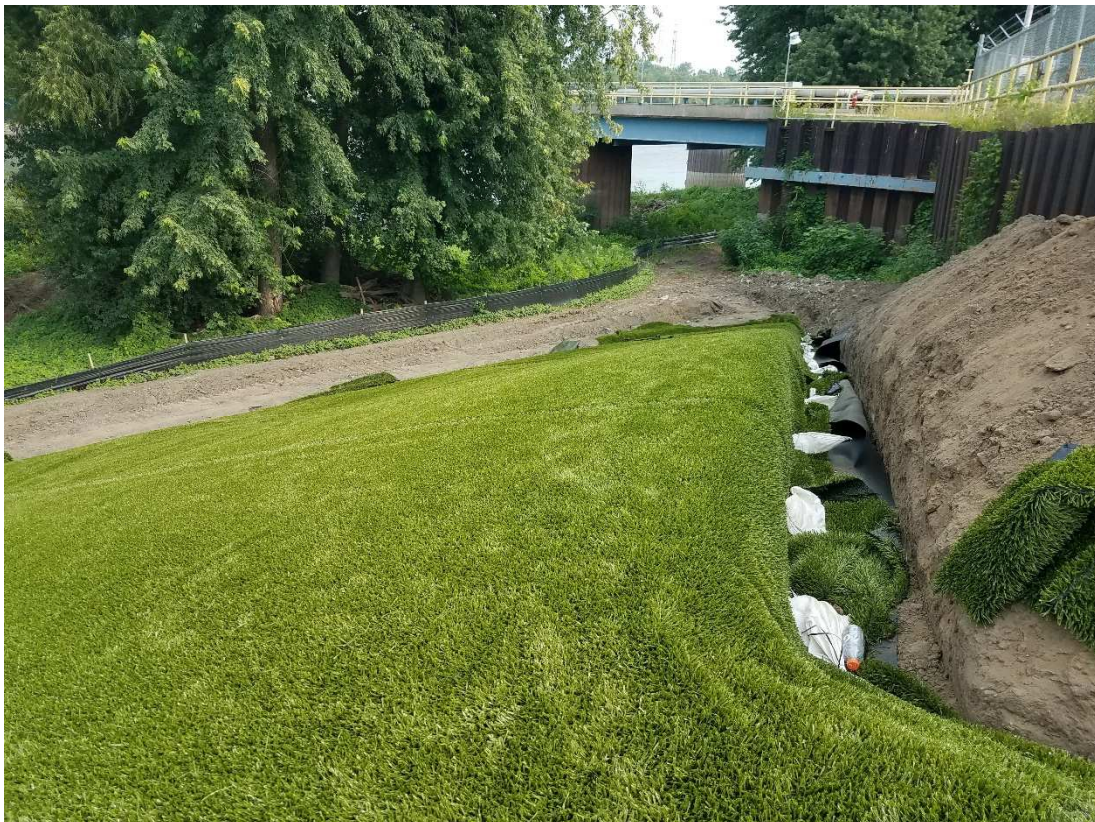
Photograph 4 ▲ - View of anchor trench at the Bottom Ash Berm, looking northwest.

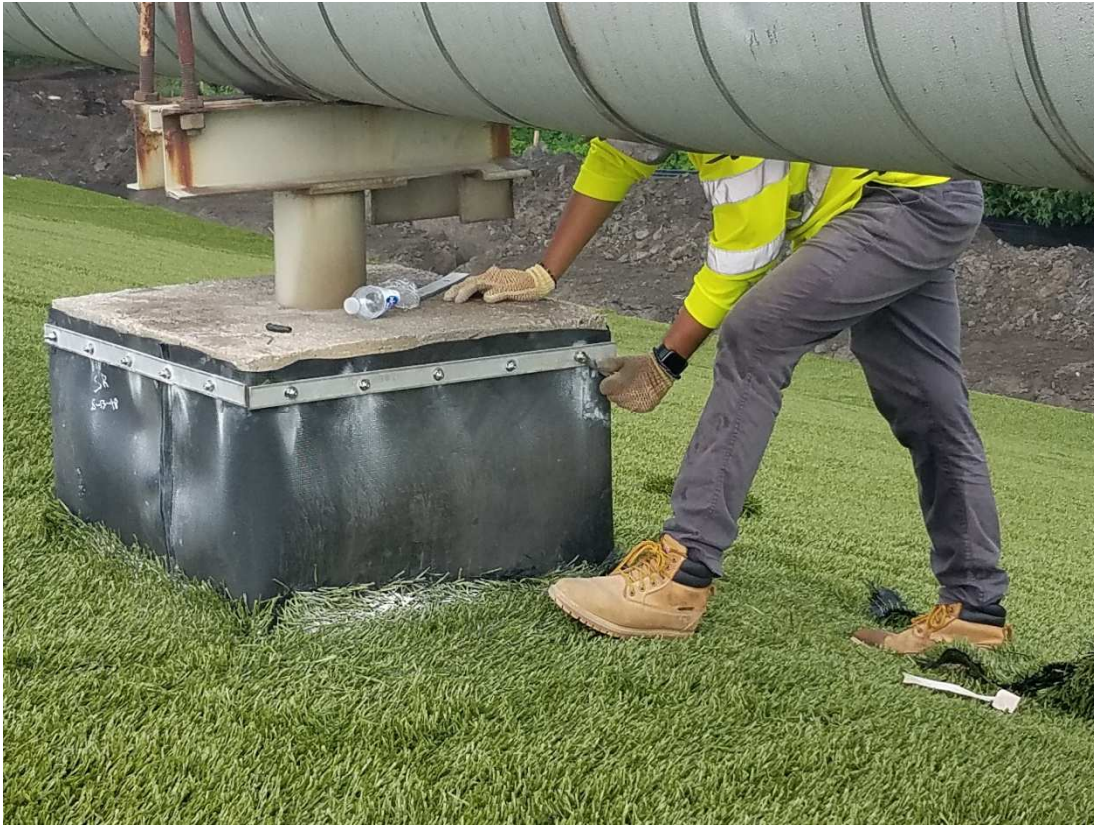
Photograph 5 ▲ - View of pipeline batten at the Bottom Ash Berm, looking southwest.

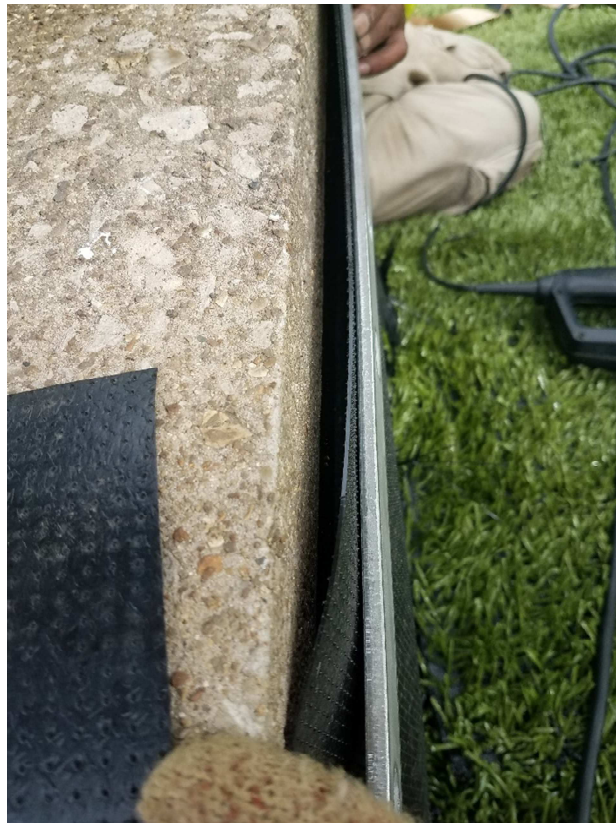
Photograph 6 ▲ - View of pipeline seal detail at Bottom Ash Berm.

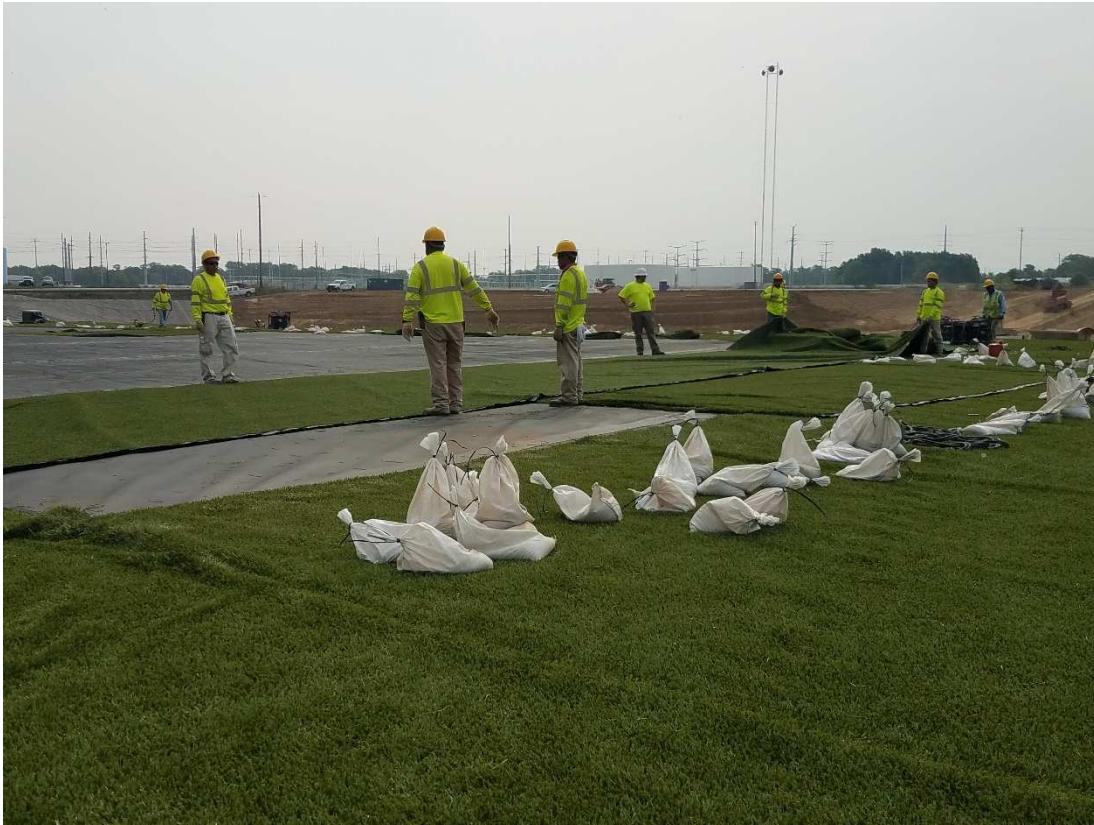
Photograph 7 ▲ - View of turf placement activities at the Bottom Ash Berm, looking northeast.

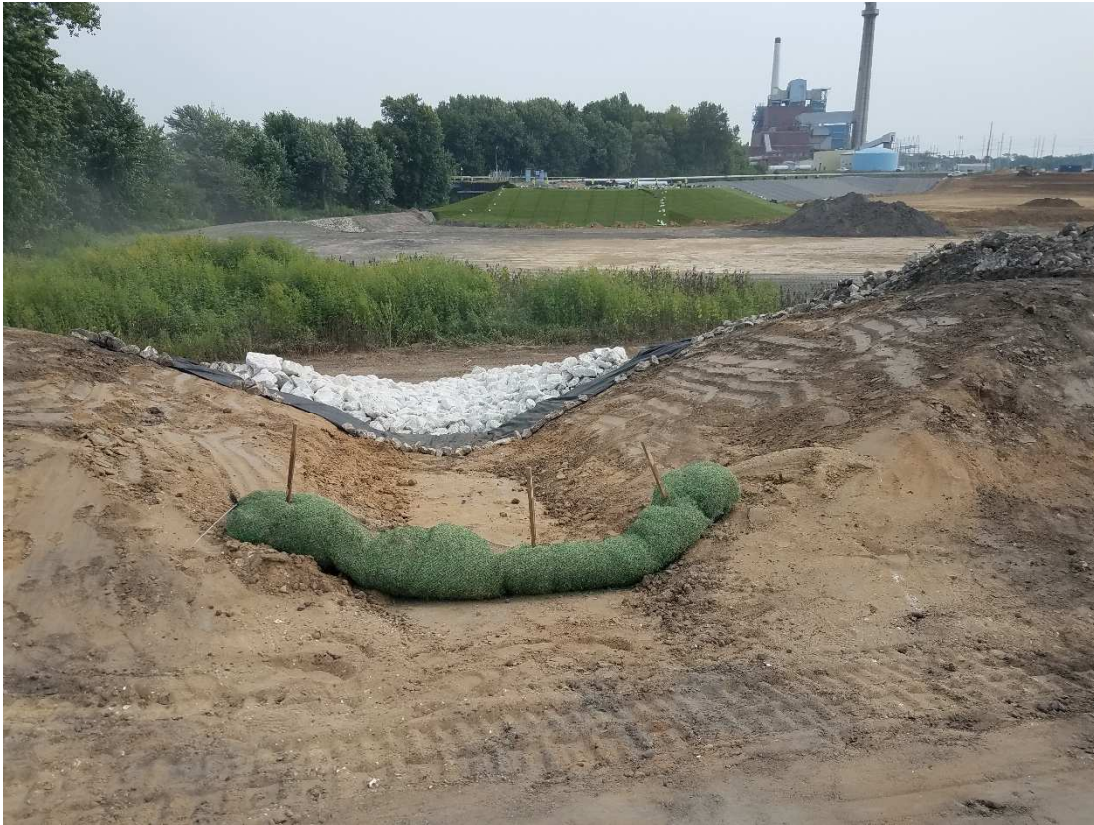
Photograph 9 ▲ - View of downlet at Fly Ash Pond, looking north.

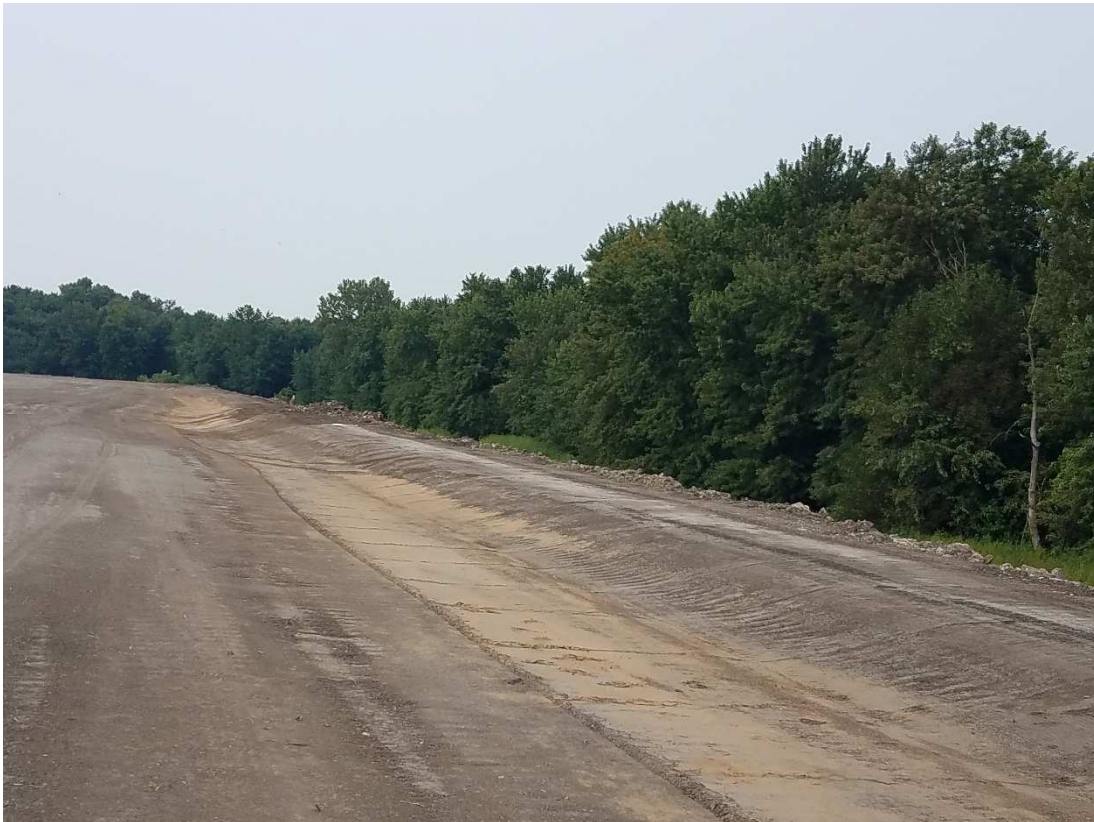
Photograph 10 ▲ - View of final outside ditch at the Fly Ash Pond, looking south.

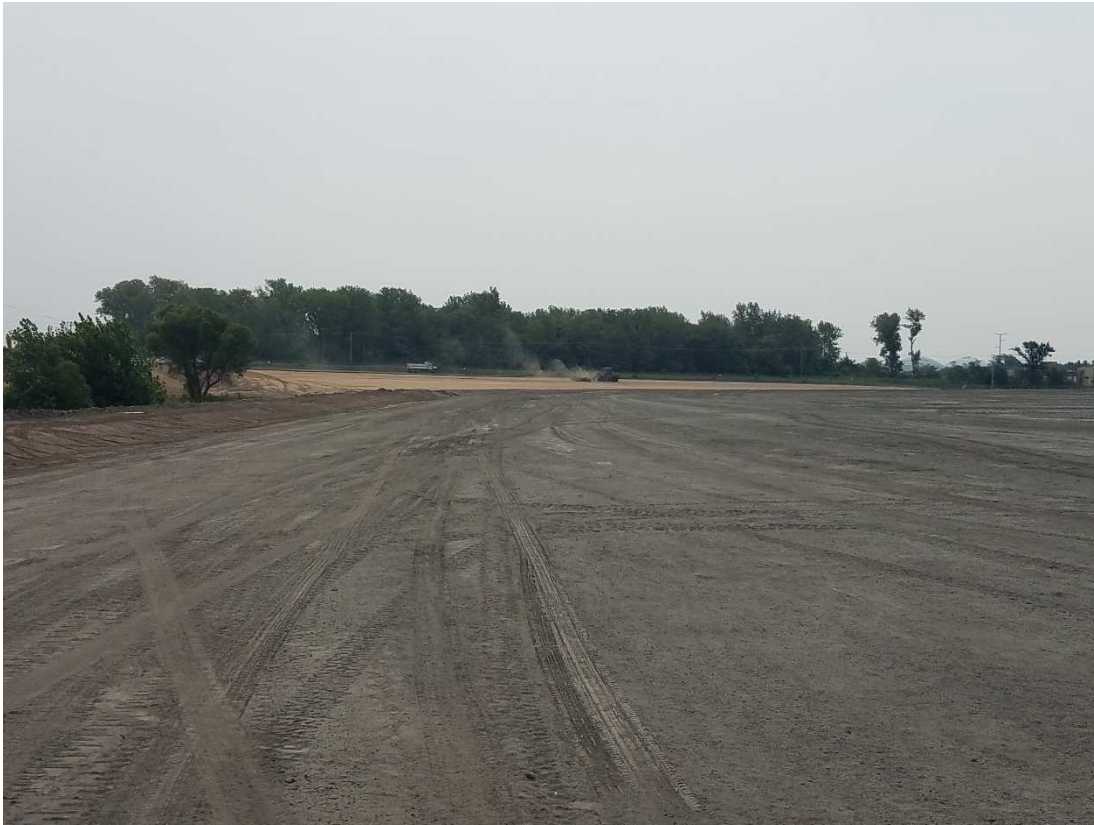
Photograph 11 ▲ - View of Fly Ash Pond final grading activities, looking east.

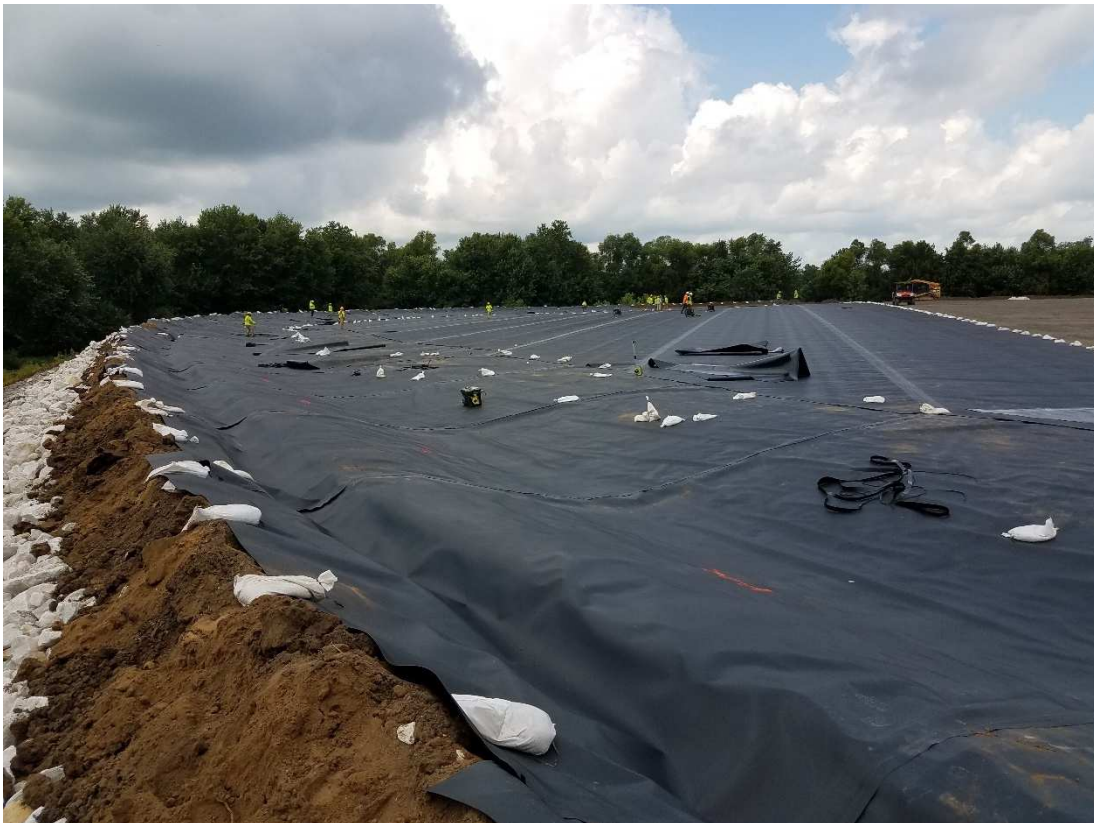
Photograph 12 ▲ - View of geomembrane installation at the Fly Ash Pond, looking northeast.

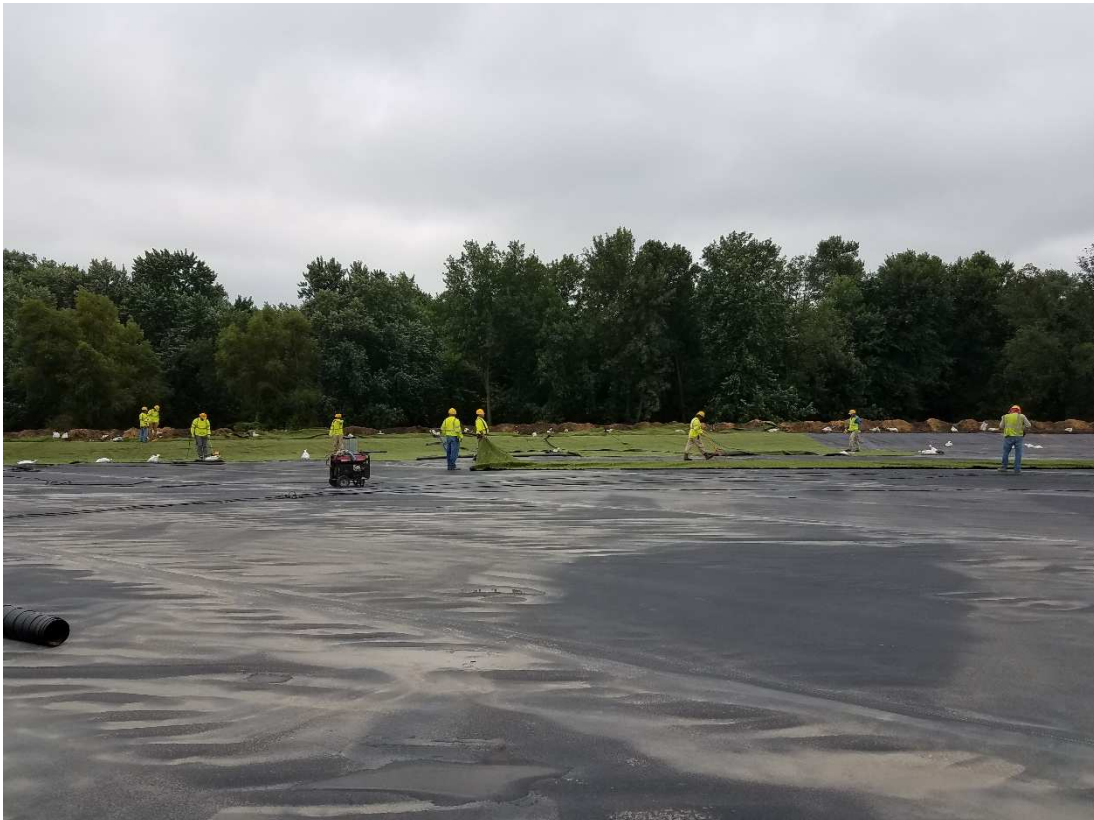
Photograph 2

- Typical view of turf installation, looking west.

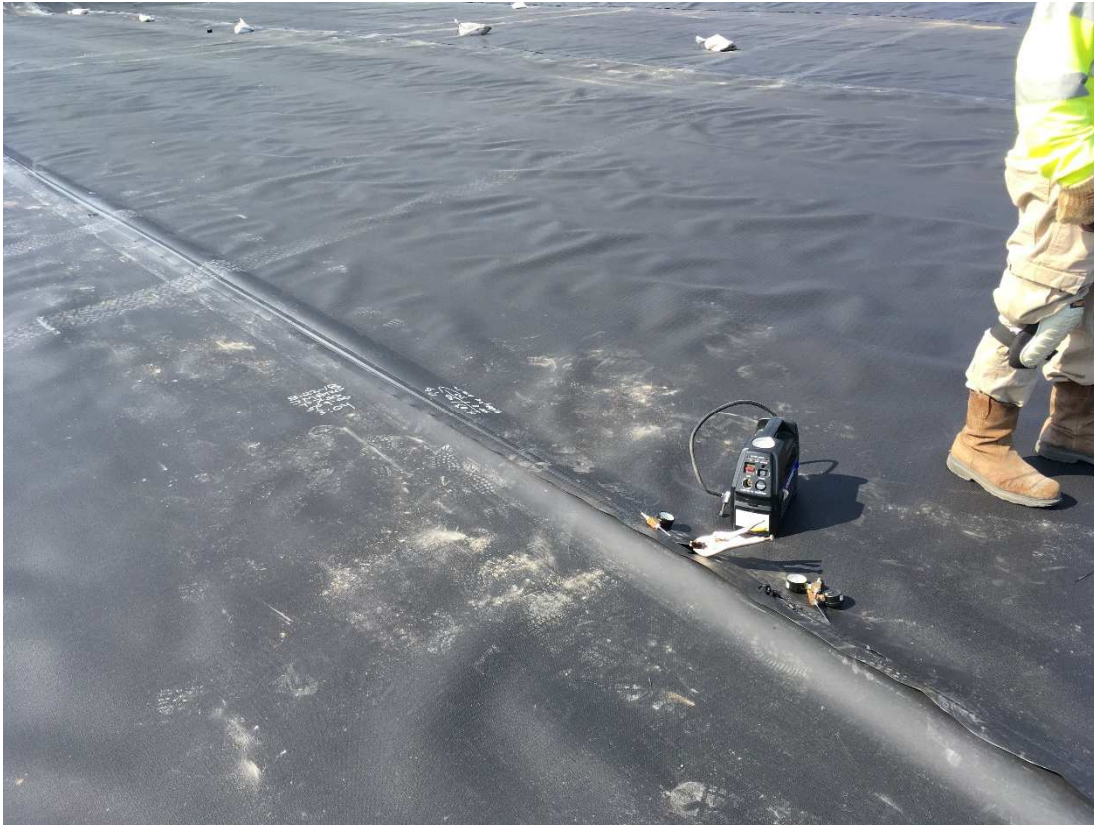
Photograph 3 ▲ - Typical view of air testing at the Fly Ash Pond.

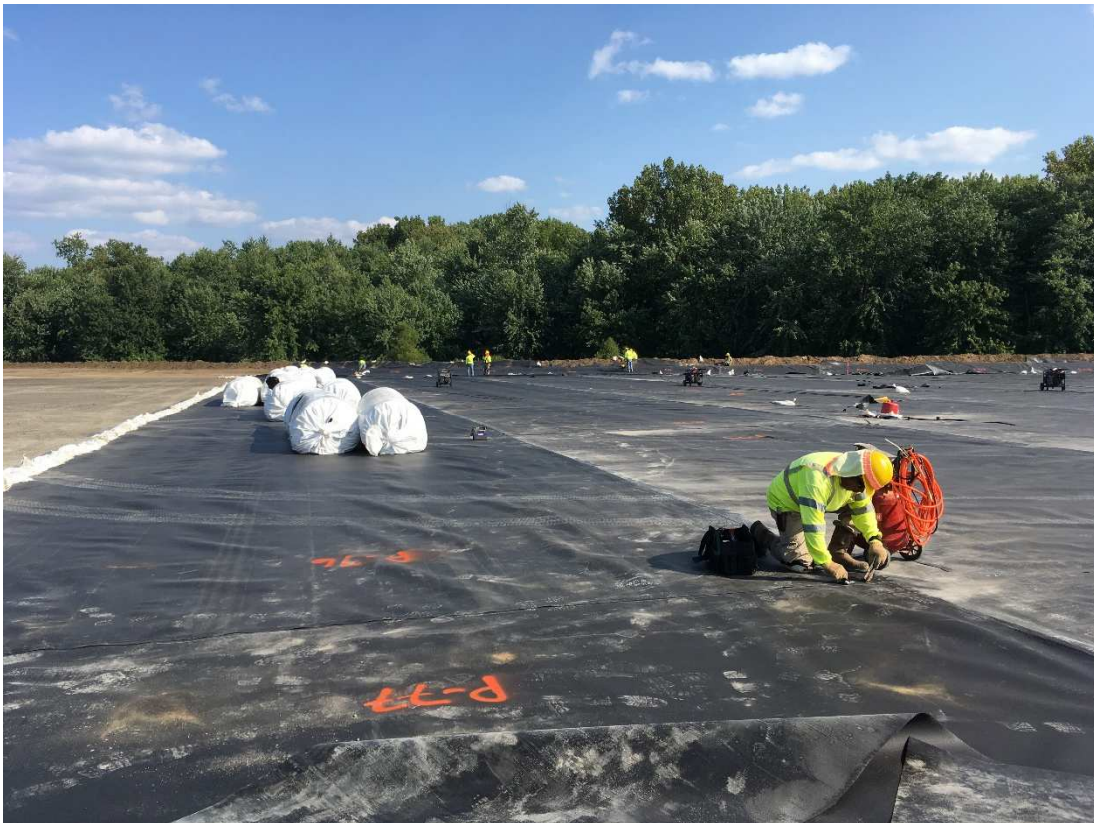
Photograph 4 ▲ - Typical view of geomembrane installation and testing, looking southwest.

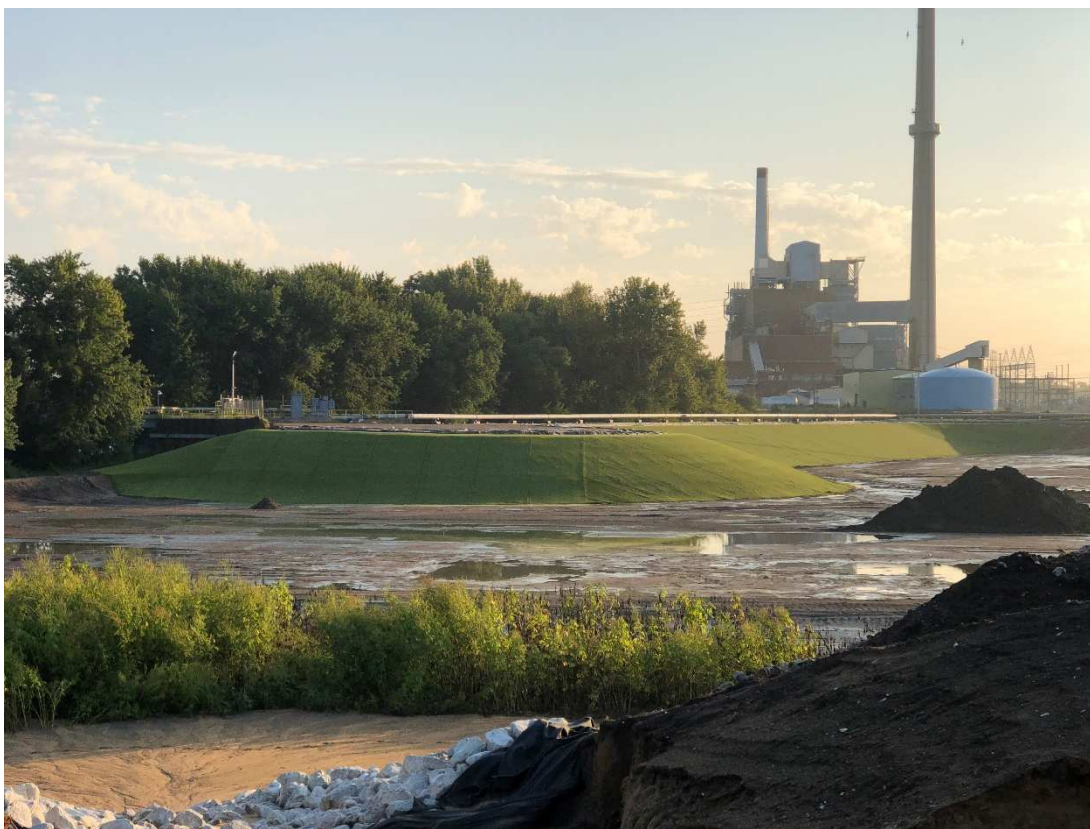
Photograph 4 ▲ - Typical view of Bottom Ash Pond after the rains, looking north.

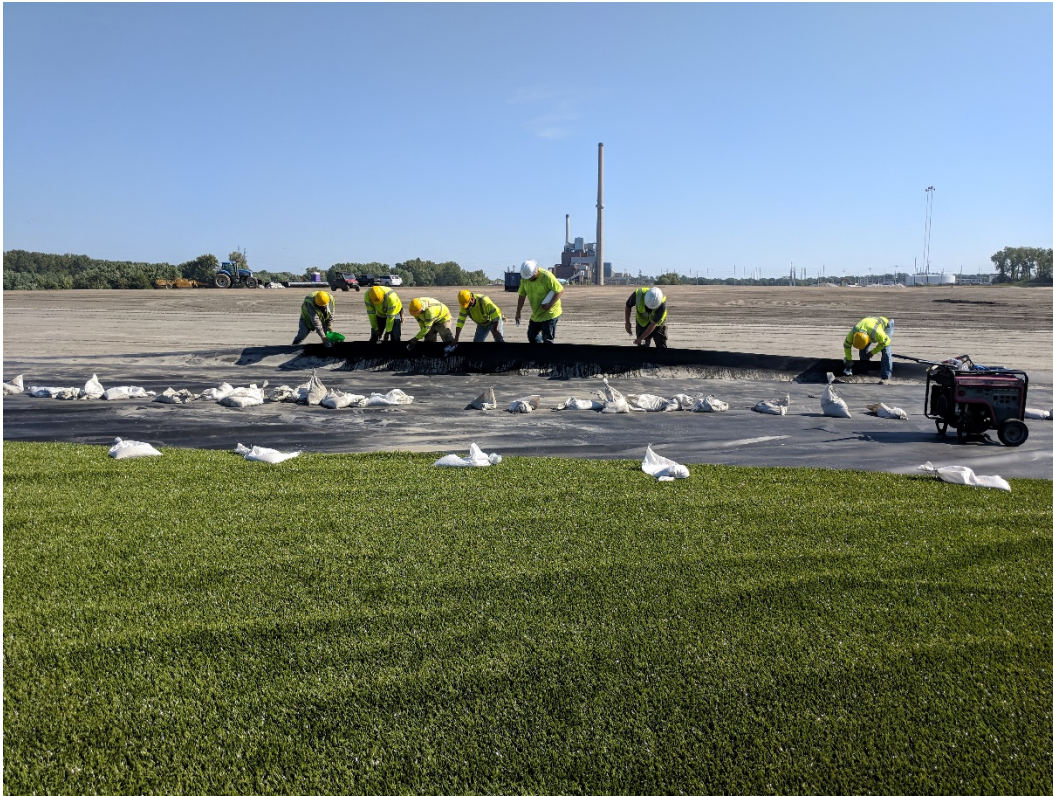
Photograph 5 ▲ - Typical view of liner cleaning activities prior to additional geomembrane installation, looking northeast.

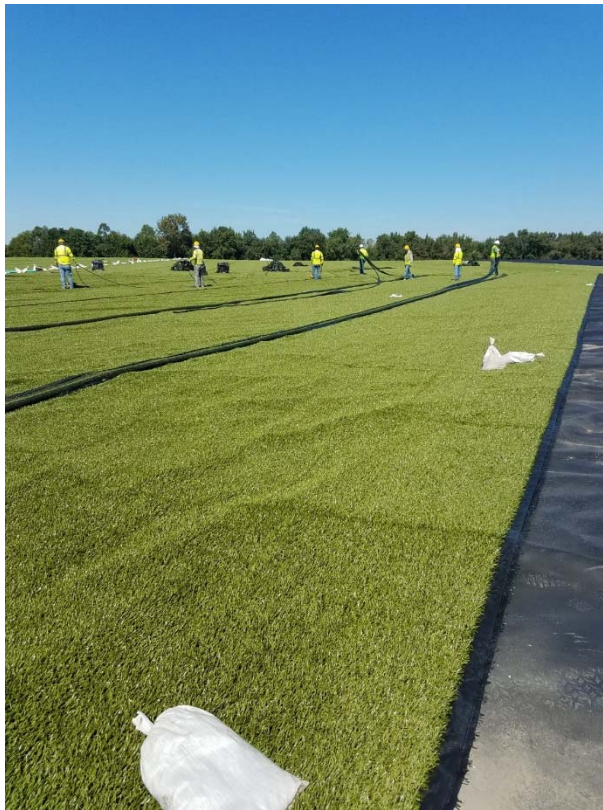
Photograph 1

- View of engineered turf installation activities at the Fly Ash Pond, facing northwest.

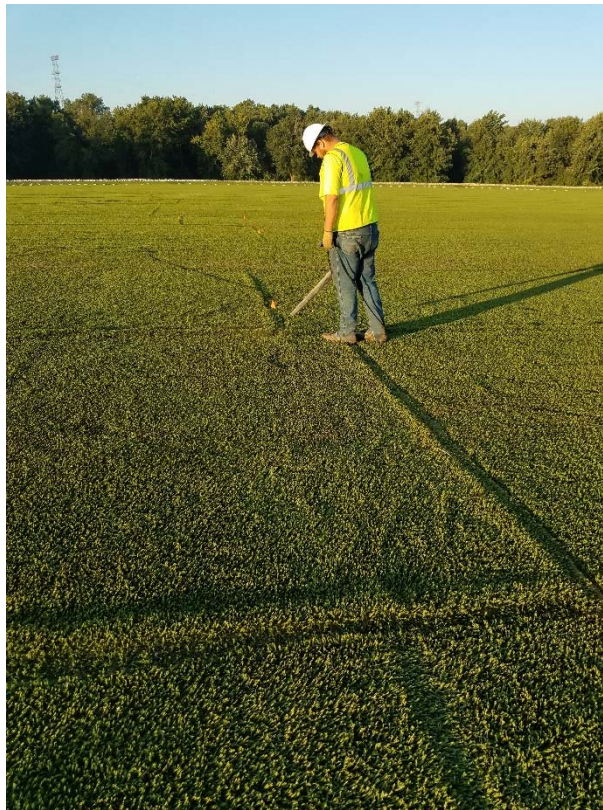
Photograph 3

- View of sand infill removal activities prior to the installation of an engineered turf repair, facing west.

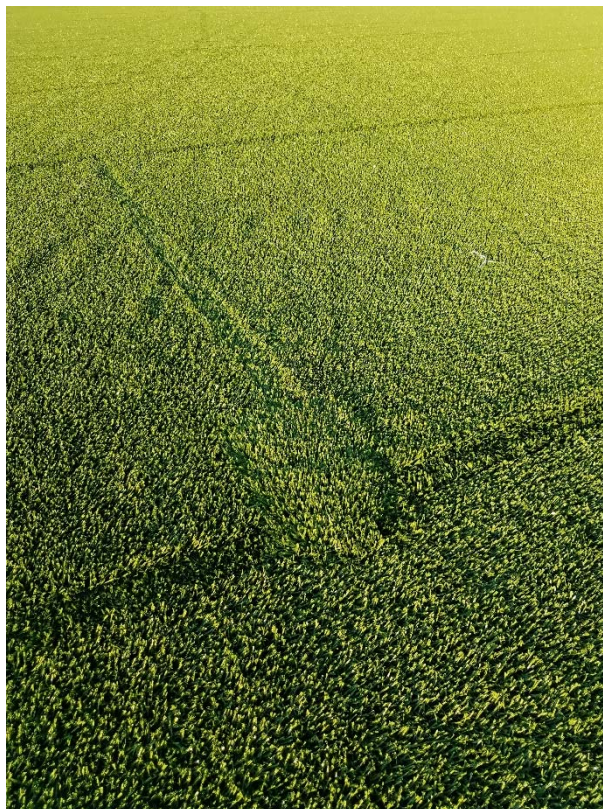
Photograph 4

- View of typical engineered turf patch.

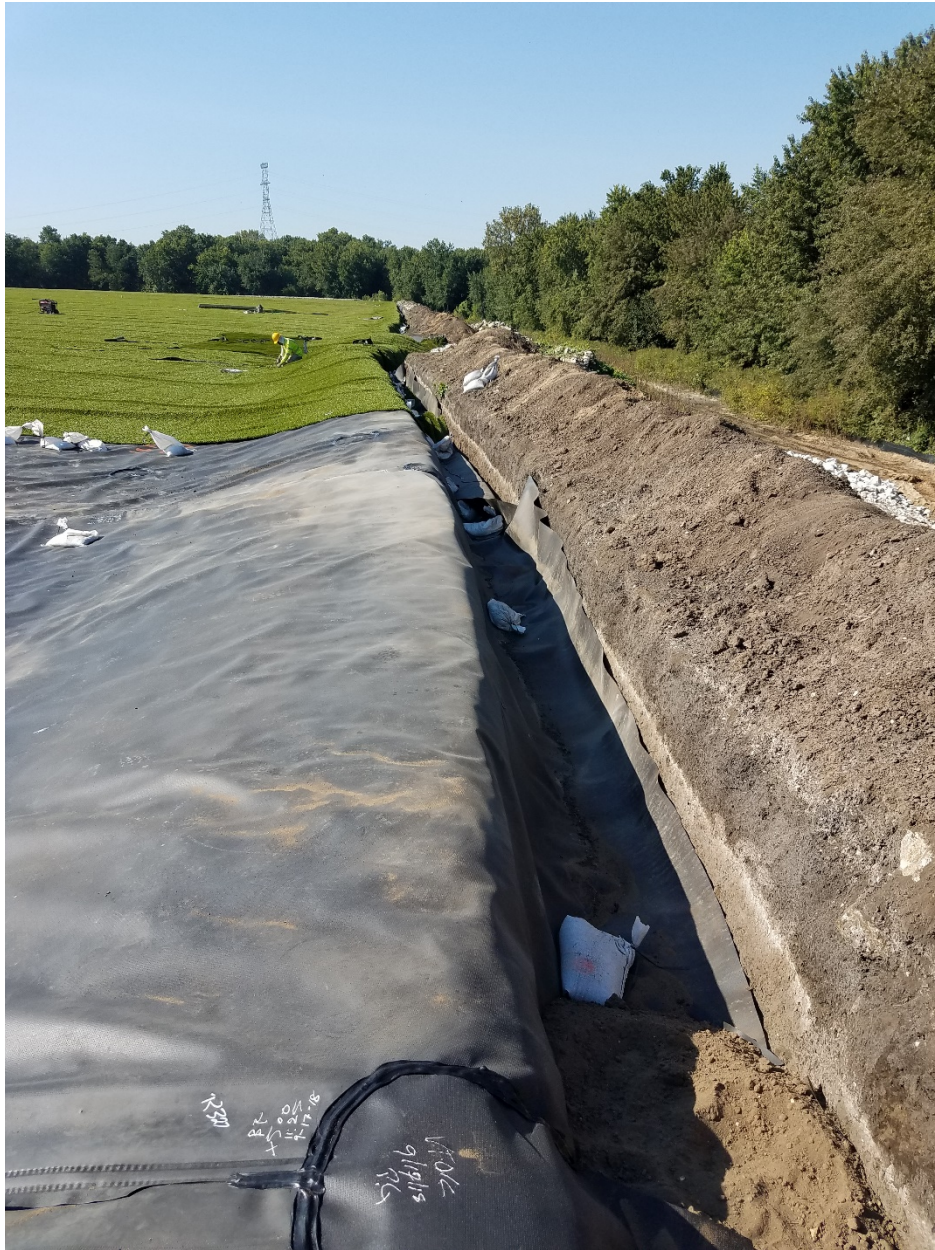
Photograph 1 ▲ - View of anchor trench at the Fly Ash Pond, looking southwest.

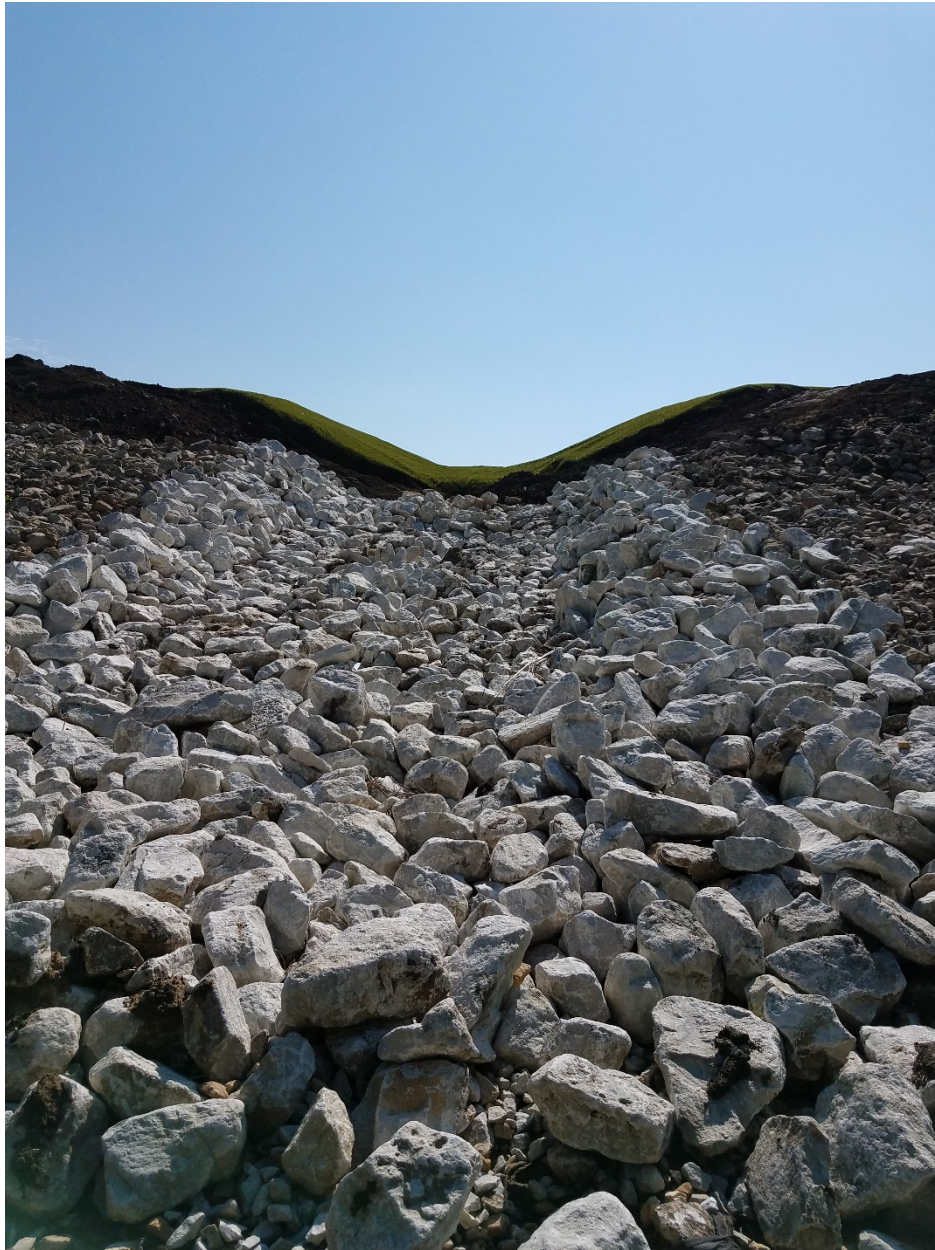
Photograph 2 ▲ - View of downlet structure at the Fly Ash Pond, facing north.

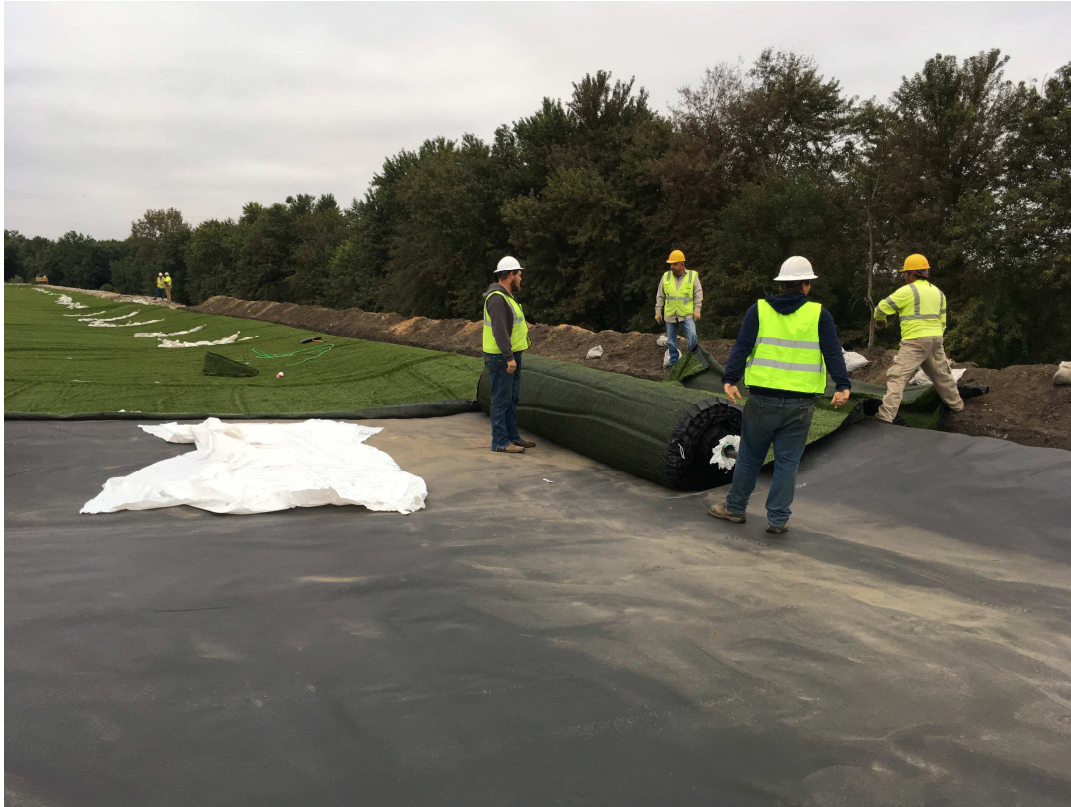
Photograph 1 ▲ - View of typical turf placement at the Fly Ash Pond, looking southwest.

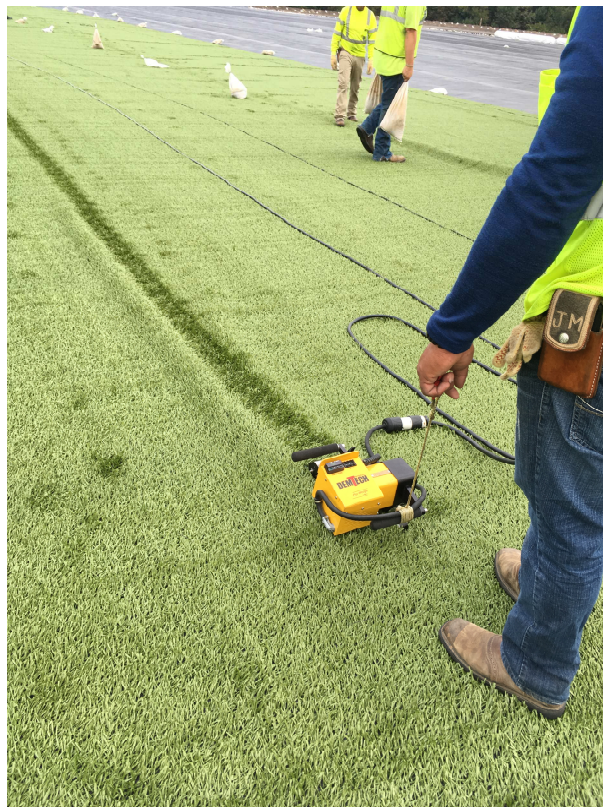
Photograph 2 ▲ - Typical view of turf welding at the Fly Ash Pond.

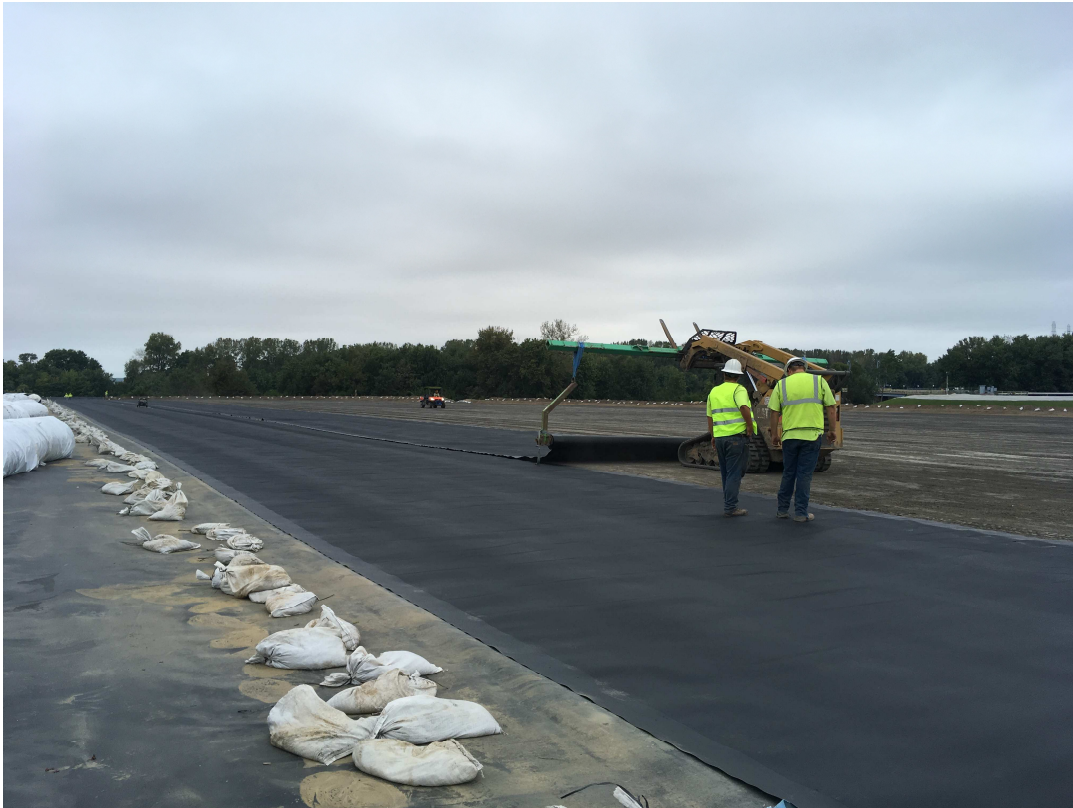
Photograph 3 ▲ - View of HDPE geomembrane placement at the Fly Ash Pond, facing west.

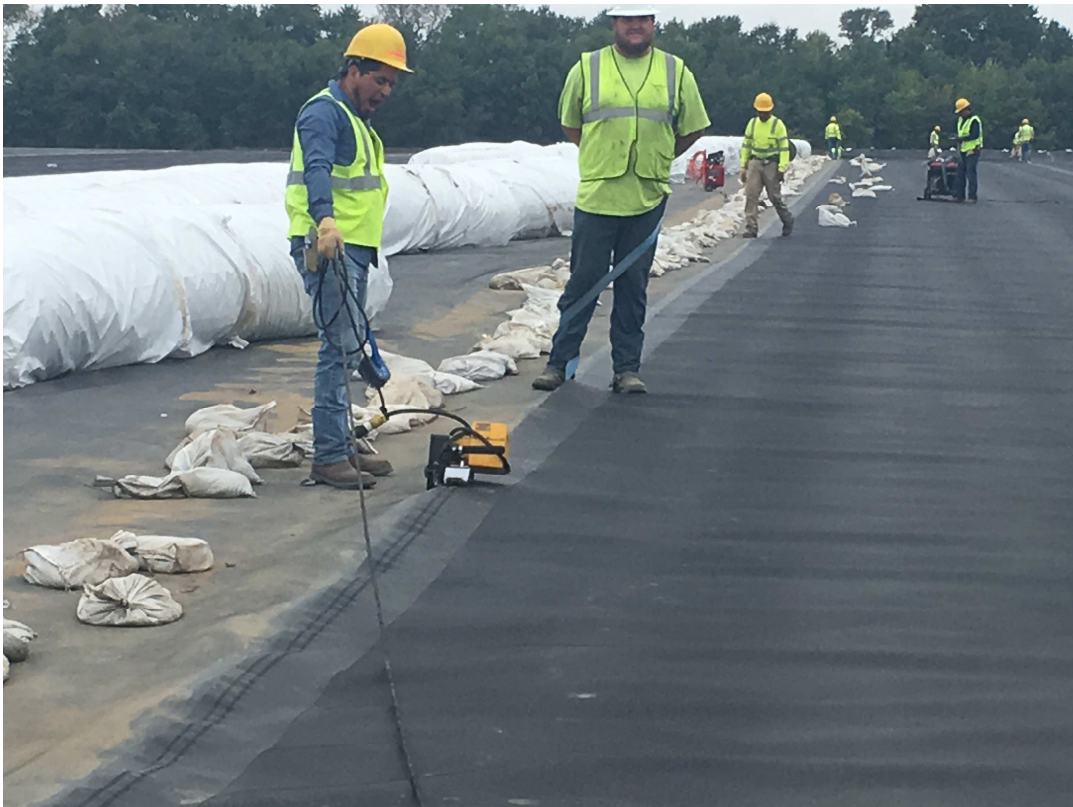
Photograph 4 ▲ - View of typical HDPE geomembrane welding activities, facing northwest.

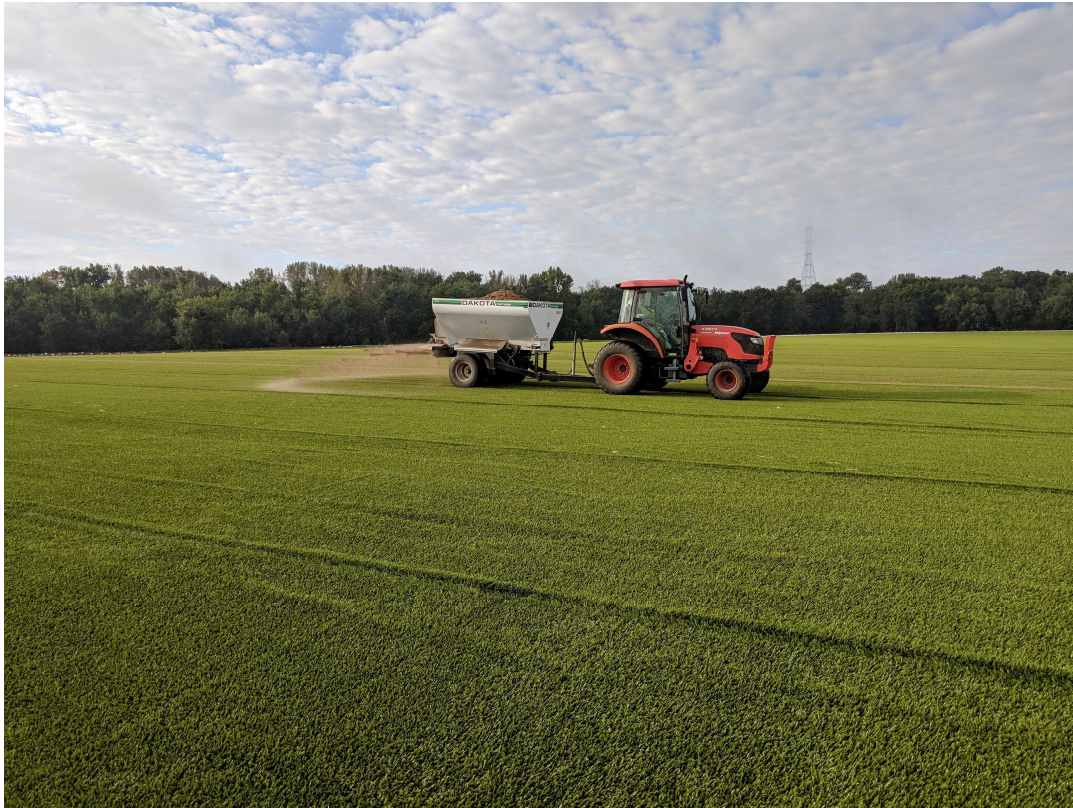
Photograph 5

- View of typical sand placement at the Fly Ash Pond, facing west.
