**CONSTRUCTION QUALITY ASSURANCE REPORT
CLOSURE OF THE BOTTOM ASH POND
AND FLY ASH POND
MEREDOSIA POWER STATION
800 SOUTH WASHINGTON STREET
MEREDOSIA, MORGAN COUNTY, ILLINOIS**

**AMEREN ENERGY RESOURCES
ST. LOUIS, MISSOURI**

**GEOTECHNOLOGY, INC.
ST. LOUIS, MISSOURI**

JANUARY 18, 2019

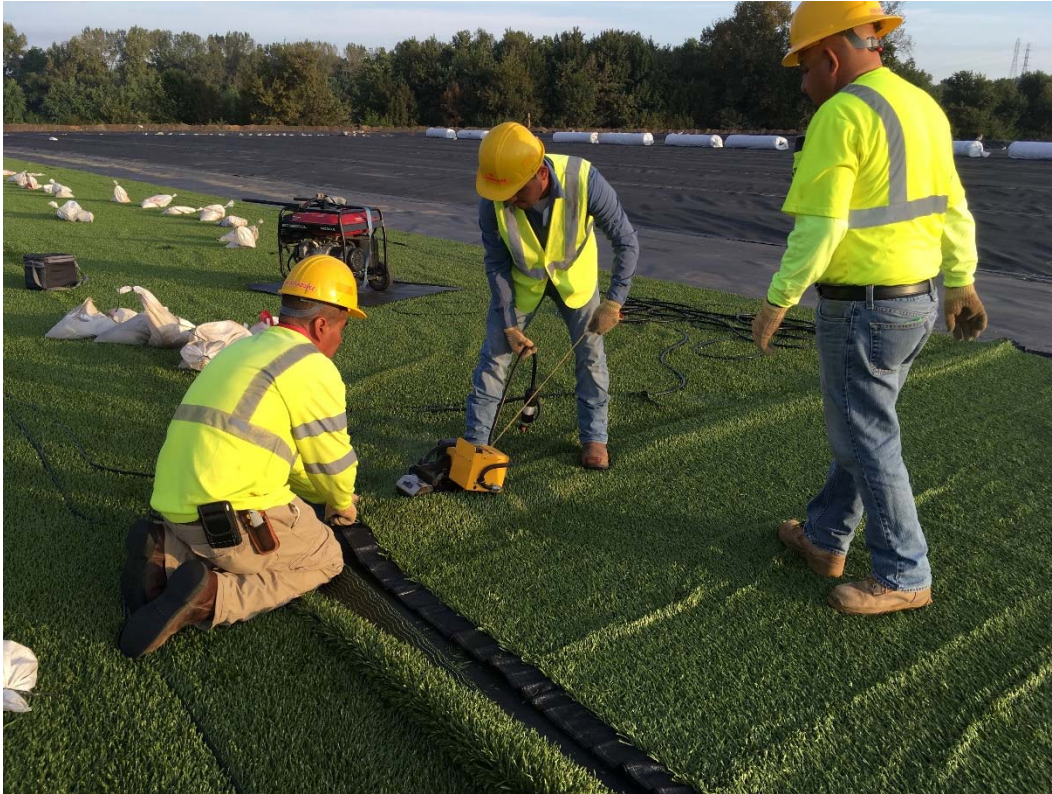
Photograph 1 ▲ - Typical view of engineered turf welding at the Fly Ash Pond, facing north.

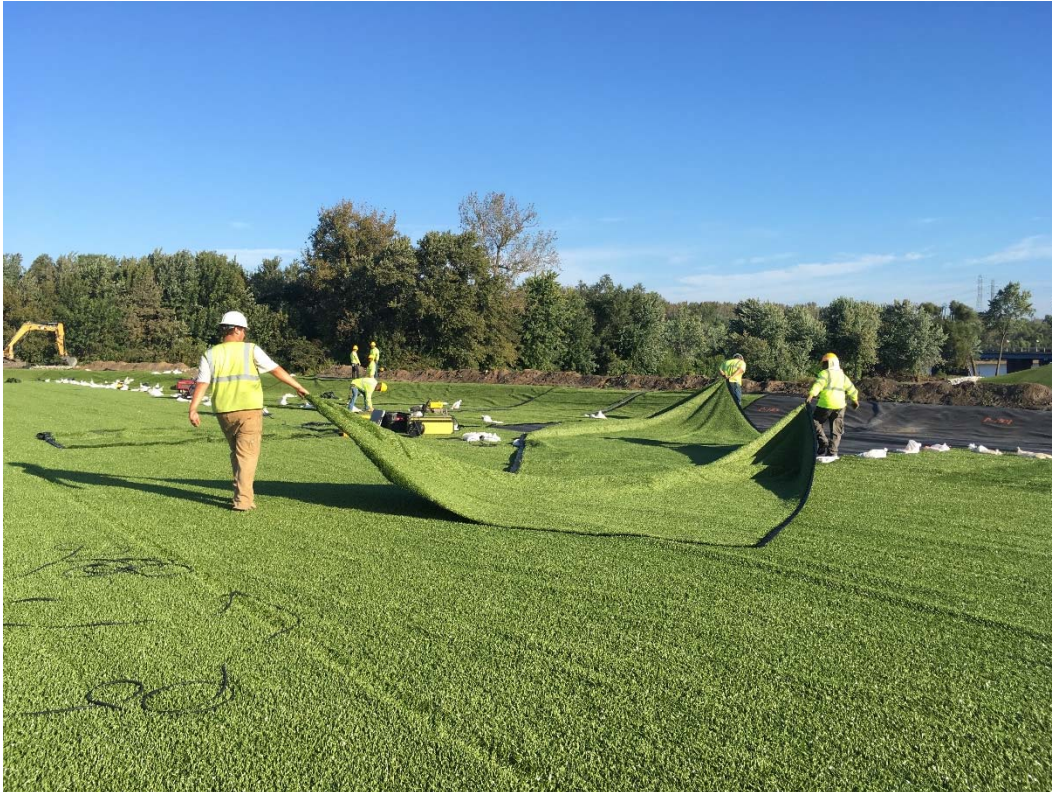
Photograph 2 ▲ - Typical view of engineered turf placement at the Fly Ash Pond, facing north.

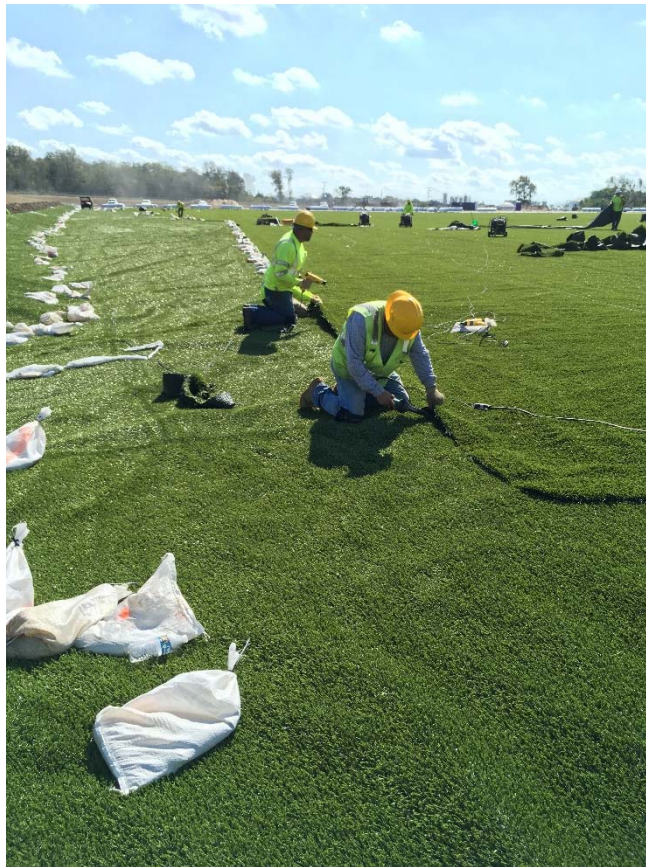
Photograph 3 ▲ - Typical view of engineered turf hand welding at the Fly Ash Pond, facing southeast.

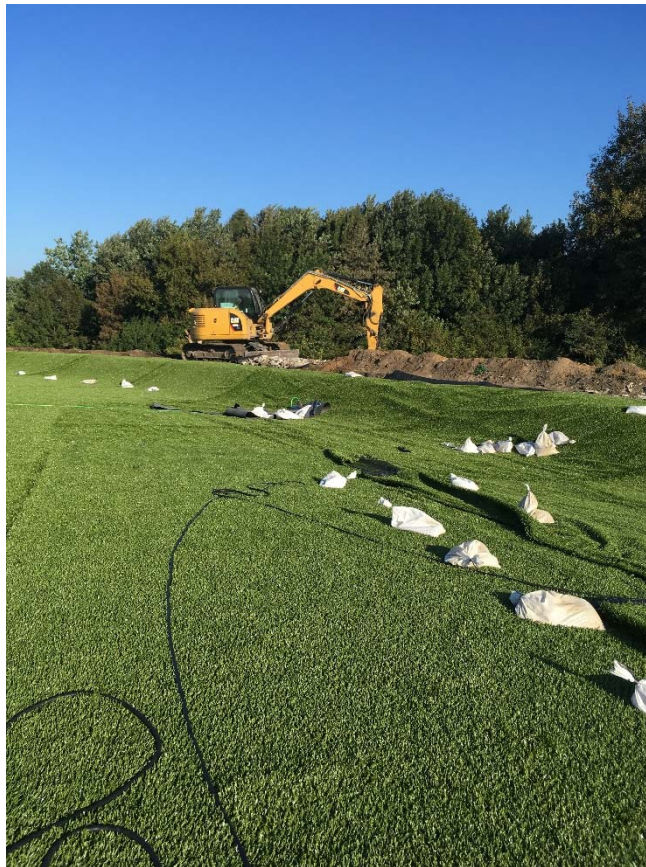
Photograph 5 ▲ - View of typical anchor trench backfill at the Fly Ash Pond, facing west.

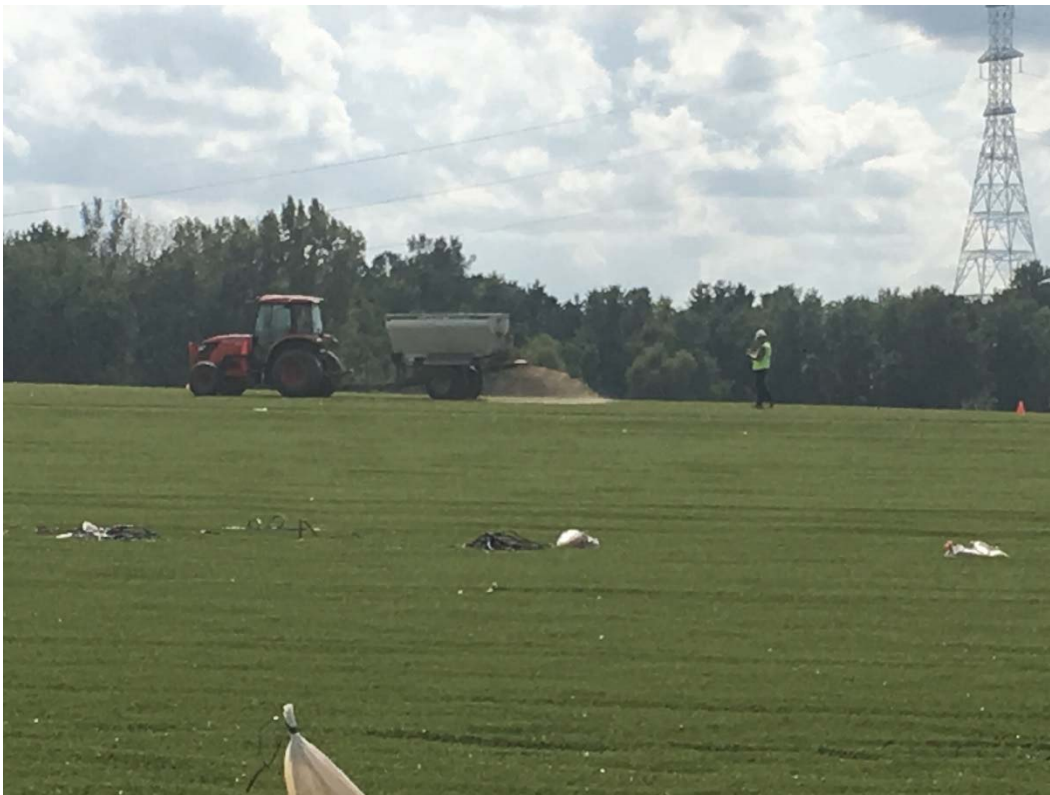
Photograph 6 ▲ - View of typical sand placement at the Fly Ash Pond, facing south.

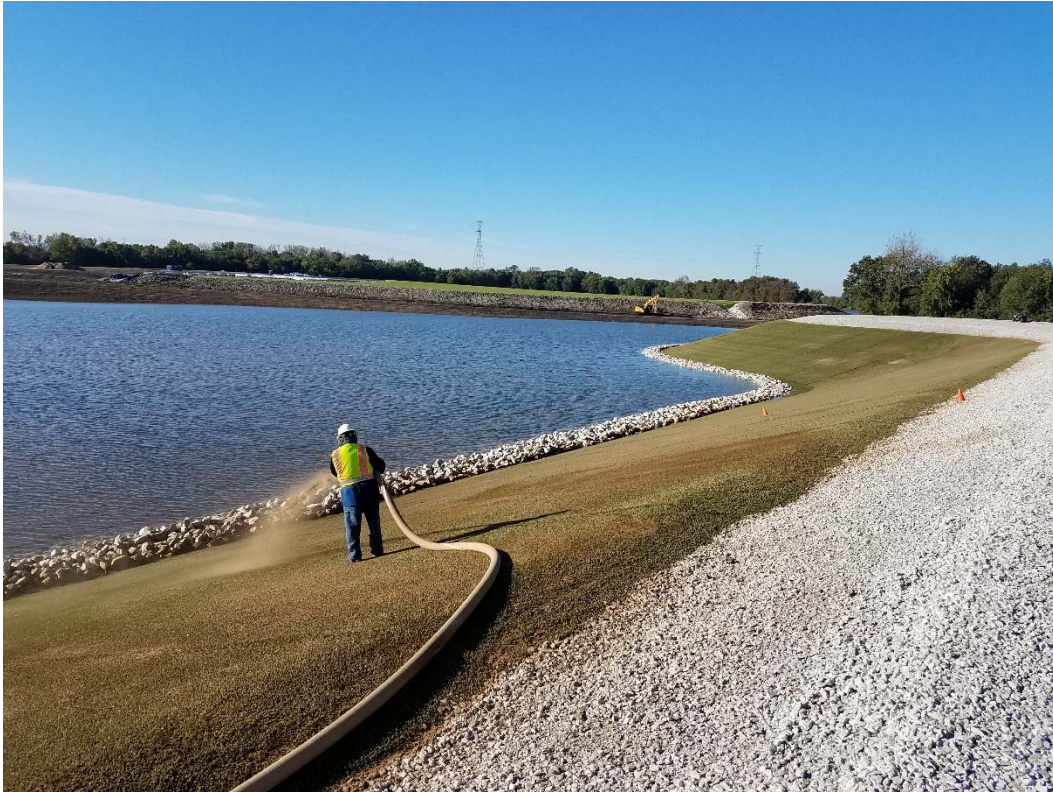
Photograph 1

- View of sand placement at the Bottom Ash Pond berm, facing west.

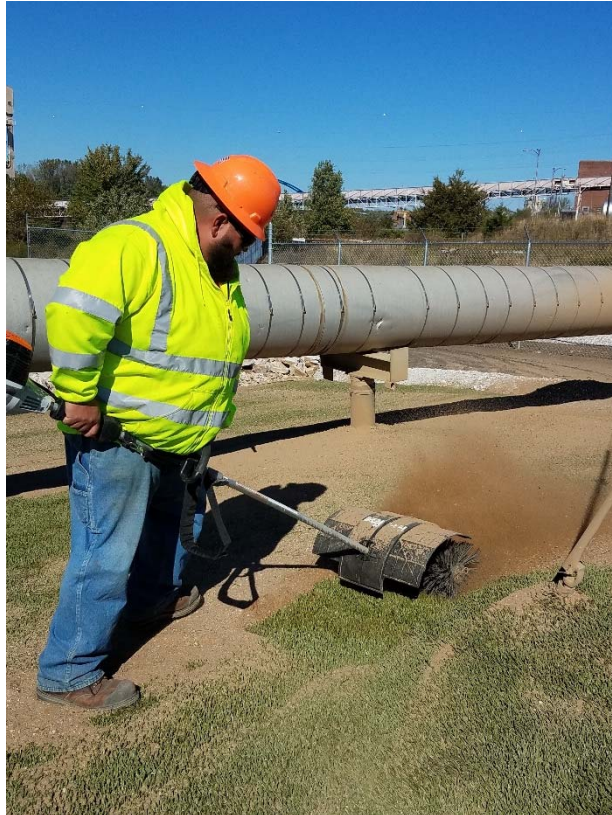
Photograph 3 ▲ - View of sand brushing at the Bottom Ash Pond berm, facing northeast.

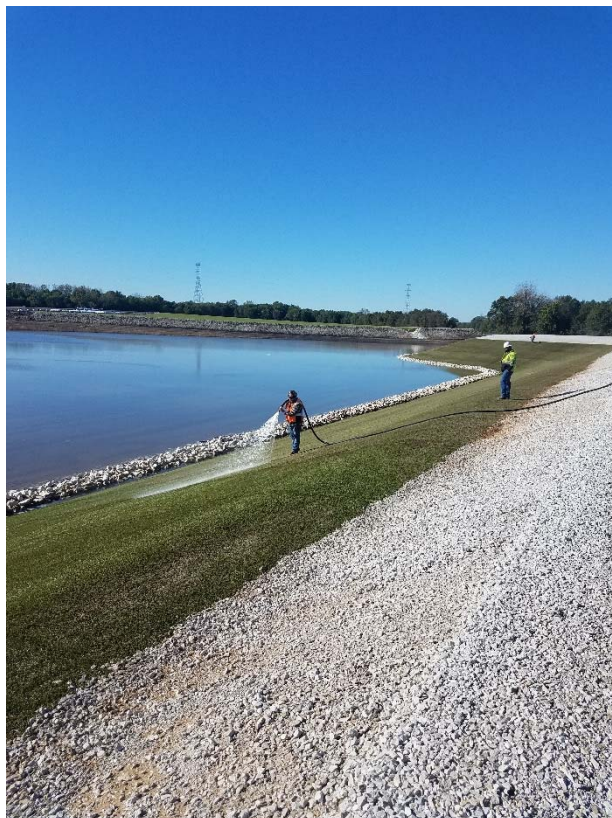
Photograph 4 ▲ - View of ArmorFill placement activities at the Bottom Ash Pond berm, facing west.

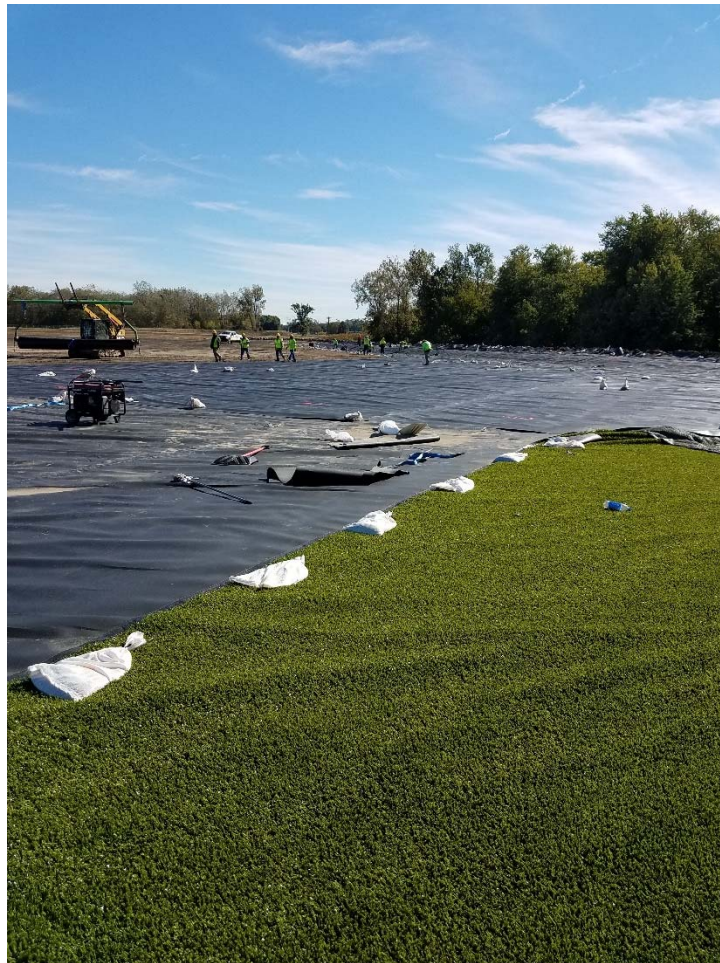
Photograph 5 ▲ - View of HDPE geomembrane placement at the Fly Ash Pond, facing southeast.

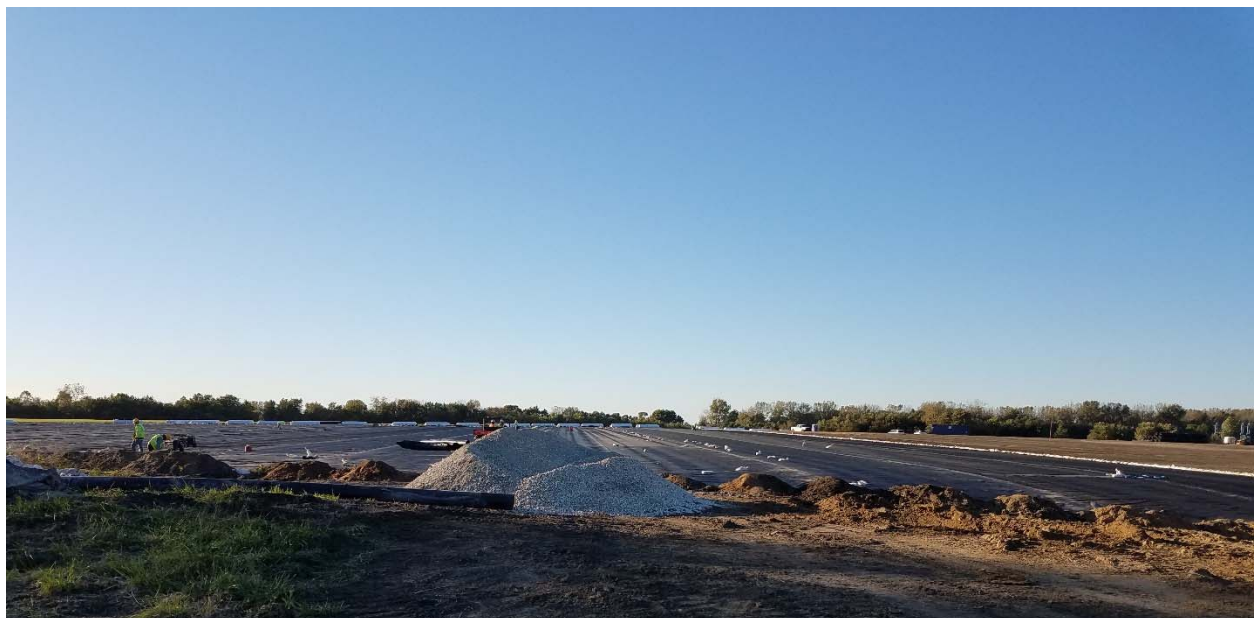
Photograph 6 ▲ - View of HDPE geomembrane placement at the Fly Ash Pond, facing northwest.

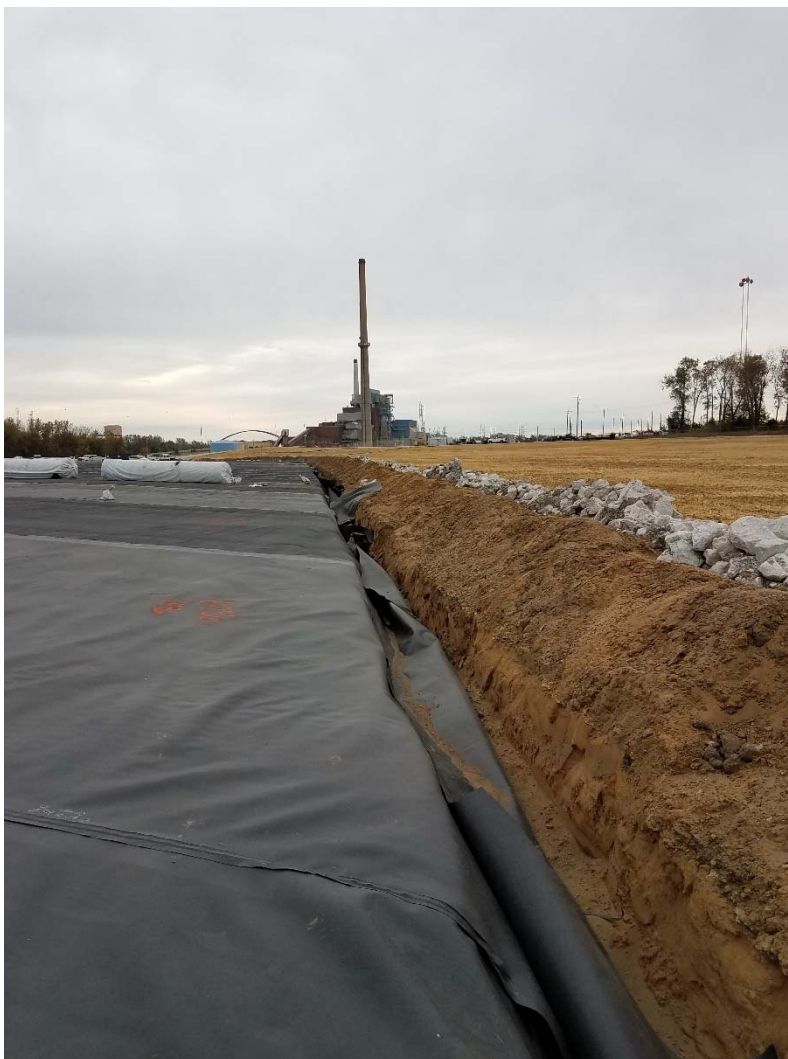
Photograph 2 ▲ - View of the eastern anchor trench at the Fly Ash Pond, facing northeast.

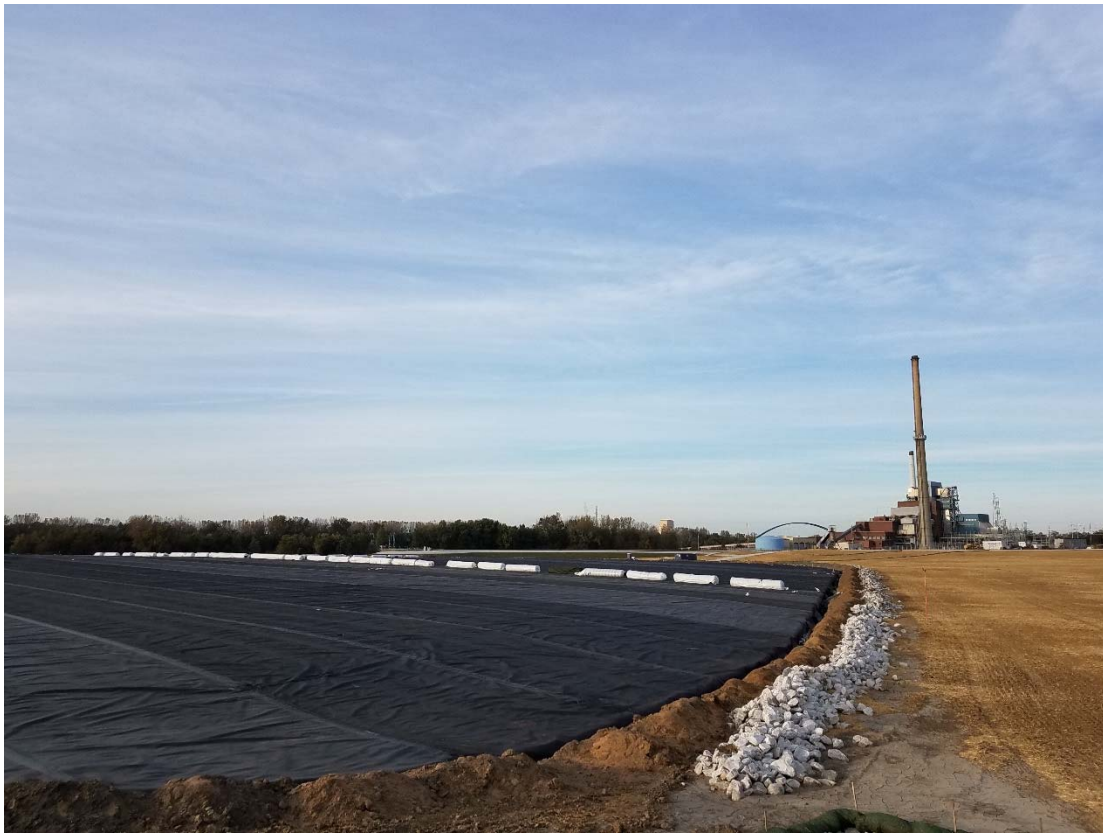
Photograph 3 ▲ - View of the Fly Ash Pond with 40 mil HDPE geomembrane and the seeded former Fly Ash Stockpile, looking north.

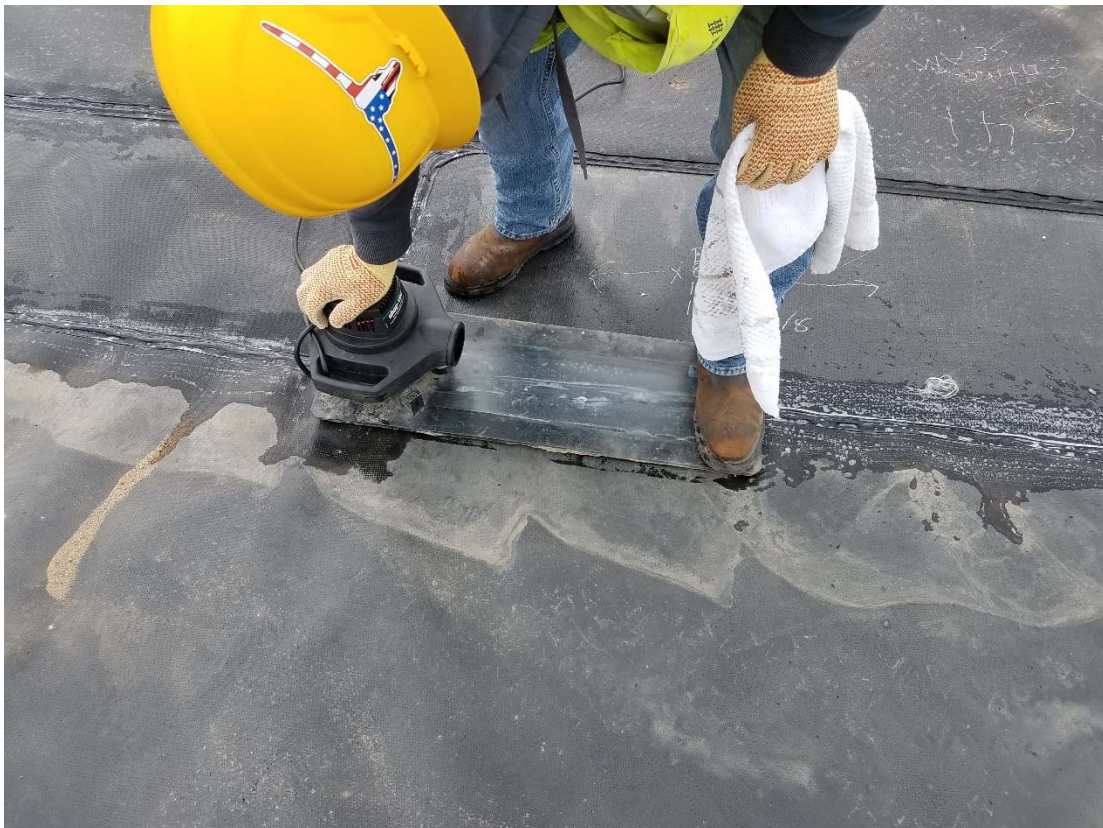
Photograph 4 ▲ - View of typical vacuum box testing of the 40-mil HDPE geomembrane.

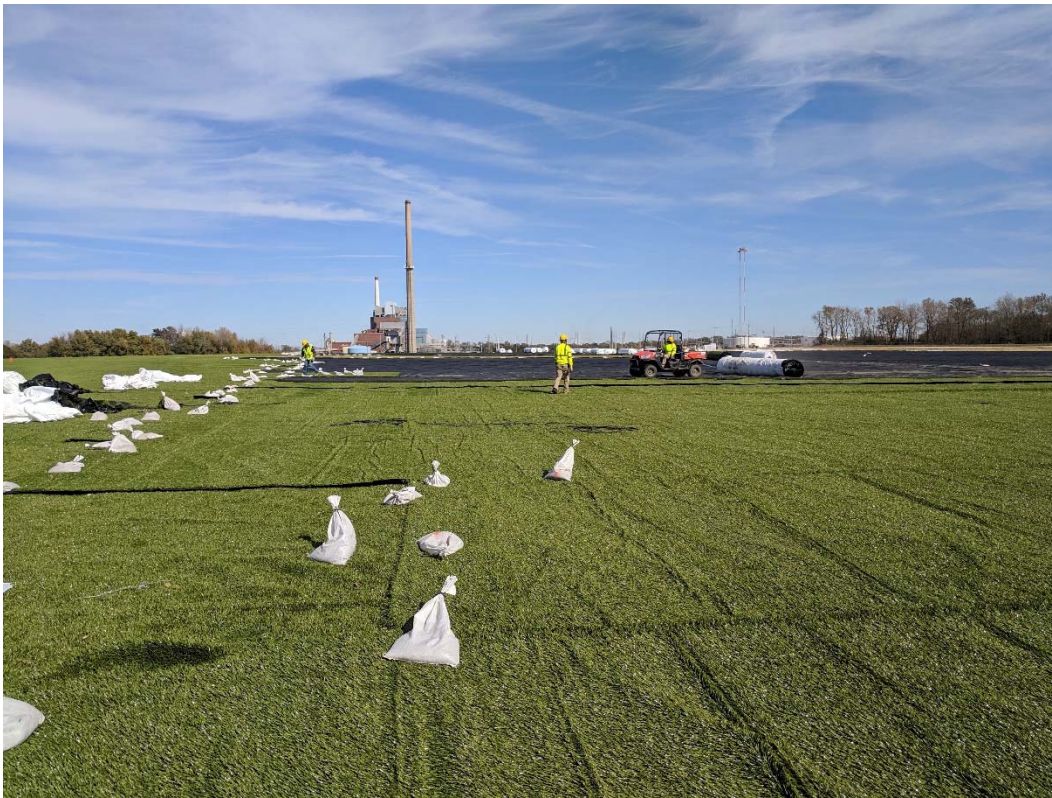
Photograph 1 ▲ - View of typical placement of the engineered turf geotextile, facing north.

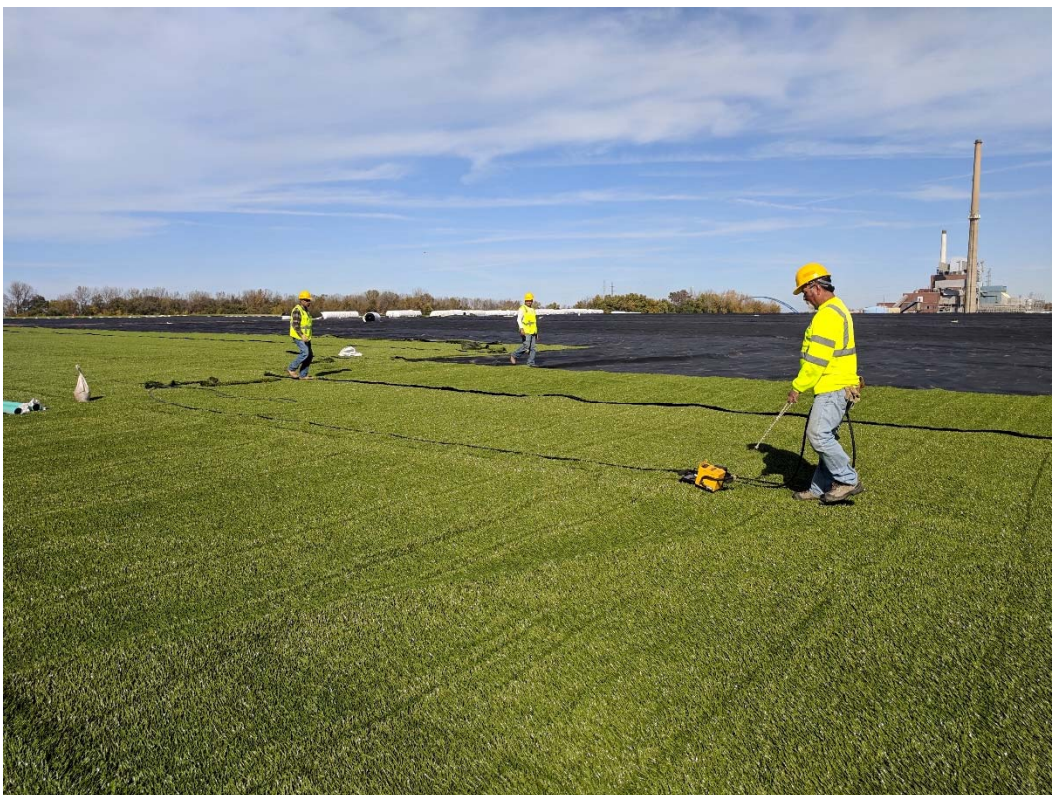
Photograph 2 ▲ - View of typical welding of the engineered turf geotextile, facing north.

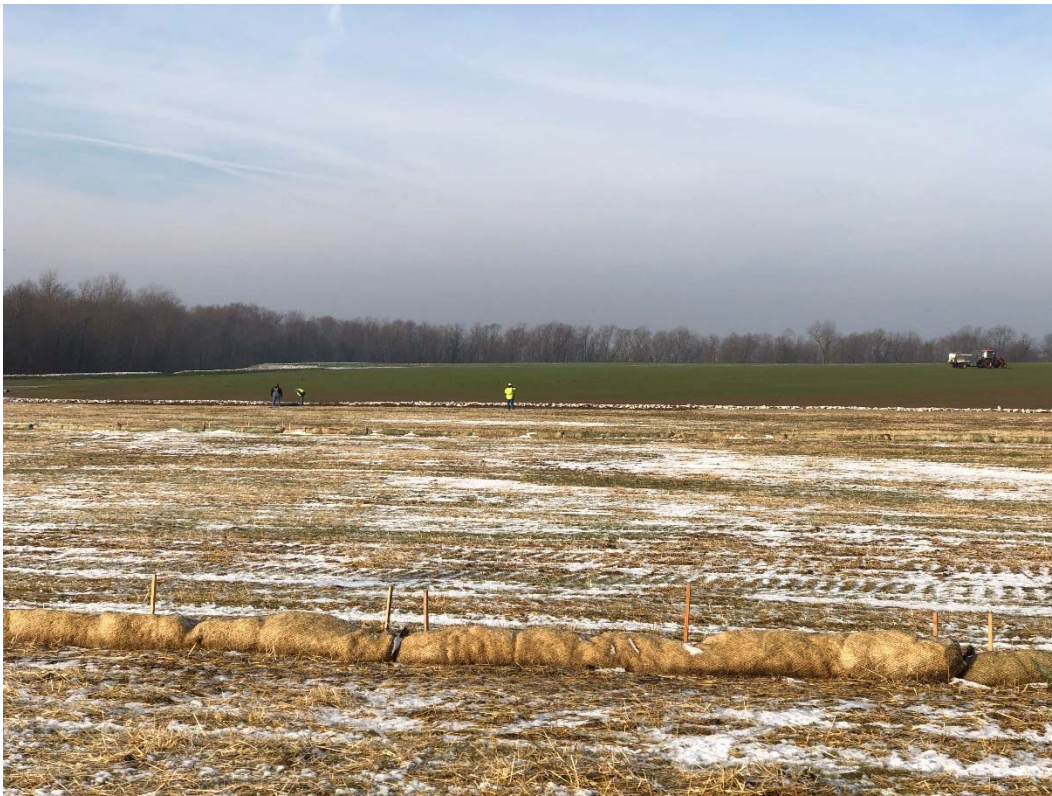
Photograph 1 ▲ - View of seeded Fly Ash Stockpile area, looking west.

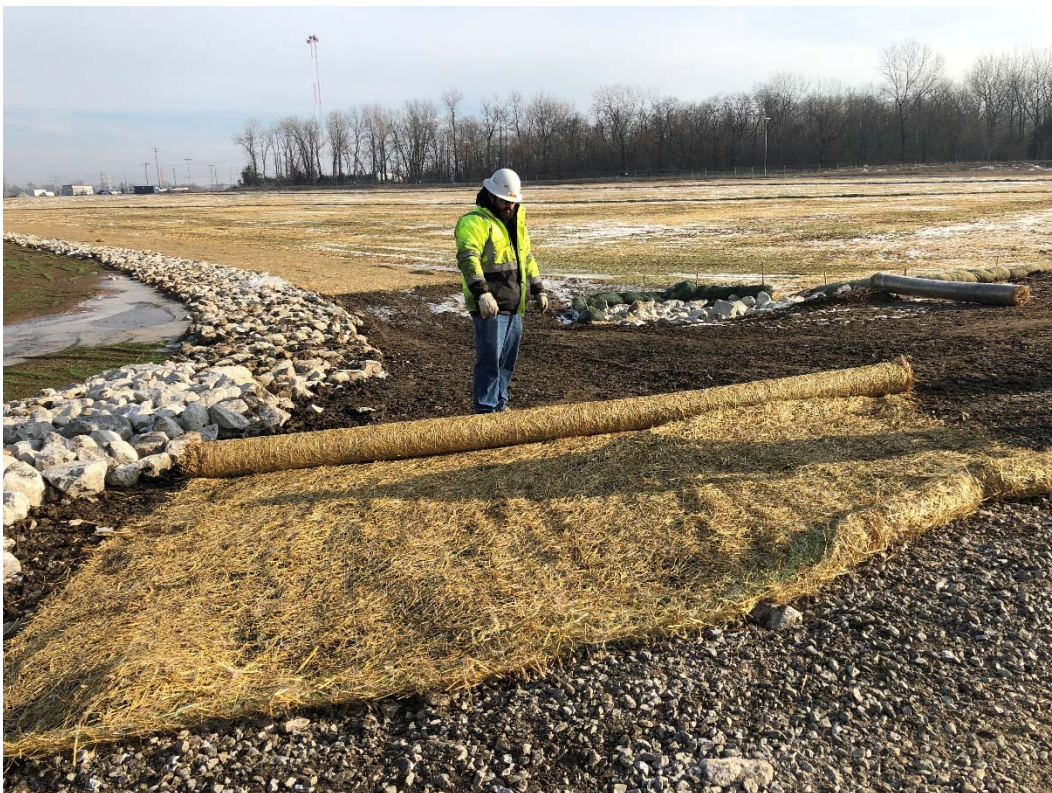
Photograph 2 ▲ - View of straw blanket placement near the Fly Ash Pond, facing northeast.

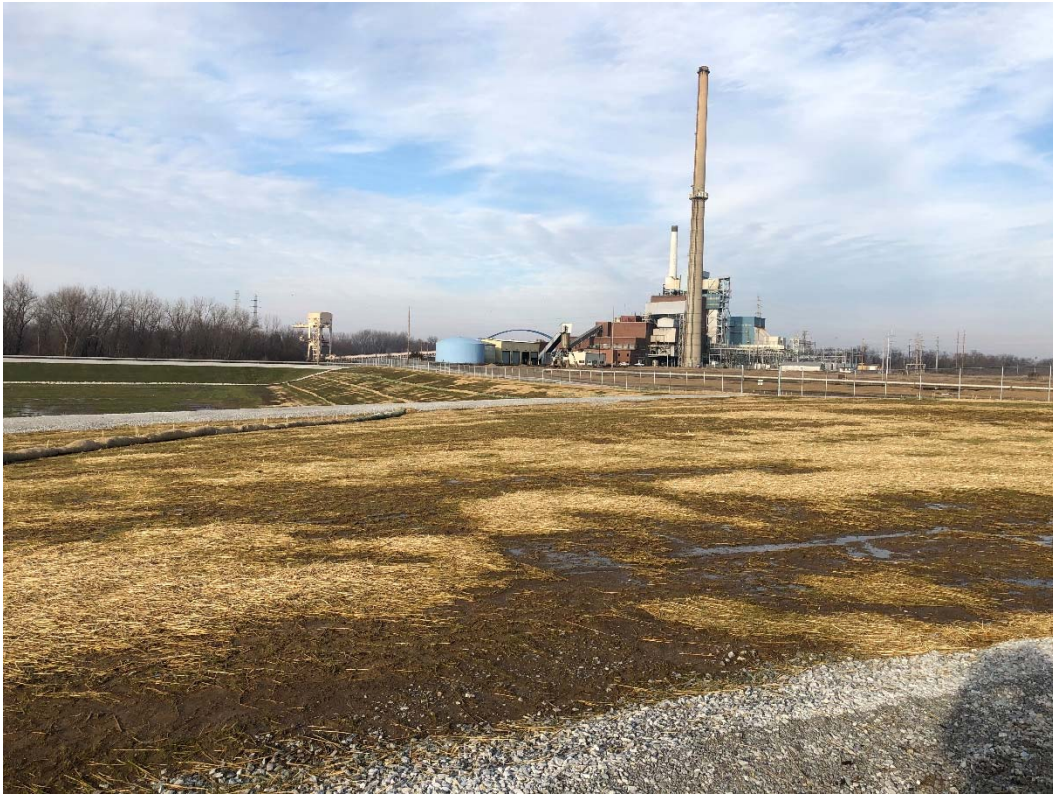
Photograph 3 ▲ - View of seeding and straw at the Bottom Ash Pond and adjacent areas, looking north.

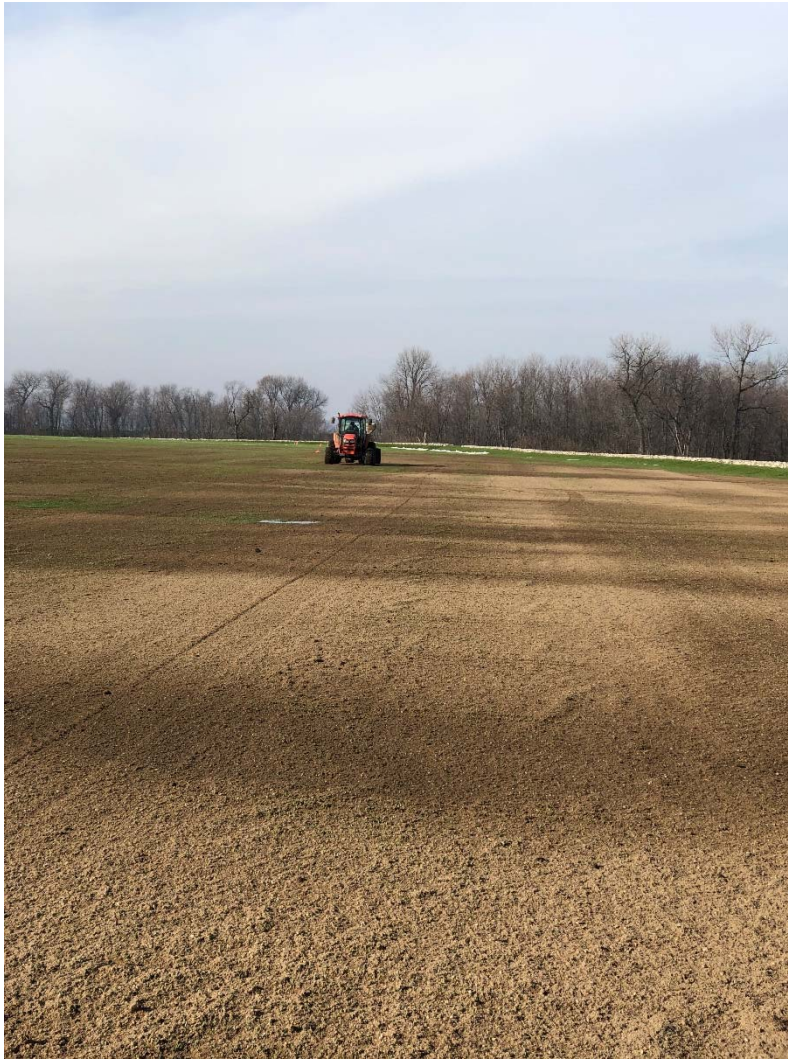
Photograph 4 ▲ - View of sand spreading activities, looking northwest.
