REPORT  
2020012463

**AMEREN MISSOURI LABADIE ENERGY CENTER  
EVALUATION OF CCR UNITS  
40 CFR PART 257  
FRANKLIN COUNTY, MISSOURI**

October 2021

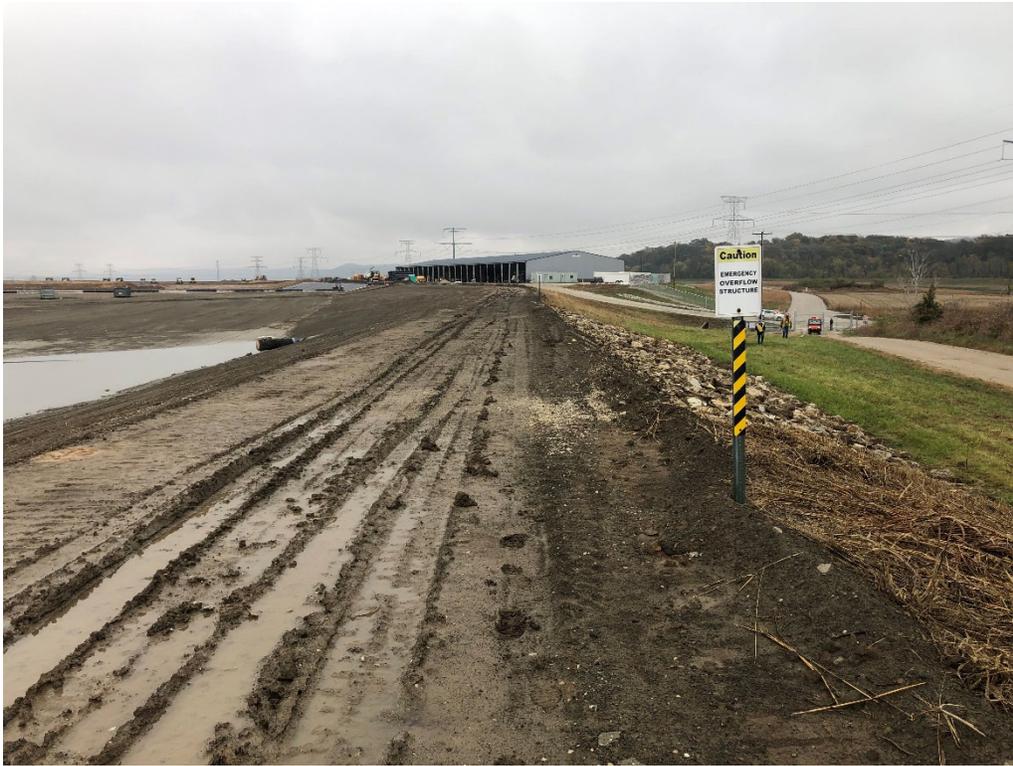
*Figure 3 – Embankment crest on southwest side of LCPA.*

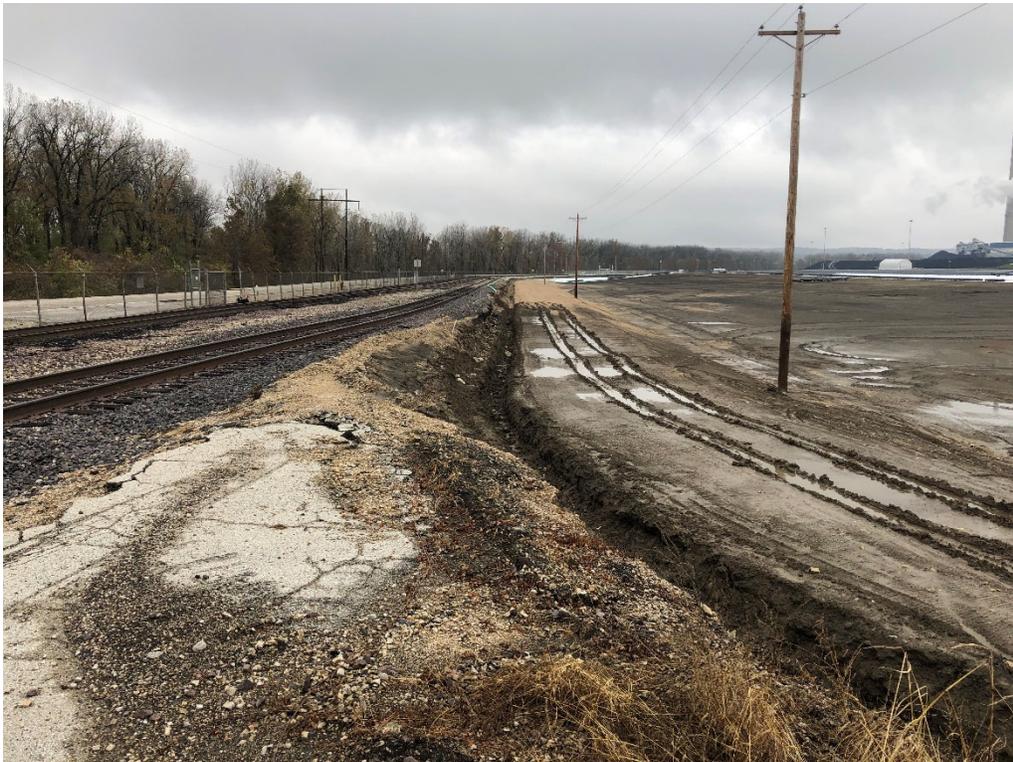
*Figure 4 – Embankment crest on the west side of the impoundment.*

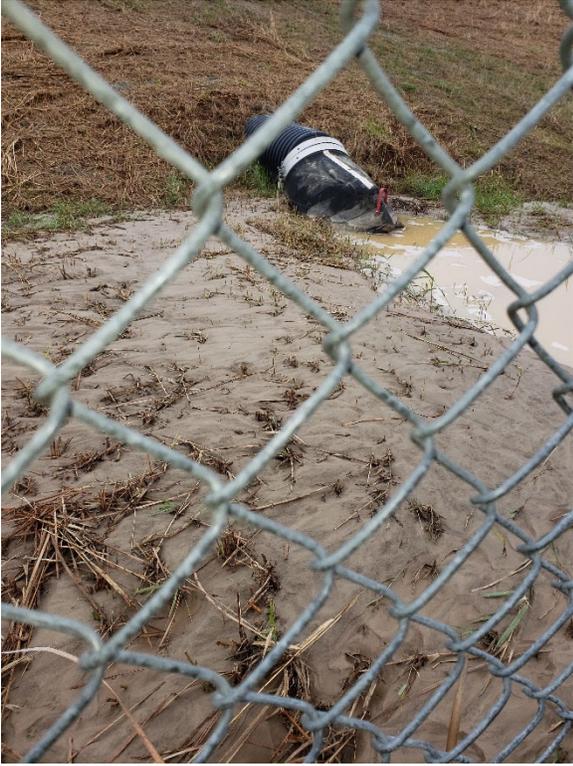
*Figure 7 – Duckbill valve at Station 8+00 is no longer attached.*

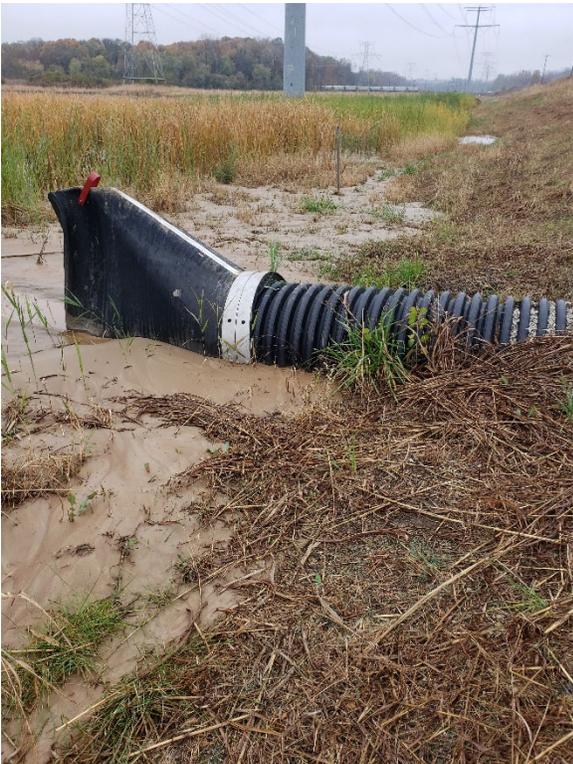
*Figure 8 – The duckbill valve at Station 16+00 is partially buried in sediment.*

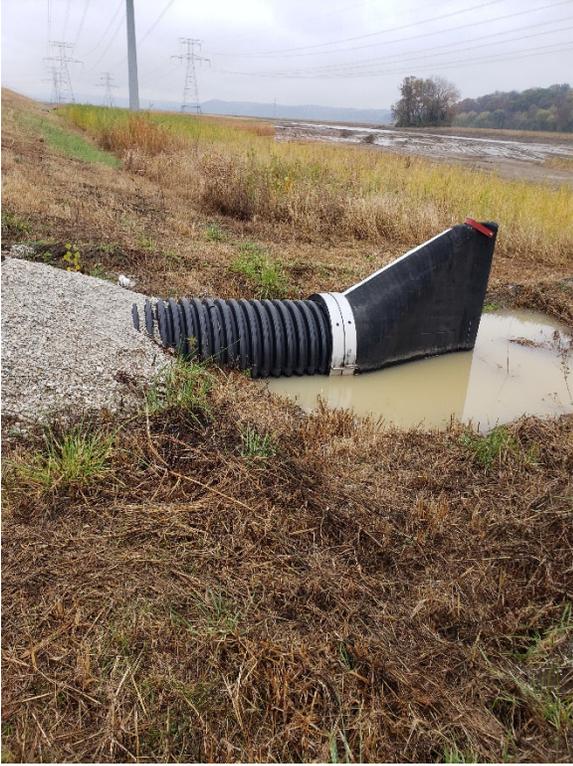
*Figure 9 – There is ponding above the invert of the duckbill valve at Station 21+00.*

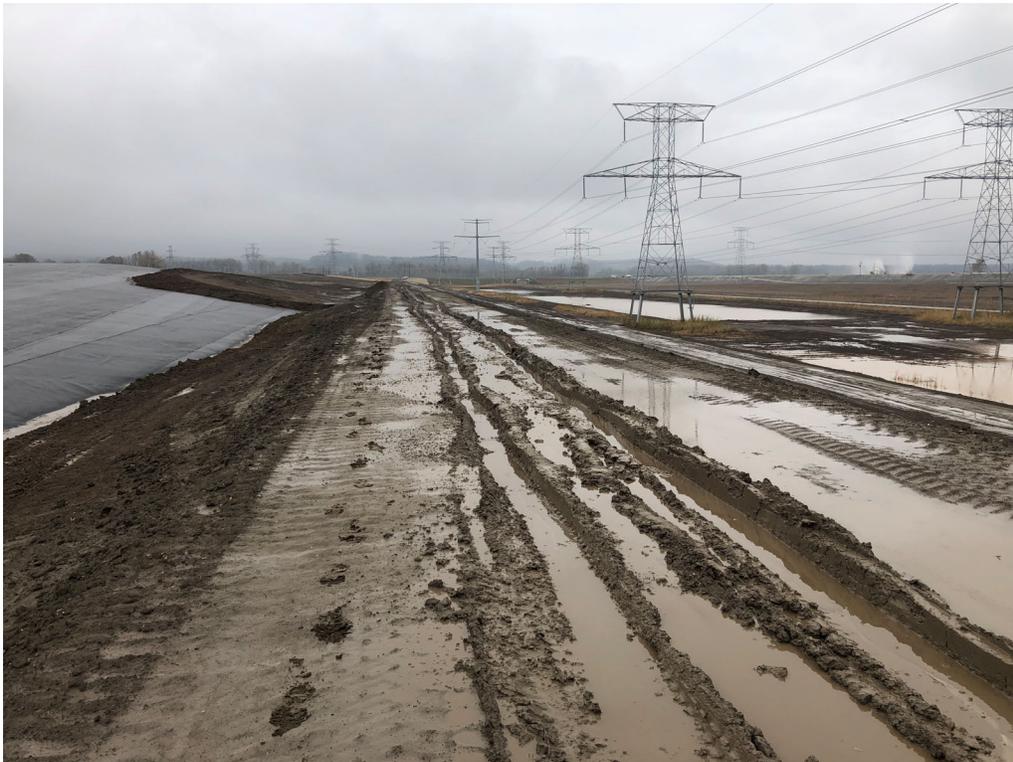
*Figure 2 – LCPB embankment crest with ruts on east side of the impoundment.*

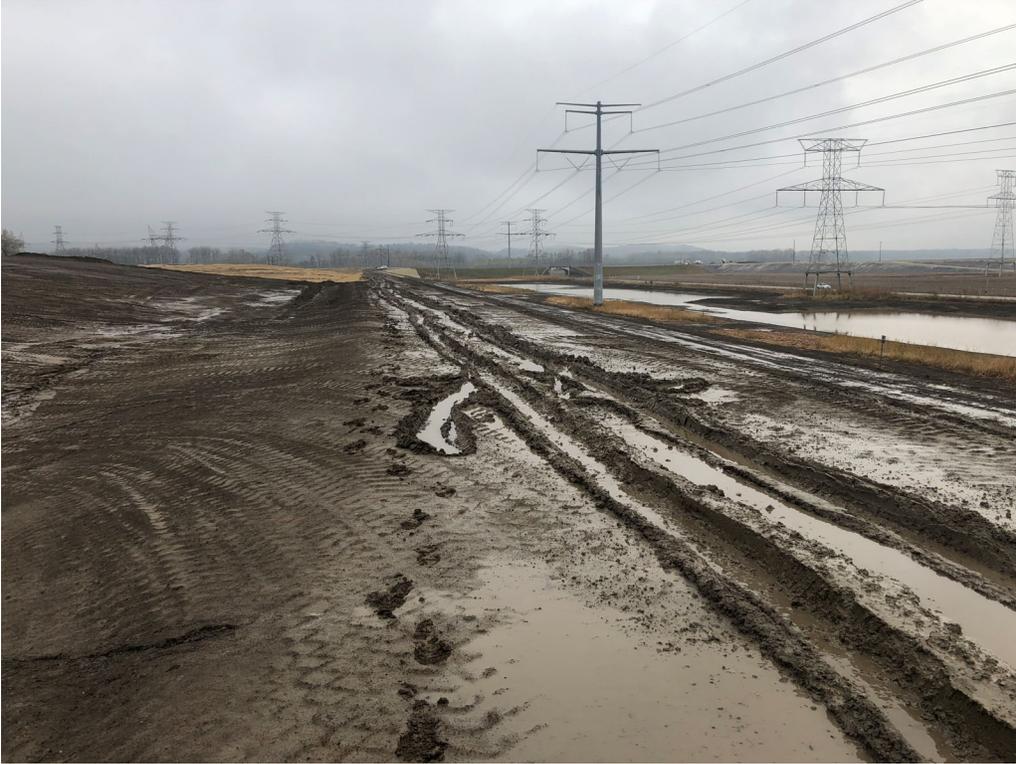
*Figure 3 – LCPB embankment crest with ruts on east side of the impoundment.*

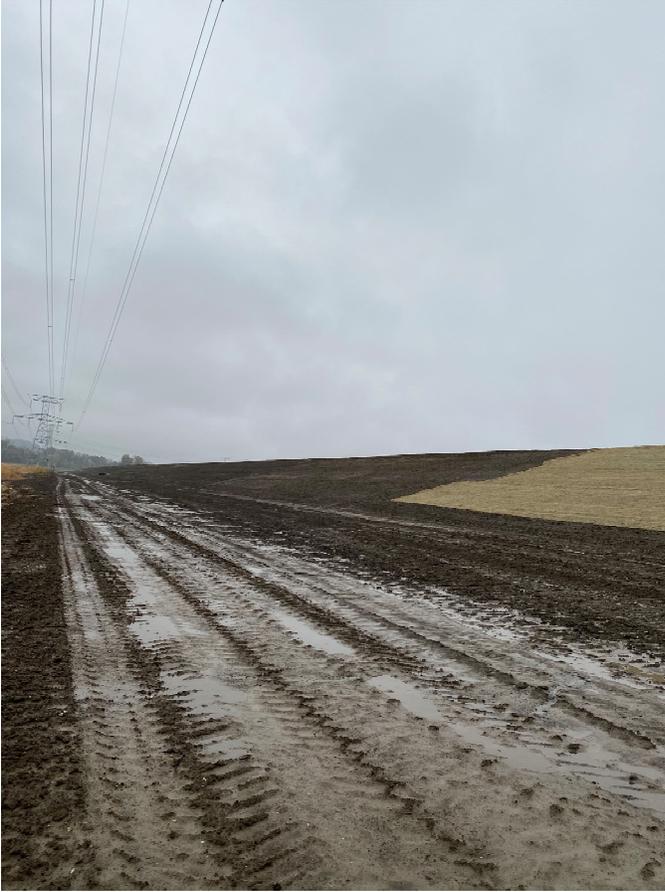
*Figure 4 – The downstream slopes have been highly disturbed by closure construction.*

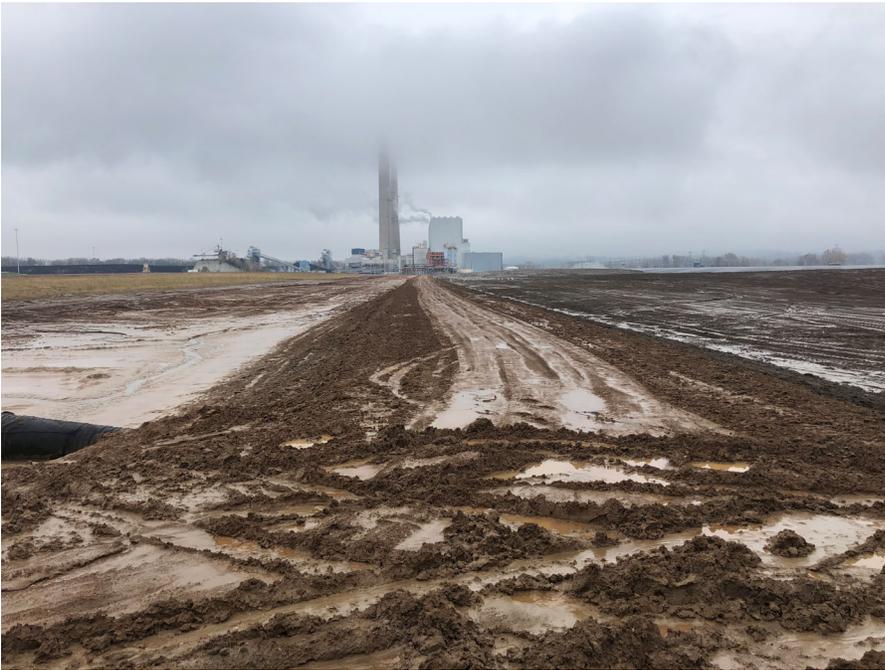
*Figure 5 – LCPB outlet works have been removed.*
